WORK DESCRIPTION FOR FIELD MEASURE

Code: 22P9790021 **Version: 2.1**

Check seam seal in left front wheel arch, rework if necessary

Model 295

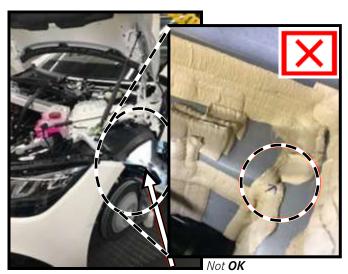
Figure 1

- 1. Remove left front fender liner rear section.
 - i For basic data, see AR88.10-P-1301EQE.
- 2. Check seam seal in left front wheel arch.
 - I Seam seal must be full-length (without interruptions).

- a. Seam seal in left front wheel arch not OK: Perform check/test procedure B.
- b. Seam seal in left front wheel arch OK: End measure.

- 1. Rework seam seal in left front wheel arch.
 - I Seam seal must be full-length (without interruptions).
- 2. Assemble in reverse order.
