WORK DESCRIPTION FOR FIELD MEASURE

Check gap dimension of fender to left and right tail lamp, rework if necessary

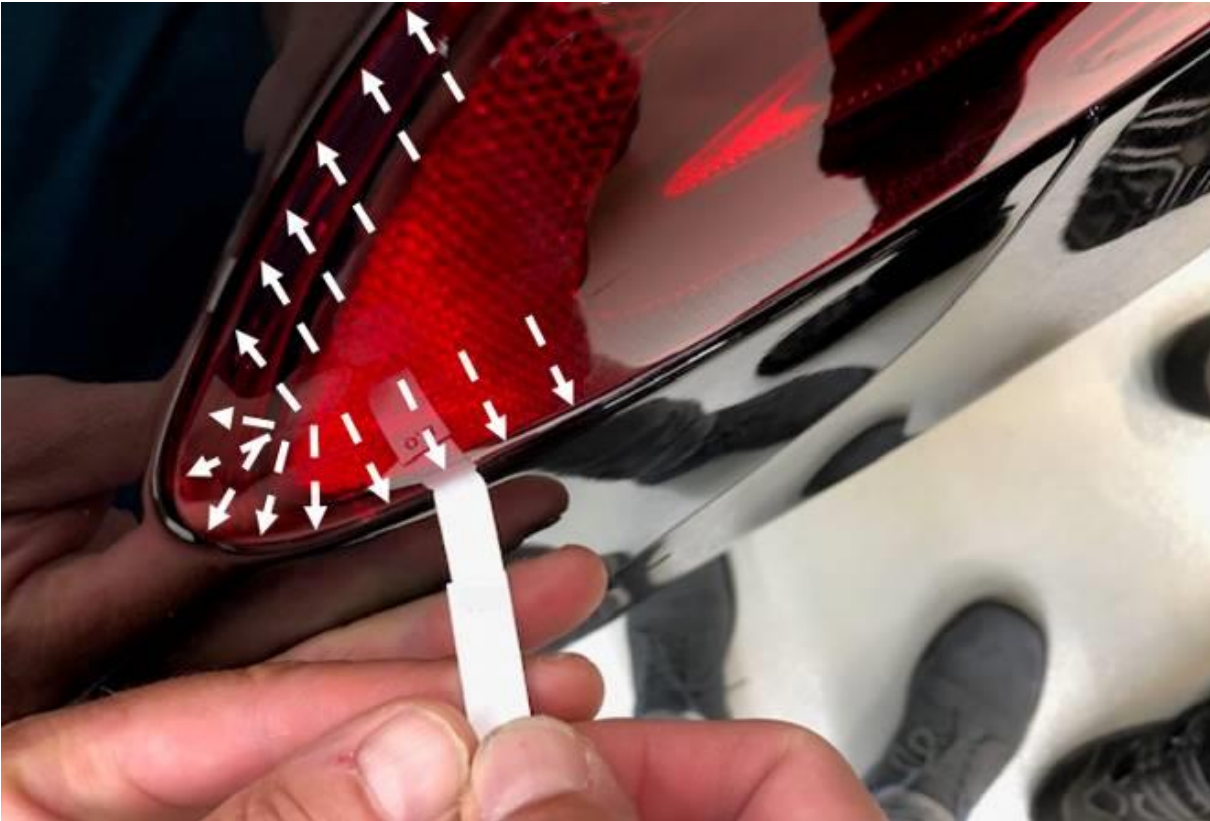
Figure 1

1. Check gap dimensions (figure 1) of tail lamp (left and right) to fender in radius.

i Specified value for fender to tail lamp = **1 mm +/-0.5 mm**

- a. If the gap dimension **does not** correspond to 1 mm +/-0.5 mm: Carry out **work procedure** .
- b. If there is paint damage due to a too small gap dimension: **Process paint damage in accordance with Mercedes-Benz specifications.**
- c. If gap dimension corresponds to 1 mm +/-0.5 mm: **End measure.**

1. Release tail lamp and reposition.

2. In the case of paint damage in the area of the lamp housing, carry out a paint repair.
