GROUP Body	MODEL 2013MY Sorento (XMa)
	NUMBER PS239	DATE March 2013

SUBJECT: RATTLE FROM THE RIGHT AND/OR LEFT SIDE OF DASHBOARD

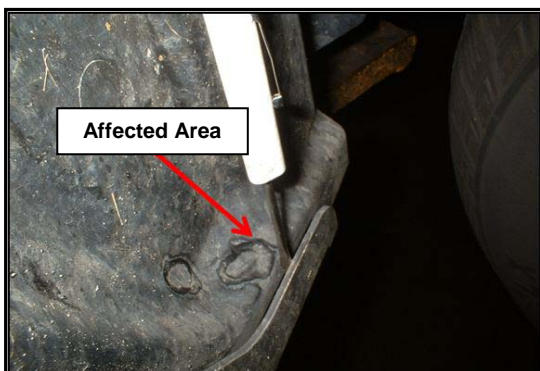
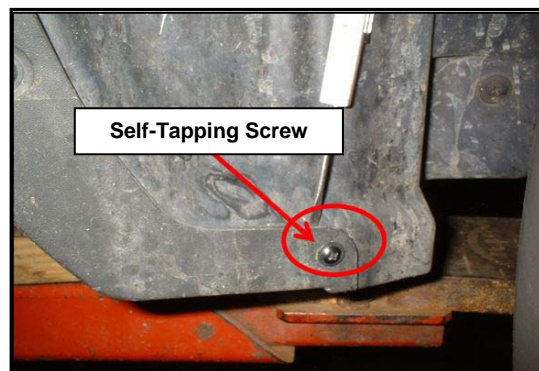
Some customers may complain of a rattle type noise coming from the right and/or left side of the dash while driving at highway speeds. This concern may be caused by the fender trim rubbing against the fender liner. To resolve this concern, use a self-tapping screw to secure the fender trim and the fender liner, as shown. Test drive the vehicle and confirm the noise is no longer present.
