MODEL
Optima Hybrid
(TF HEV)

NUMBER
PS241

SUBJECT: HARSH ENGAGEMENT FROM TRANSMISSION AT
LOW SPEEDS

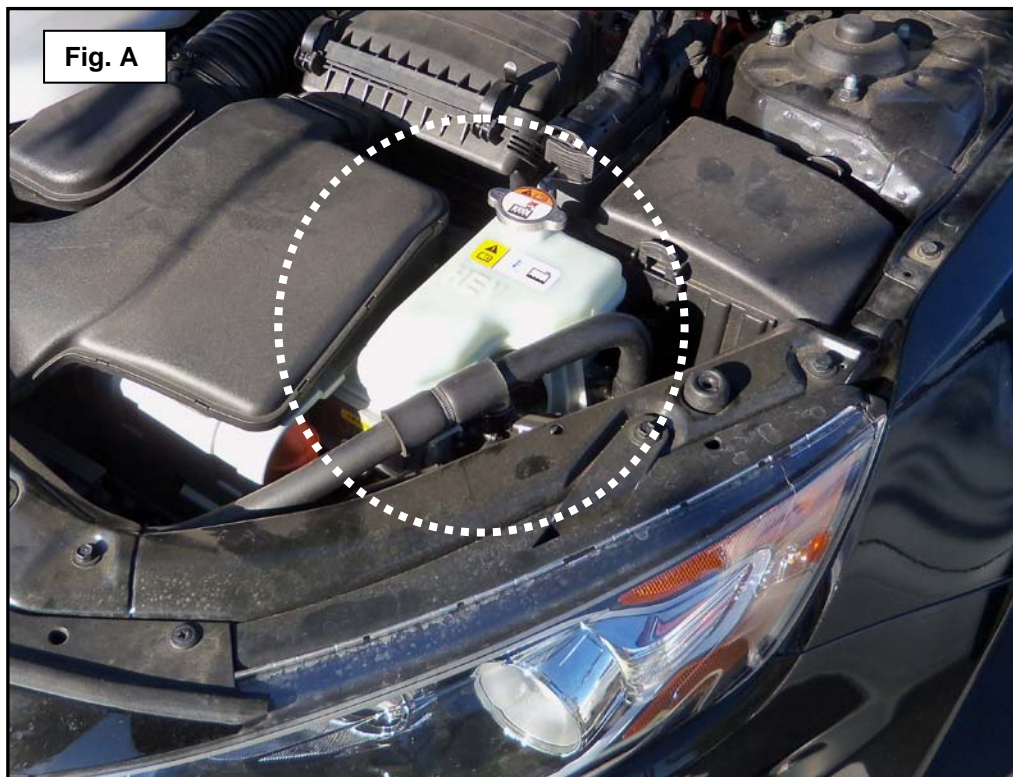
If you encounter a customer complaint relating to harsh engagement from the transmission at low speeds, check the HPCU/HSG coolant reservoir is at the proper level and that no leaks are present (Fig. A). Also, check the Electric Water Pump (EWP) operation using the GDS "Actuation Test". Do not rely on the "Success" message displayed on GDS as proof of proper pump operation. Listen for the pump noise coming from the right front fender area in order to confirm operation. If the EWP makes no noise while in operation, diagnose further and repair accordingly.
