MODEL  
Rio (UB)  
2012-2013MY

NUMBER  
PS244

**SUBJECT:** MOISTURE PRESENT ON PASSENGER SIDE FLOOR

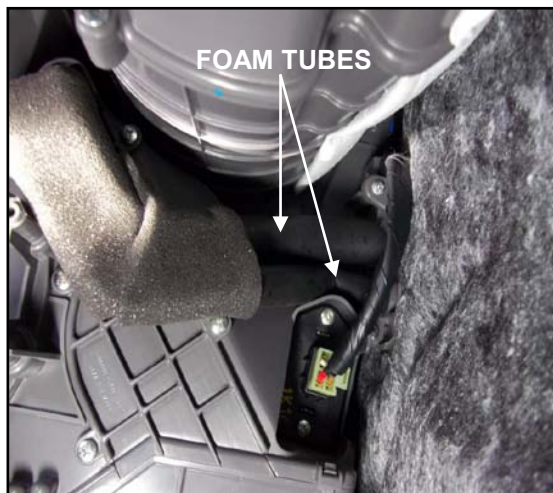
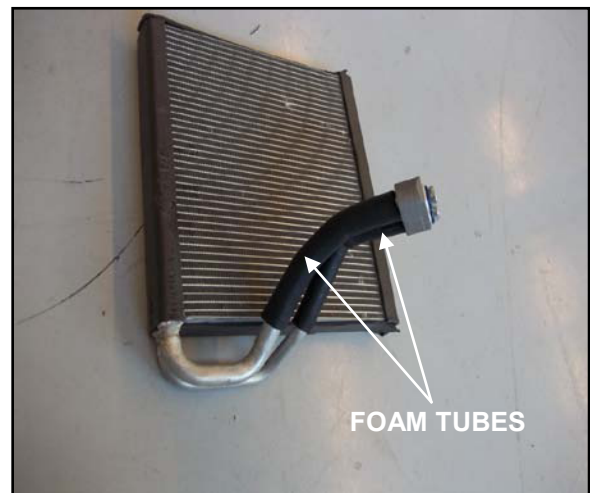
If you encounter a customer complaint relating to moisture being present on the passenger side floor, check the evaporator lines as a possible source for the moisture. On some 2012-2013MY Rio vehicles, the evaporator lines may have been insulated with foam tubes that may not be adhering properly to the evaporator lines and allowing for an air gap to form. This may cause condensation to form on the lines which may then find its way onto the passenger floor. Remove the evaporator and all insulation from the pipes. Locally source and apply new foam insulation tape to the lines, making sure to completely wrap the lines from the evaporator core to the expansion valve, in order to prevent condensation from reoccurring.
