GROUP
Engine

MODEL
2010-2013MY
Forte (TD)

NUMBER
PS267

SUBJECT: THERMOSTAT RE-INSTALLATION PROCEDURE – REPEAT REPAIR (DTC P0128)

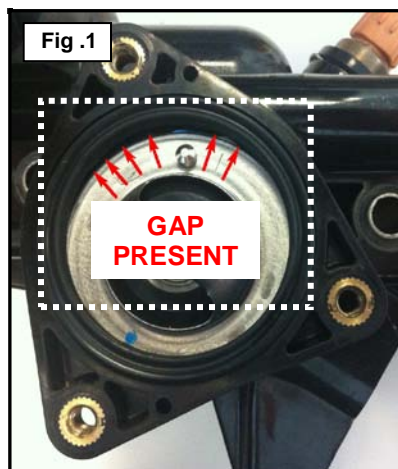
When diagnosing a Forte returning with a repeat DTC P0128 after replacement of the thermostat, remove the thermostat housing to verify if the thermostat was installed incorrectly during the previous repair. Incorrect installation may be difficult to determine due to the sideways orientation of the thermostat housing, however, pay close attention when the housing is removed for coolant flowing out and displacing the thermostat as soon as the housing is separated. In some cases if the housing is closely inspected, witness marks on the housing or gasket outside of the thermostat outer edge may be visible; if so, the thermostat was installed incorrectly (Fig. 1).

Improper Installation

To prevent any further repeat repairs, follow the procedure outlined on KGIS and remove all necessary components to gain proper access, **including the air box assembly**. Correctly position the thermostat in the housing by aligning the tab on the thermostat housing (Fig. 3) with the tab on the thermostat body (Fig. 4). Try rotating the thermostat to validate if it is properly indexed and seated. No movement should be possible, if properly installed. Make sure the thermostat does not move during installation of the housing as this could cause repeat repairs.

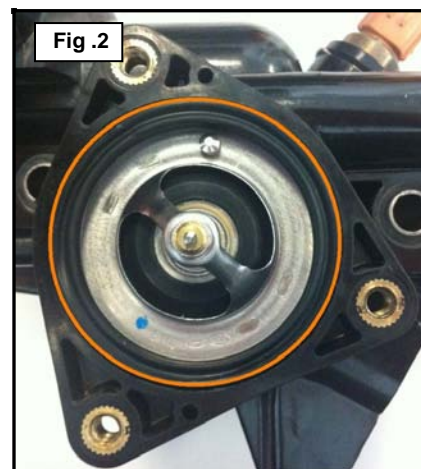
Proper Installation
