GROUP <b>Chassis</b>	MODEL <b>2011-2013MY Sorento (XM)</b>
	NUMBER <b>PS269</b>	DATE <b>April 2013</b>

<b>SUBJECT:</b> GRINDING OR CREAKING NOISE WHEN TURNING

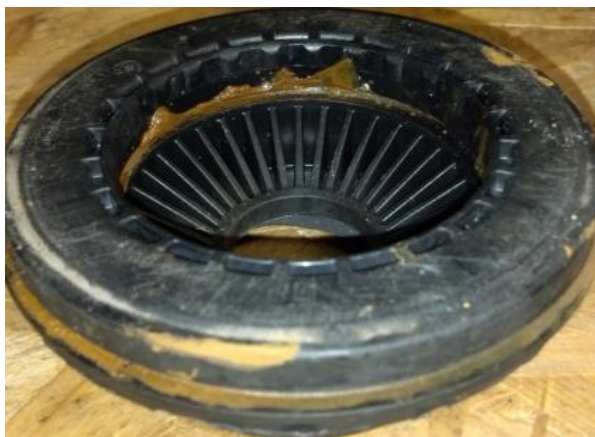
This article provides information regarding a potential grinding or creaking noise heard from the front of the vehicle when turning the wheel quickly at slow speeds, on some 2011 - 2013MY Sorento (XMa), produced prior to August 28, 2012. This concern may be caused by corrosion of the Front Strut Bearing due to water or debris entry and is more commonly found in regions with higher snowfall and road salt usage.

Verify the customer complaint of a grinding or creaking noise during turning and remove the front strut bearings for inspection. If there is a rough feeling when turning the bearing by hand, replace it with a new part and recheck to verify that the noise is no longer heard.
