GROUP Body	MODEL 2014~2016MY Cadenza (VG)
	NUMBER PS282 (Rev 1, 04/28/2015)	DATE January 2014

SUBJECT: RATTLING, SQUEAKING OR CREAKING NOISES FROM ROOF AREA

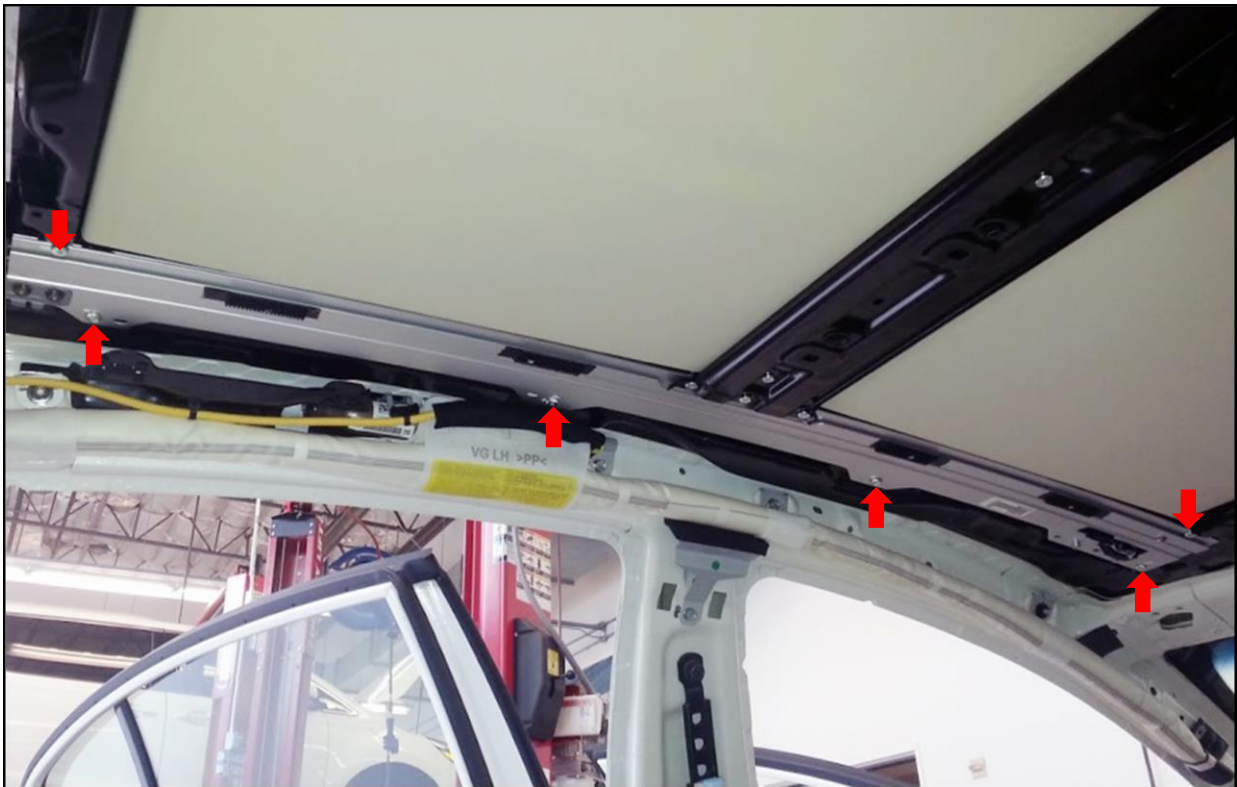
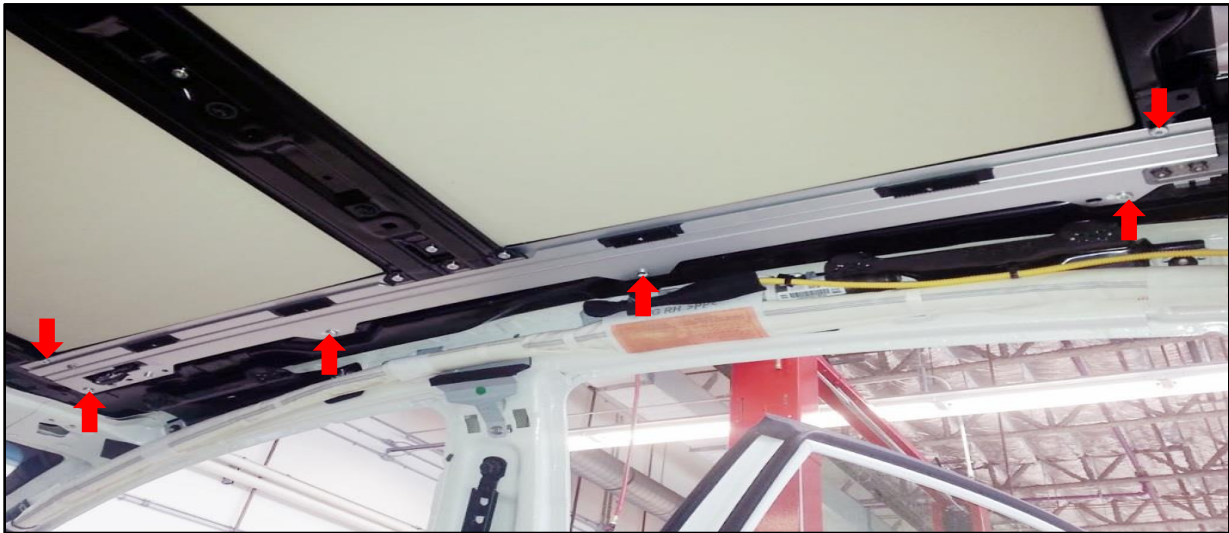
Left and right side rails:

Check for possible loose Torx® head screws in the Panorama Sunroof mounting rails and crossbar. If any bolts are found to be loose, make sure to re-tighten them to specifications.

1. Drop the headliner by referring to the Service Information in KGIS under “roof trim” replacement. **NOTE: Complete removal of the headliner from the vehicle is NOT necessary to perform this procedure.**
2. Fully recline the two front seatbacks to provide more room for the headliner to be lowered and for easier access to the twenty-two (22) Torx head screws. **NOTE: Be very careful when handling the headliner, as it is very susceptible to creasing.**
3. Use an inch-pound torque wrench to properly torque all of the Torx® head screws, as shown below, on the left, right rails and center cross bar of Panorama Sunroof.

Torque specification for the Torx® head screws: 53 in-lbs (4.4 ft-lb, 5.96 Nm) **Note: do NOT over-tighten the screws.**
