MODEL
2014MY
Soul (PS)

NUMBER
PS300

DATE
May 2014

SUBJECT: INCORRECTLY ROUTED HIGH PRESSURE A/C LINE

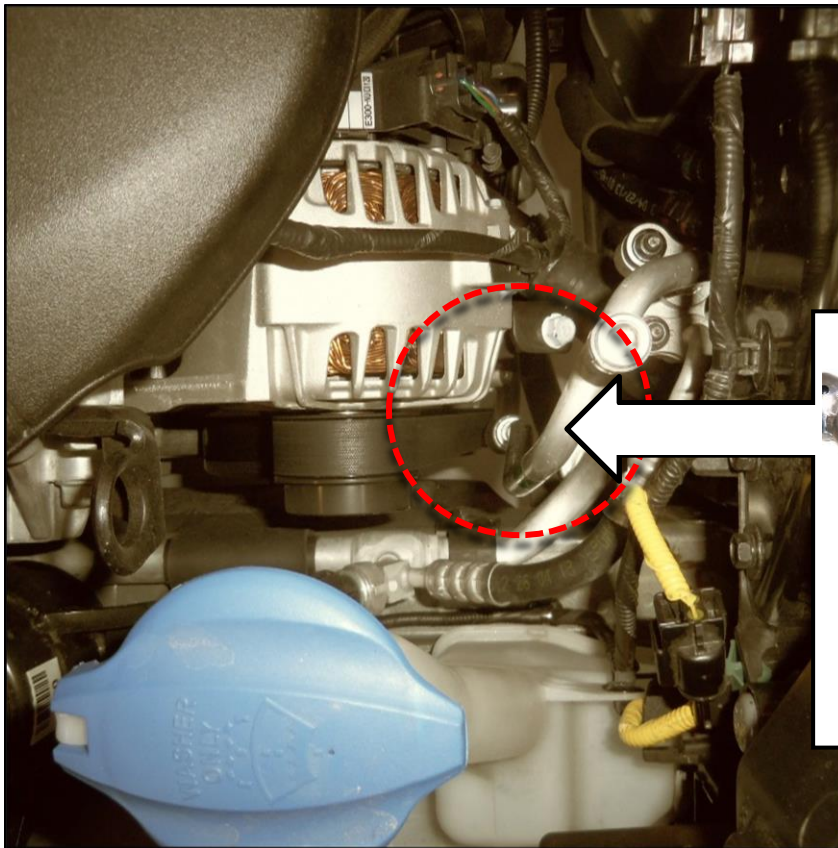
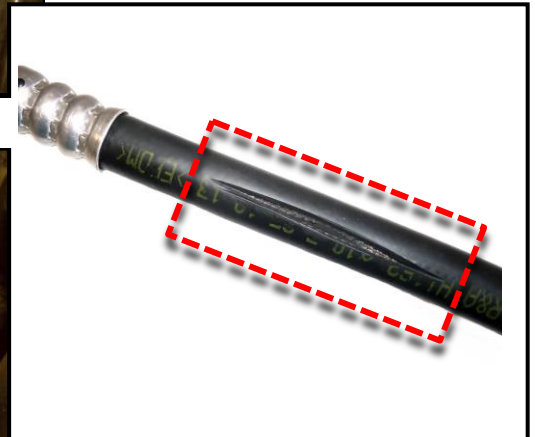
Some 2014 Soul (PS) produced prior to February 7, 2014, may exhibit a concern related to poor performance from the A/C system, accompanied by low refrigerant. In such cases, check the routing for the A/C high pressure line to make sure it is not coming into contact with the accessory drive belt (see image). If the line has come into contact with the belt and has sustained damage, replace the line and recharge the system to resolve the concern.
