GROUP Body	MODEL 2006-2014MY Sedona (VQ)
	NUMBER PS306	DATE June 2014

SUBJECT: SECOND ROW SEAT RELEASE MECHANISM INOPERATIVE

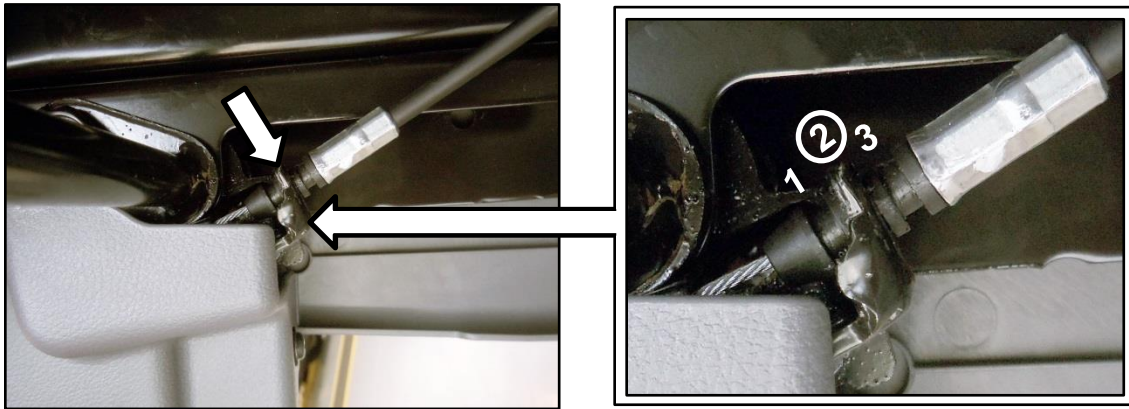
2. Check the current position for the seat release cable adjuster. The default setting from the factory is in slot two (2).

3. If more tension is required to operate the release mechanism, remove the cable adjuster from the default slot and place it in slot one (1).
4. If there is excess cable tension in the mechanism, remove the cable adjuster from the default slot and place it in slot three (3).
5. Operate the seat release handle to make sure the seat will tumble forward.
6. Repeat the steps above on the opposite side second row seat, if necessary.
