MODEL  
2014MY  
Sorento (XMa)

NUMBER  
PS323

**SUBJECT:** INTERMITTENT POPPING NOISE FROM REAR OVER BUMPS

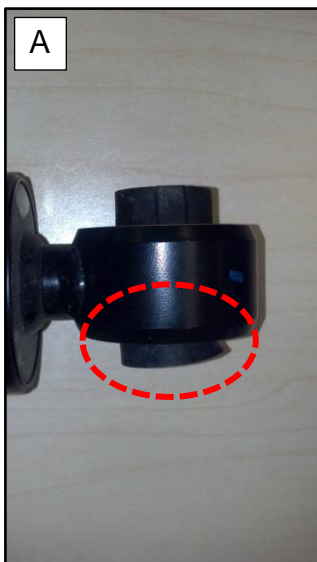
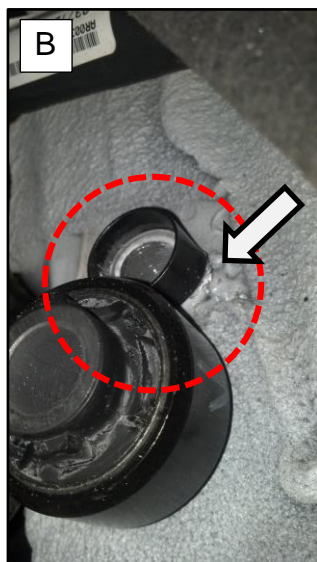
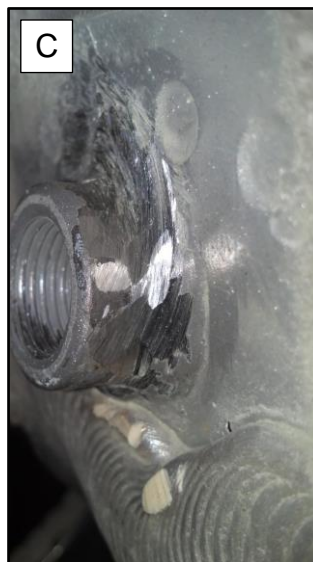
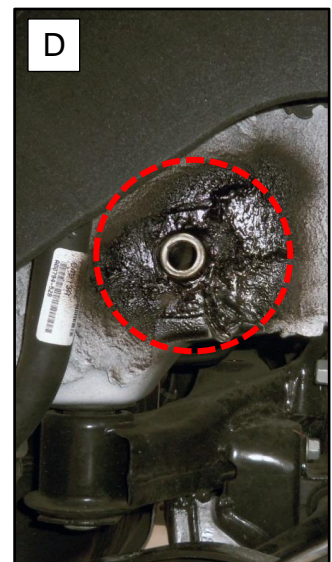
On some 2014MY Sorento (XMa) vehicles, built before September 26, 2013, a customer may complain of a very intermittent light knock, or popping noise, heard from the rear of the vehicle over rough road surfaces. This condition is caused by an excessive amount of weld bead applied around the rear shock upper mount which prevents the shock from being seated squarely against the vehicle body mount and may cause damage to the mounting flange on the shock absorber (A).

To correct this concern, remove the shock absorber and inspect for an excess amount of weld bead around the upper rear shock absorber vehicle mounts (B). If excess weld bead is present, use a die grinder, or small abrasive disk, to remove the excess material until the shock will sit flush against the mounting surface (C). After all excess material has been removed, spray any exposed surfaces with rubberized undercoating (D). If the original shock is damaged, install a new shock absorber and submit a warranty claim using the op code in the LTS. Finally, test drive the vehicle to confirm the repair.
