## **SVE BULLETIN**

QVM Bulletin: Q-277 Date: 29 August 2017

## <u>Under Hood Electrical Equipment Mounting</u>

Models Affected: 2017 and later Model Year Super Duty Pickups and Chassis Cabs

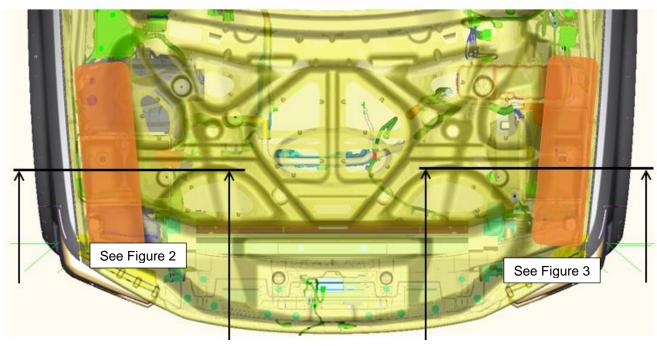
Ford has received a number of reports of upfitted chassis cab trucks that have experienced electrical grounding concerns, resulting in interior smoke, odor, and in some cases, fire. Ford recently investigated this concern with several upfitters and concluded the cause was aftermarket electrical equipment involving B+ power contacting the underside of the hood.

Do not mount or place electrical equipment, including but not limited to connection terminals, cables, relays, fuses, and fusible links on top of or near the primary or secondary battery in a location that has low clearance to the underside of the hood as indicated by orange rectangles in the figures that follow.

Figure 1: 2017 Super Duty Under Hood Plan View. Low clearance to underside of hood in areas highlighted in orange

The reduced clearance to the underside of the hood for added electrical equipment on top of or near the primary or secondary battery may not be apparent when the hood is open. If any B+ equipment is mounted in the low clearance zone as indicated by the diagram, a minimum of 15mm must be confirmed between bottom of hood and any equipment (including any B+ shielding and under hood insulation) mounted in the engine compartment when hood is fully closed. Several methods exist to confirm equipment and shielding meets minimum clearance to bottom of hood (e.g. clay test, borescope).

The upfitter must ensure that any electrical equipment or shielding mounted under hood does not come into contact with the hood or hood components.

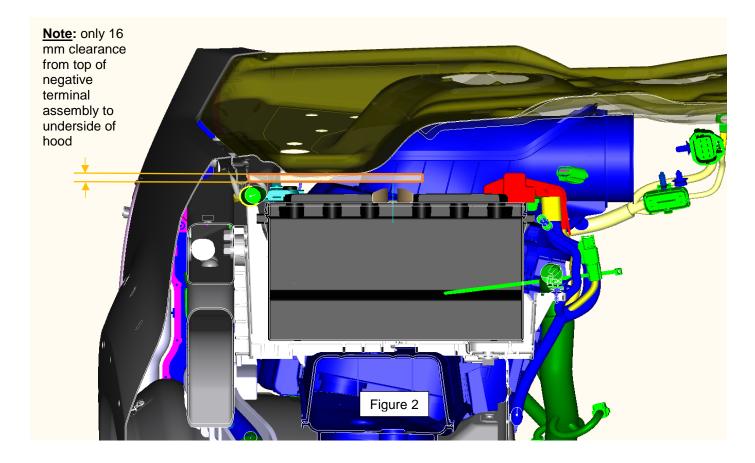
<u>Figures 2 & 3:</u> Vehicle X-Sections. low clearance areas (orange rectangles) for aftermarket equipment between battery & hood inner
