Wind Noise From Moon Roof

Service Category Vehicle Exterior

Section Sliding Roof/Convertible

YEAR(S)	MODEL(S)	ADDITIONAL INFORMATION
2005 – 2008	tC

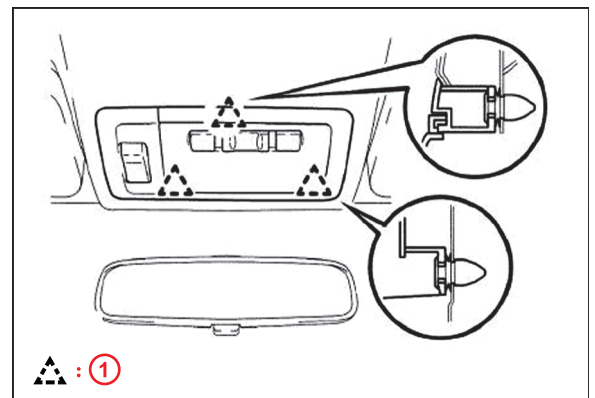
Figure 1.

1	Clip
---	------

2. Remove the map light assembly.
 - A. Using a clip remover, detach the 3 clips and remove the light.
