# Service Bulletin

Bulletin No.: PI0675

**Subject:** Information for No Trouble Found (NTF) Turbochargers Returned to Warranty Part Center (WPC)

**Models:** 2011-2012 Chevrolet Cruze  
2012 Chevrolet Sonic  
Equipped with Engine RPO LUJ or LUV

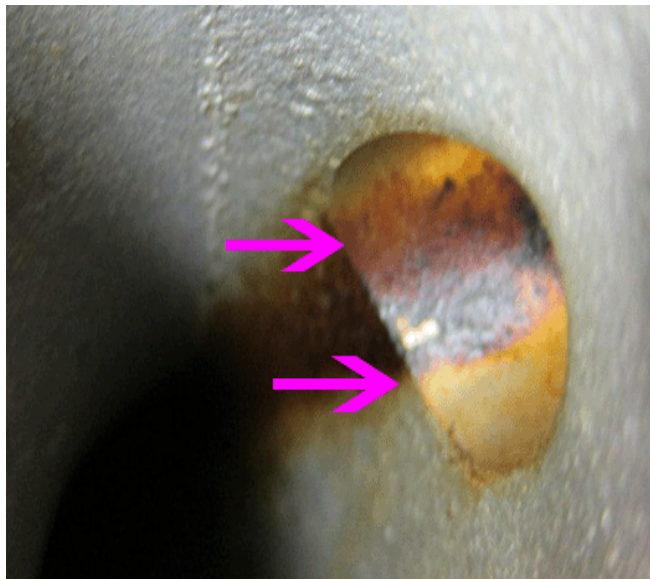
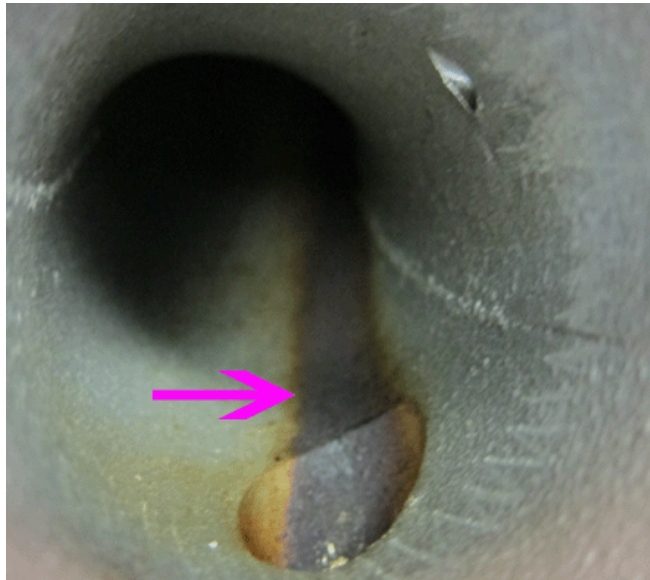
**Notice:** The views shown in the graphics are for identifying NORMAL oil staining in the opening for the PCV fresh air intake hose and the stain travel into the TC bore and DO NOT represent an oil leak.

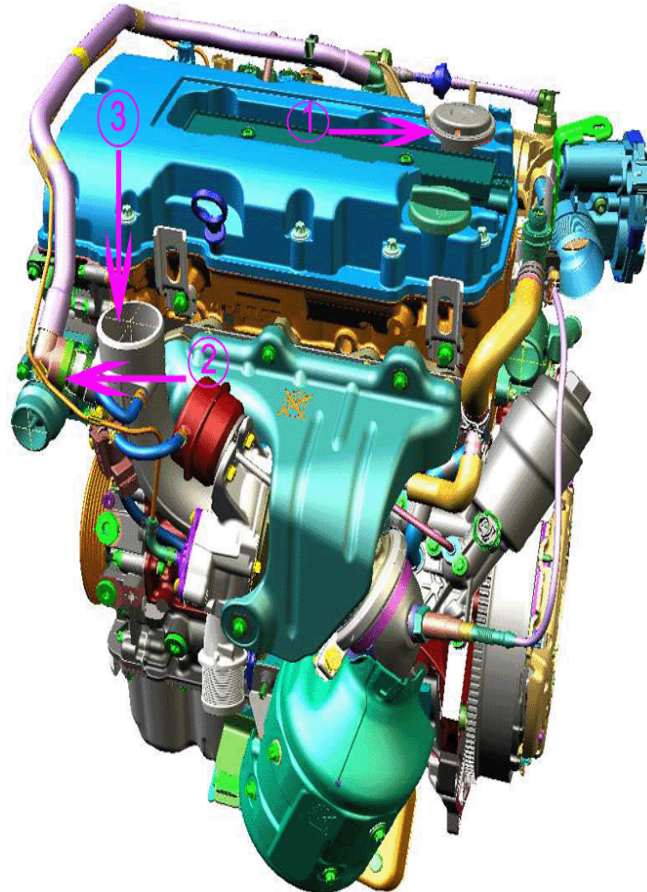
2762383

7. Inspect the inside of the turbocharger outside air inlet tube (3) for oil leaking into the opening in the TC bore for the PCV fresh air intake hose.
  - ⇒ If oil is leaking into the opening in the TC bore for the PCV fresh air intake hose, proceed to Step 8.
  - ⇒ If oil is not leaking into the opening in the TC bore for the PCV fresh air intake hose, proceed to Step 10.
