Service Bulletin

Bulletin No.: PIT5171C

Subject: Service Stability, Traction, ABS Rear Wheel Speed DTC Or Chassis Expansion And High Speed Bus Communication Fault

Models: 2010 - 2013 Chevrolet Equinox
 2010 - 2013 GMC Terrain
 With Any Combination of DTCs U0073 U0074 U1826 U1827 U18A2 U0125 C0196 C0287
 C0186 C056D C0045 C0050 Symptom 00 06 3B 4A 4B 5A 39 42 54 71

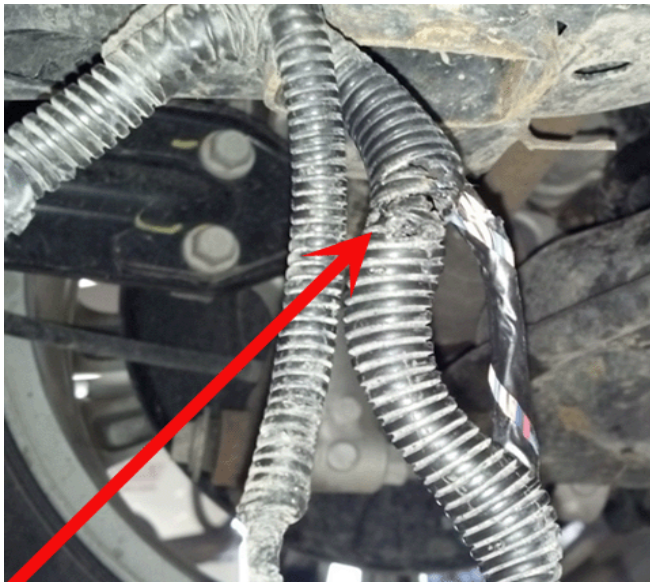
3420854

Damaged conduit

Several conditions and symptoms have been found to be related to a wire harness at the left rear under vehicle. Inspect the wire harness insulation within 1 inch of the X411 before and after connector. It may be necessary to remove the tape and conduit from the wire harness for inspection upstream from the X411 connector. Some Issues have been found with circuits 6105 and 6106 for chassis bus wires and serial enable circuit 5986 and 120 ohm opens in 2500 and 2501 or 6106 and 6106. Other circuits 884, 885, 882, and 883 when related to rear wheel speed sensor codes C0045 or C0050. During inspection you may notice chewed up conduit or a discoloration in insulation in one spot of the wire. If you pull the wire near that area the insulation it will break exposing the broken wire and possible corrosion or rodent damage. Repair the circuit to complete the procedure.

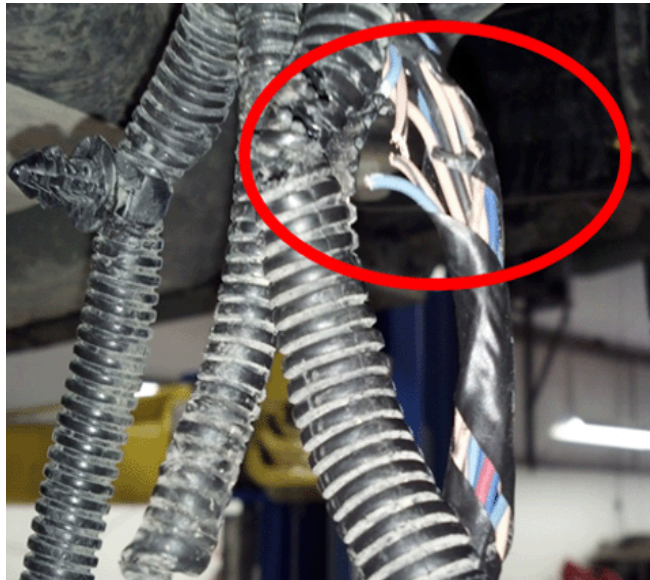
3420856

Wires chewed through
