**SERVICE BULLETIN**

**APPLICABILITY:** 2013MY Legacy and Outback 2.5L Models  
 2012-13MY Impreza 2.0L Models  
 2013MY XV Crosstrek  
 2011-2014MY Forester  
 2013MY BRZ

**NUMBER:** 11-130-13R

**SUBJECT:** Difficulty Starting, Rough Idle, Cam Position or Misfire DTCs  
 P0340, P0341, P0345, P0346, P0365, P0366, P0390, P0391,  
 P0301, P0302, P0303 or P0304

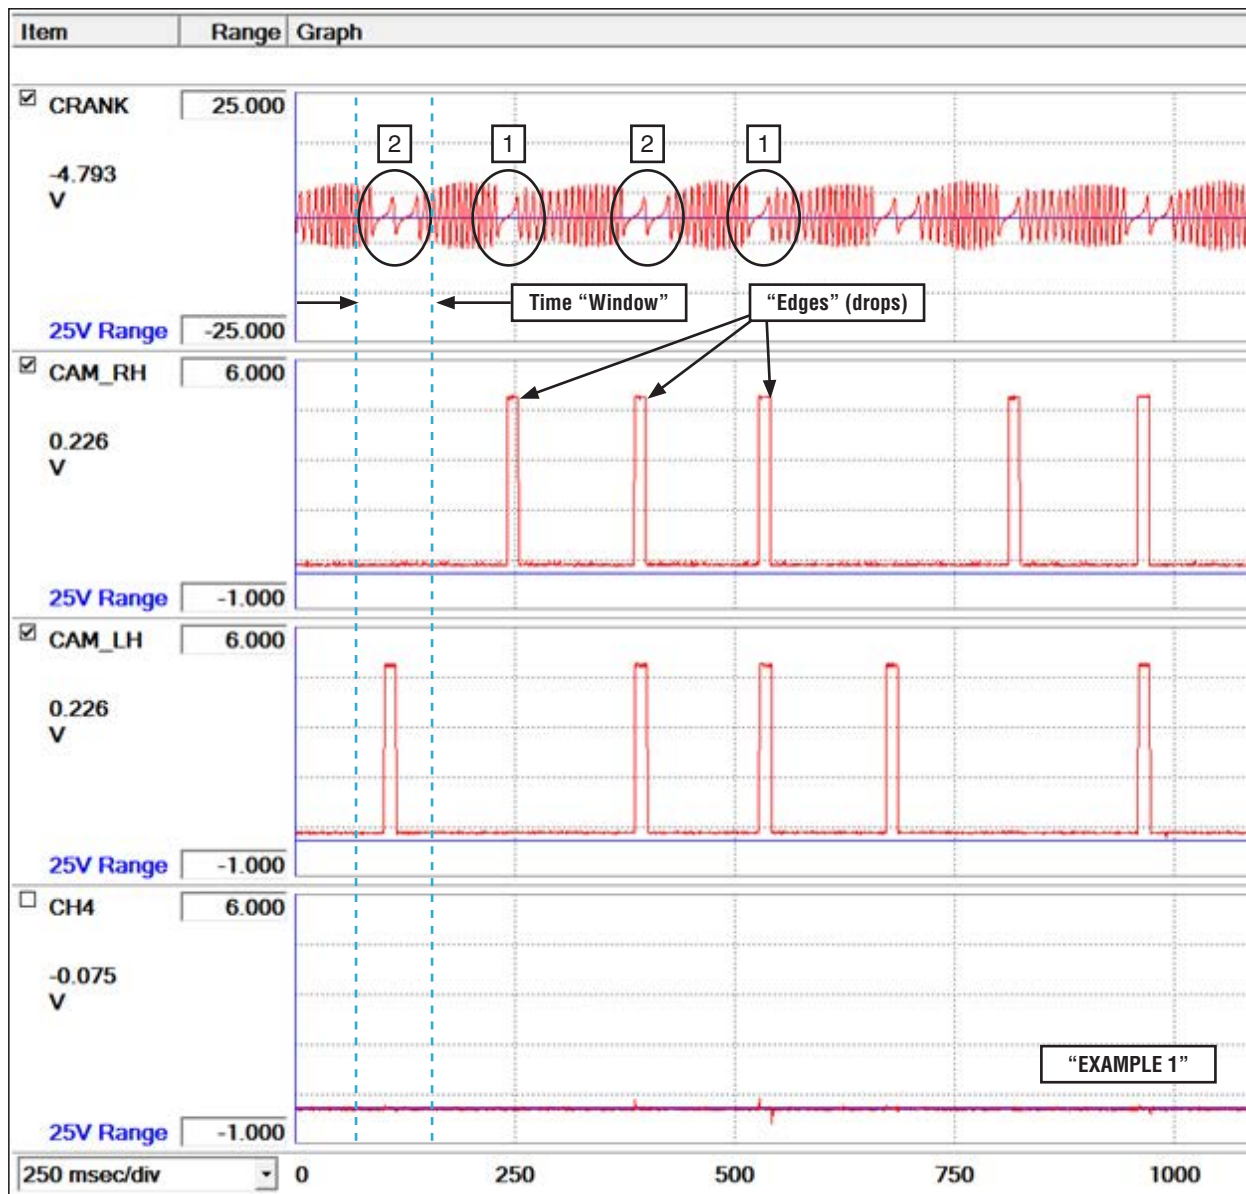
Using the chart above and comparing it to **Example 1**, it can be determined the first cylinder shown in the screen shot is #3 because the crank signal is a "2" and there is an edge signal within the window on the LH but not the RH cam sensor. Next cylinder in the firing order would be #2 as the crank position signal is a "1" and there is an edge signal in the window for the RH but not for the LH, and so on...

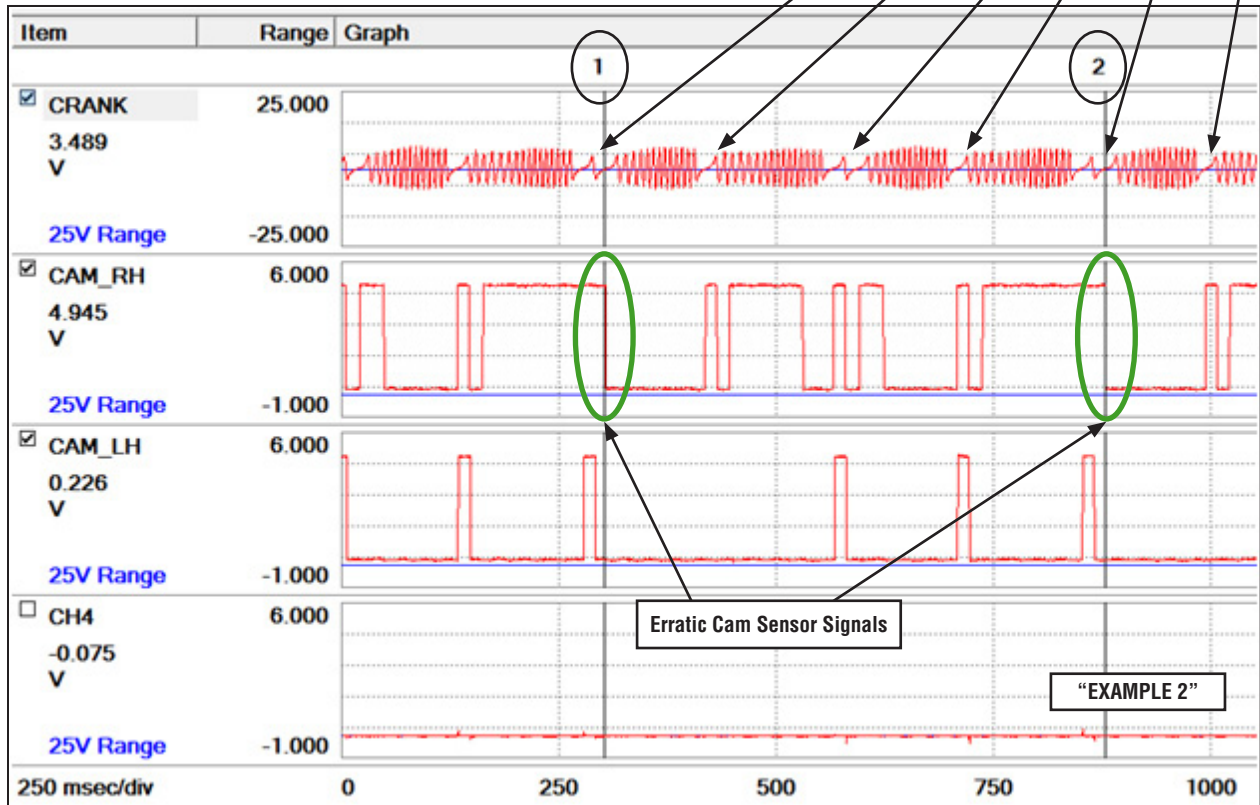
**Example 2** below shows a “Bad” pattern for the RH cam sensor. Marks #1 and #2 show what appears to be #4 cylinder firing but, the next cylinder to fire according to the screen shot is #2 followed by #4 then #1. The pattern for the RH sensor never shows the proper sequence to fire #3 cylinder. In this case, recheck the data again after installing a .2mm shim under the RH cam sensor.

**Proper Firing Order is:** #3 #2 #4 #1 #3 #2

**Firing Order shown in screen shot:** #4 #2 #4 #1 #4 #2

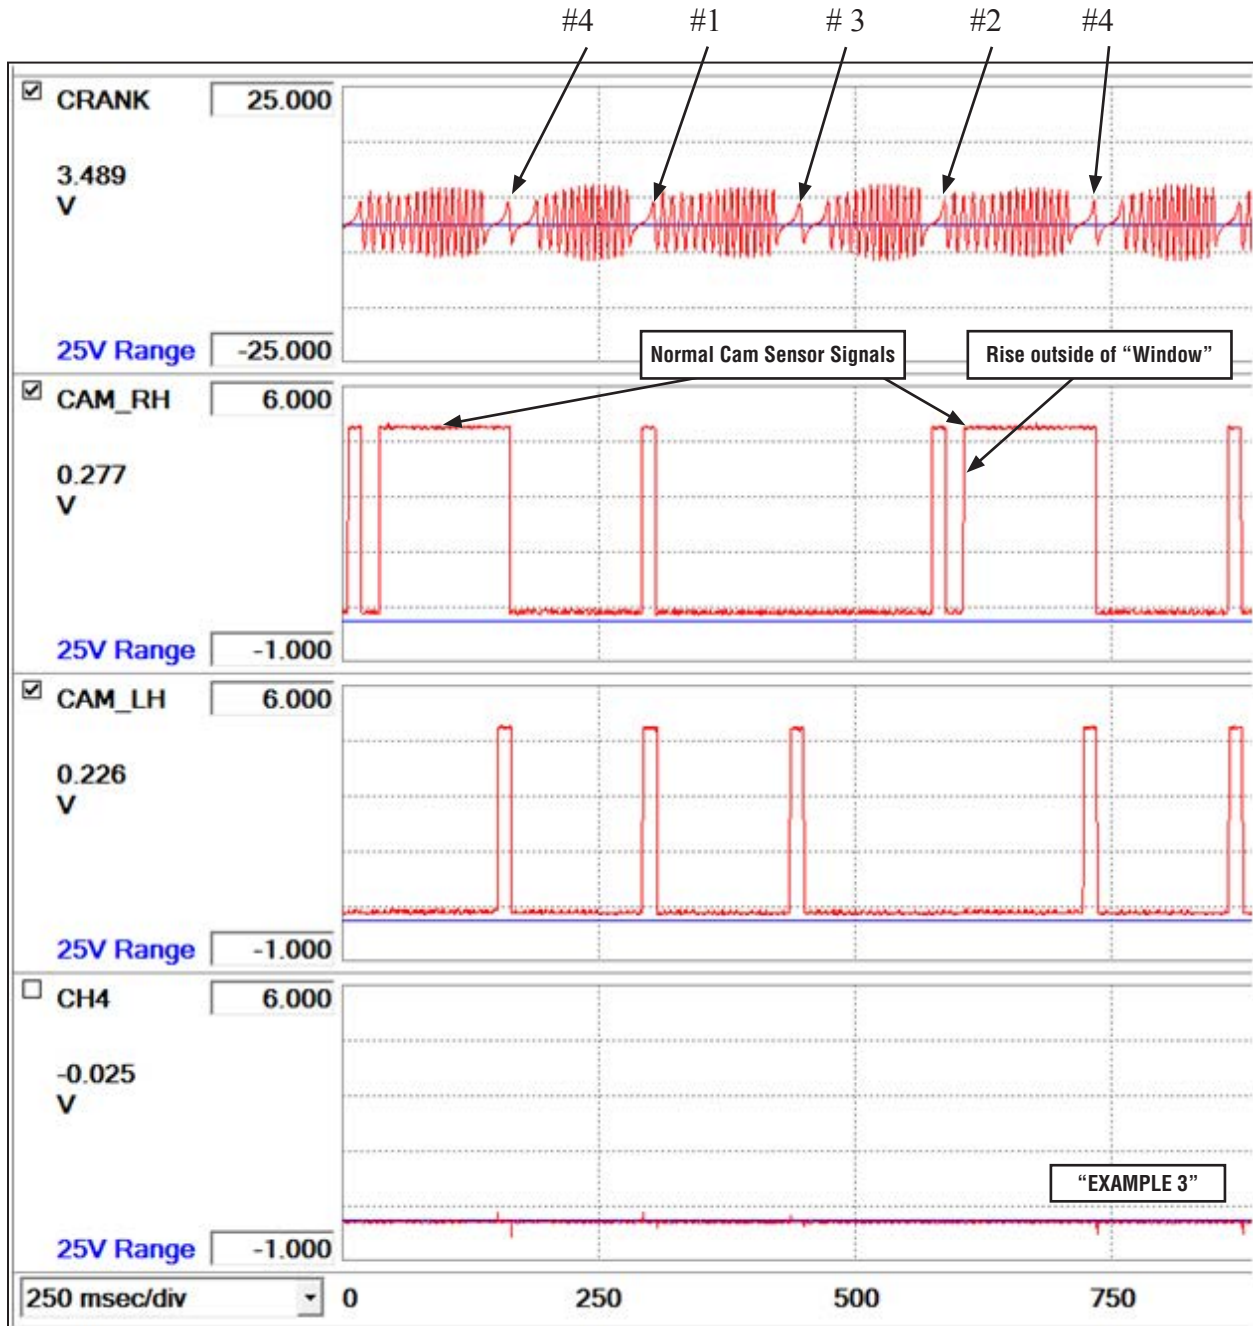
**Example 3** shows what appears to be an erratic signal from the RH cam sensor but, you can see all the cam sensor data signal edges (drops) follow the chart and firing order as they are supposed to. Other signal edges (rises or drops) outside the “window” or a longer time line as shown here prior to the #4 signal edges seen on the RH cam sensor pattern are examples of signals which will be “ignored” by the ECM and are not a cause for concern.

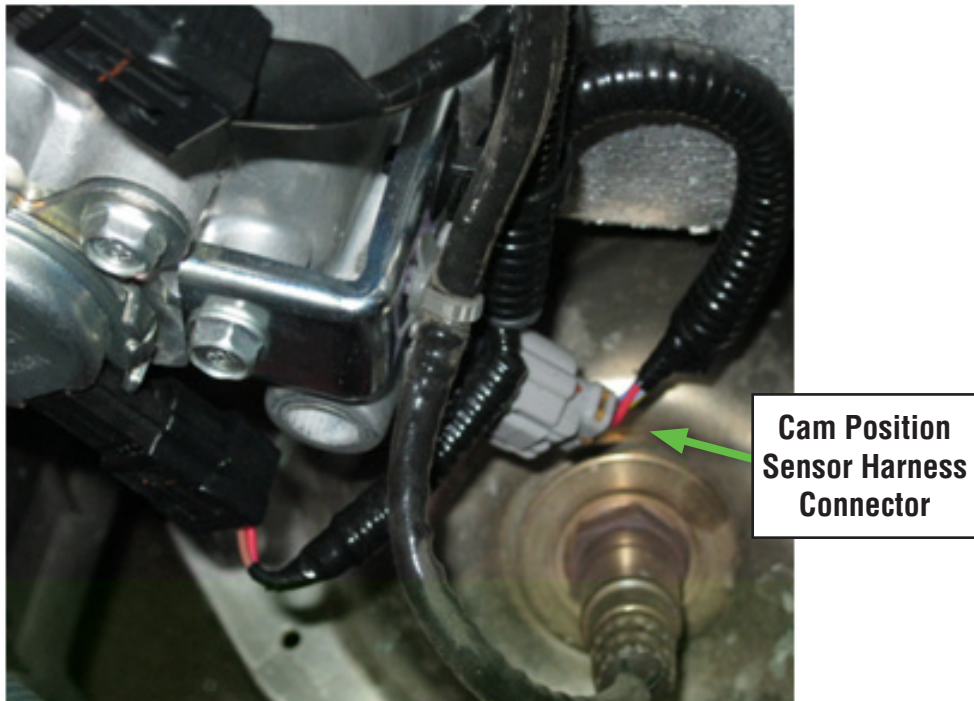
In the event you have a DTC stored for an exhaust camshaft position sensor, the repair procedure has been revised. Due to the position of the right-hand (Bank 1) sensor, measurement of the gap without removing the front catalyst is extremely difficult as shown in the photo below.

1. Confirm the irregular oscilloscope pattern for the corresponding DTC stored.
2. Remove the sensor from the timing cover and install a .2mm thick shim from the applicable kit.
3. Reinstall the sensor, torque the sensor retaining bolt to 6.4 Nm (4.7 ft. lbs. or 56.4 inch-pounds) then recheck the oscilloscope pattern.

If the pattern is normal, the repair is complete. If the irregular pattern persists, repeat Steps 2 and 3 after removing the .2mm shim and installing a .3 mm thick shim. **ONE SHIM ONLY, NO STACKING.** Repeat as necessary increasing the shim thickness .1 mm at a time until a normal scope pattern can be verified.
