SERVICE BULLETIN

APPLICABILITY: 2012MY and Later Impreza Models with FB Engine **NUMBER:** 02-141-13
 2011MY and Later Forester, N/A and Turbo Models **DATE:** 05/28/13

SUBJECT: Design Change to Rubber Sealing Cap for Oil Pressure Switch SB-10052503-5220

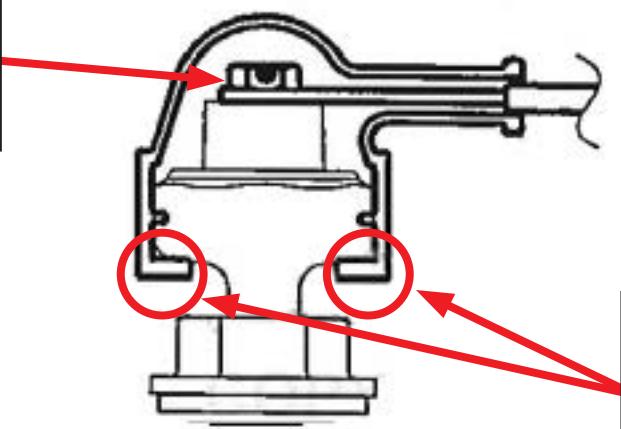
Be sure to follow the applicable procedure for tightening this electrical connection terminal as it varies by model.

The seal must be installed as shown with no roll-up of any of the edges.

Follow the procedure in the applicable Service Manual if replacing the oil pressure switch. Be sure to follow the proper torque procedure for both the switch **and** the electrical connection where applicable as it varies by model. The rubber material used to make the cap is soft and pliable enough so the wire and terminal eyelet can be pushed through the “tube” portion easily. Use a little bit of dielectric grease on the terminal eyelet as a lubricant if necessary. Confirm the new rubber cap is installed as shown in the illustration above with no roll-up of the bottom sealing edges.
