From Customer Service Department Subject Starter Ventilation Enhancement

Starter ventilation enhancement.

All Lamborghini Aventador LP 700 Coupe and Roadster MY 12,13 and 14 from VIN CLA0091 to VIN ELA02238.

Campaign Code: L83X-A.04.13

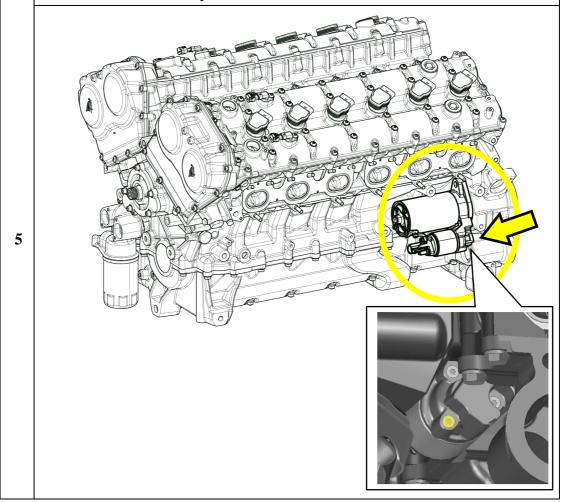
Detect the screw to be replaced: lower screw of starter motor.

Unfasten and remove the screw.
