Service Bulletin

File in Section: -
Bulletin No.: PIP5096C
Date: September, 2014

Subject: DTC P0011 P0014 P0021 Or P0024 Light With No Drivability Concerns

Models: 2012-2015 Buick Lacrosse
2013-2015 Cadillac ATS
2012-2015 Cadillac CTS SRX
2012-2015 Chevrolet Captiva Sport Equinox
2012-2015 Chevrolet Impala Classic
2014-2015 Chevrolet Impala (W1)
2012-2015 GMC Terrain
with 3.0L LFW and 3.6L LFX engines

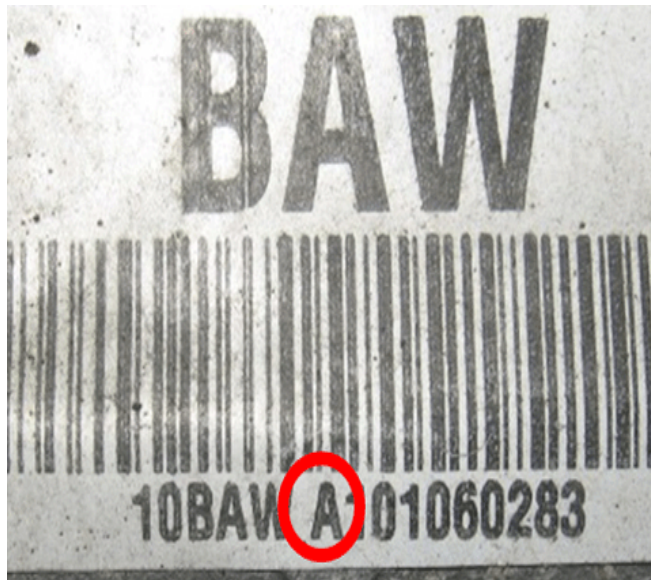
3291987

If you get a vehicle with one of these codes, and no other drivability concerns, inspect the engine EUN sticker for an A before the sequence number; before replacing the actuator.

The engine EUN sticker should be located on the engine left side below the left head or on the back of the right head.

(See the example below)

If there is an "A" before the sequence number then replace the OCV/Cam Actuator Solenoid Valve with a replacement "service" valve.

The service OCV is from a different supplier and can make up the difference in the clearance that causes this concern.
