Service Bulletin

SUBJECT: Special Coverage Adjustment – Excessive Engine Oil Consumption

**MODELS: 2010 Chevrolet Equinox
2010 GMC Terrain
Equipped with 2.4L Engine (LAF)**

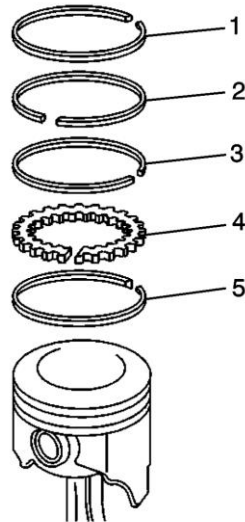
2146346

Note: The repair is to replace the pistons and rings. In some cases the bore surface may not have a uniform look to the finish (zebra stripes) as shown in Technical Service Bulletin 13-06-01-003F. As a result, some technicians may question whether the engine should be repaired or replaced. After careful evaluation, GM Powertrain has determined that the new pistons and rings will perform correctly in bores that have this appearance so engine replacement should not be necessary. The cylinder bores do not need any machine or honing work performed on them. Refer to Technical Service Bulletin 13-06-01-003F for more information.

- Engine Replacement
 - Technical Service Bulletin 13-06-01-003F
 - Piston and Connecting Rod Disassemble
 - Piston and Connecting Rod Assemble
 - Piston, Connecting Rod, and Bearing Installation (LAF, LAT, LE5, LE9, LEA, or LUK)
1. Remove the engine from the vehicle.
 2. Remove the pistons from the engine.
 3. Remove the pistons from the connecting rods.
 4. Discard the pistons and piston rings.
 5. Install the new piston rings onto the new pistons.
 6. Install the new pistons onto the connecting rods.
 7. Assemble the engine.
 8. Install the engine into the vehicle.
