Service Bulletin

SPECIAL COVERAGE

SUBJECT: Special Coverage Adjustment – Transmission Clutch Wave Plate

MODELS: 2007-2009 Buick Enclave
2008-2009 Chevrolet Equinox, Malibu
2009 Chevrolet Traverse
2007-2009 GMC Acadia
2007-2009 Pontiac G6
2008-2009 Pontiac Torrent
2007-2009 Saturn AURA, OUTLOOK

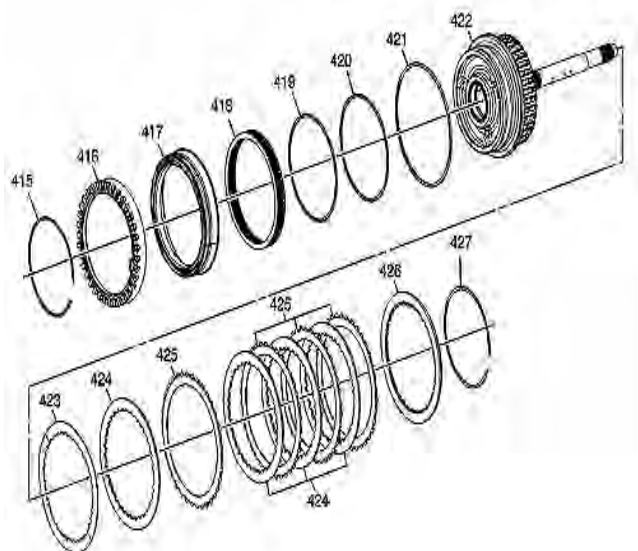
2584818

A broken 35R wave plate can generate varying amounts of debris inside the transmission. In most cases this debris has not passed through the pump fluid filter (201) potentially damaging the pump, valve bodies or torque converter. This debris can be cleaned and the transmission successfully repaired.

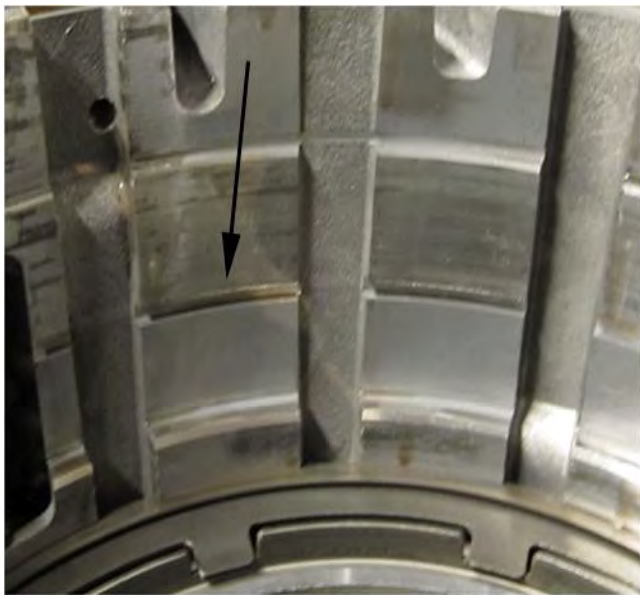
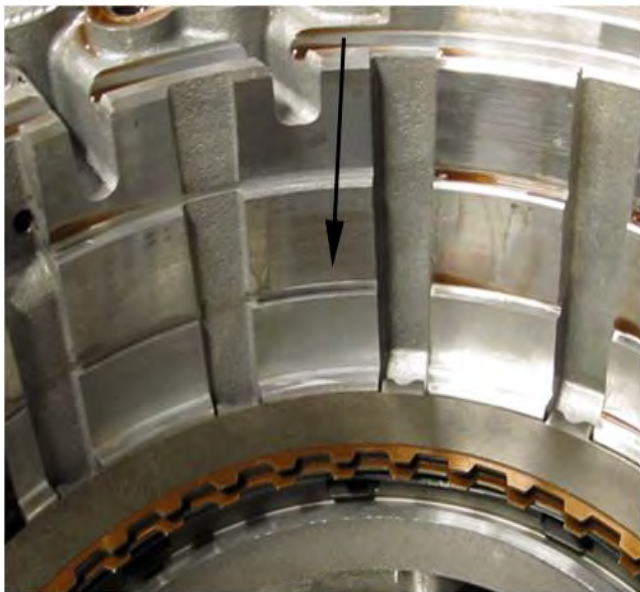
1. After removing the transmission from the vehicle, remove the case cover assembly (35). Inspect the case cover for damage. This part is serviced and can be replaced if it is damaged.
2. Remove the 35R/456 clutch housing assembly (422) and inspect it for a broken 35R wave plate (423).
3. Inspect the case (21) for damage caused by a broken wave plate as shown below.

- The snap ring groove, which is well below the 3-5-R wave plate area, is unlikely to be damaged. It should still be checked to verify the snap ring is fully seated and to be securely retained.

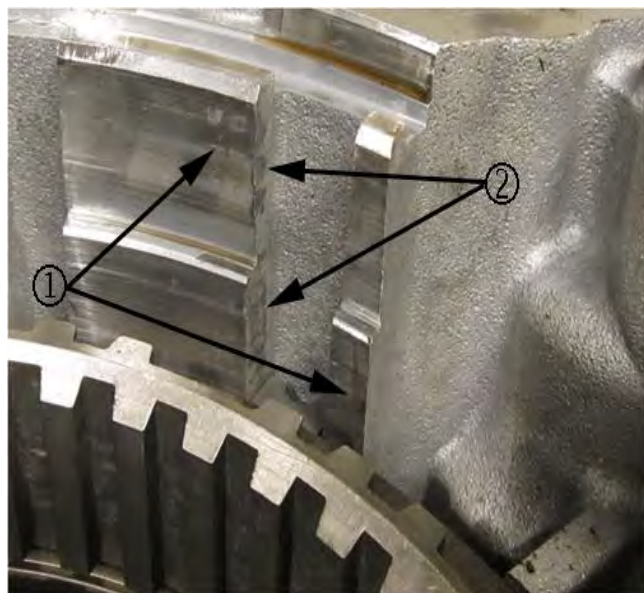
2753503

- Peening or wear of the face or edge of the case lugs that engage the steel clutch plates is normal and not cause for transmission replacement.

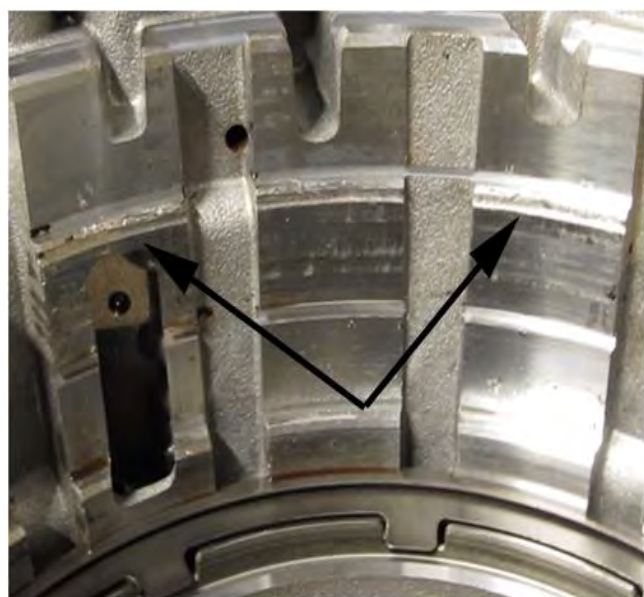
- Some degradation of the shelf for the 2-6 backing plate is acceptable as long as the plate can lie flat. A raised burr that prevents this can be removed using a de-burring tool, file or some other abrasive.

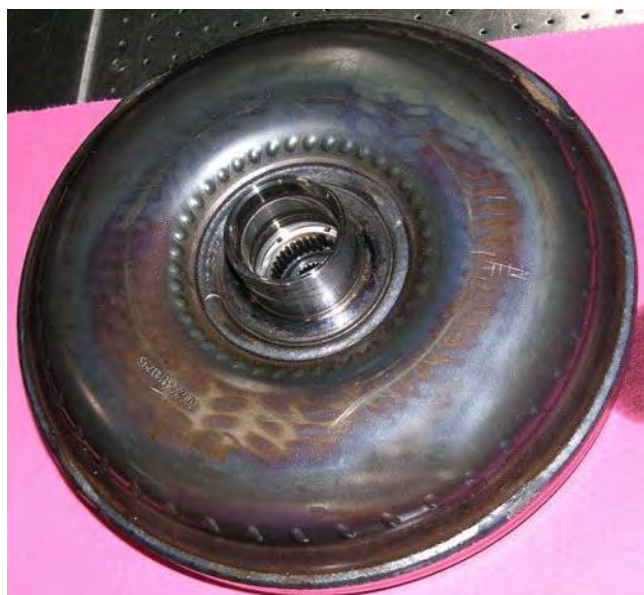
2739303

Note: The manufacturing process of the torque converter can cause the hub side to appear blue or darker in color while the lug side is a natural metal color. If the torque converter appearance is like this and no other reason is observed per the SI procedure for torque converter diagnosis, then the torque converter does not need to be replaced.

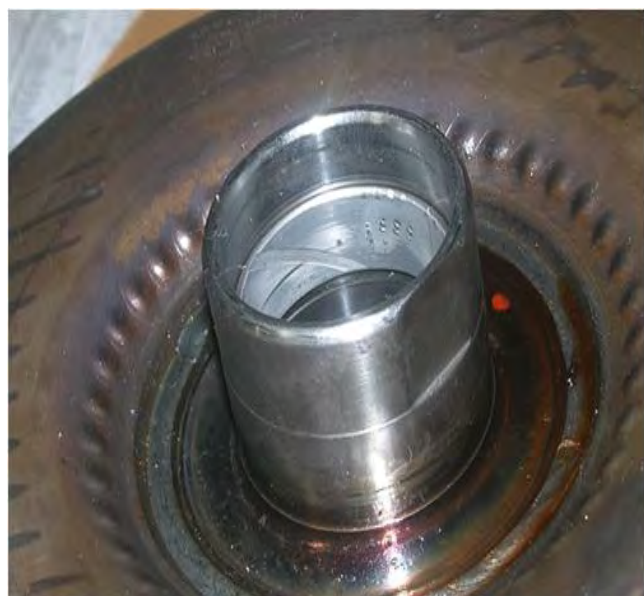
2753510

Marks such as these on the torque converter bushing are not a reason to replace the torque converter. They usually occur during removal of the transmission from the vehicle or removal/installation of the torque converter on the transmission and are caused by the bushing contacting the front differential transfer drive gear support (208) or the 3-5-R housing (422).

Also the marks are below the surface of the bushing and will not interfere with proper operation, however if there is a raised burr it can be removed with a de-burring tool or other abrasive.

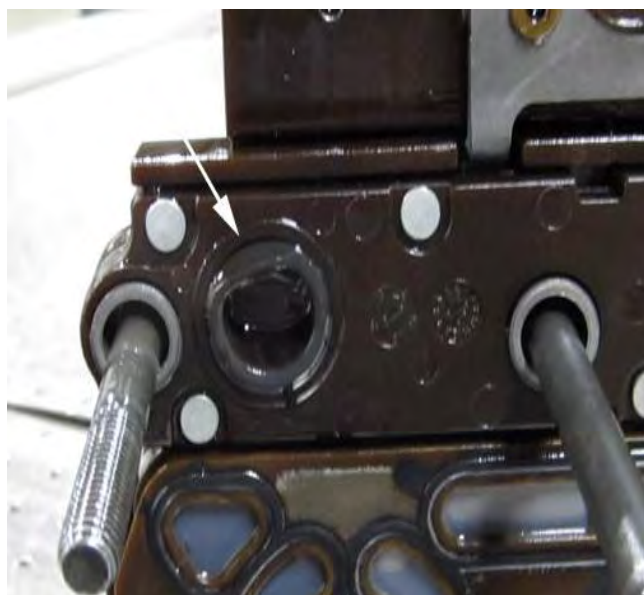
2850322

6. Inspect the control solenoid (w/body and TCM) valve assembly (TEHCM) (15) pressure switches. The O-ring seals may be deformed but if they are attached, as shown above, the TEHCM should not be replaced; it should be reused. Deformed seals do not affect switch performance.

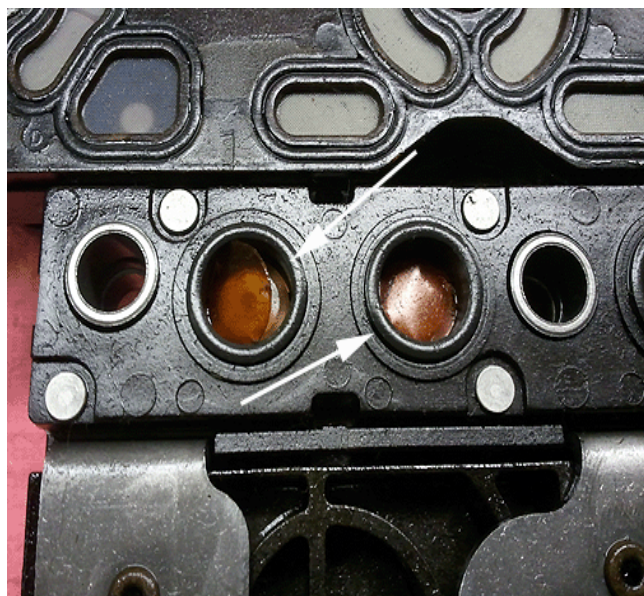
2630114

If any of the switch membranes are damaged, as shown above, the TEHCM must be replaced.

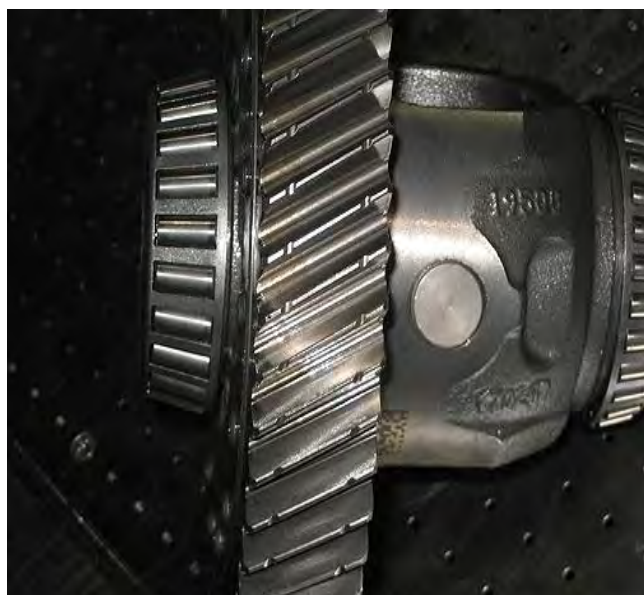
2584822

Note: The front differential carrier assembly (31) teeth are marked with notches to identify gear ratio (see picture above). Do not confuse these marks with tooth damage. Do not replace the gear for this condition.

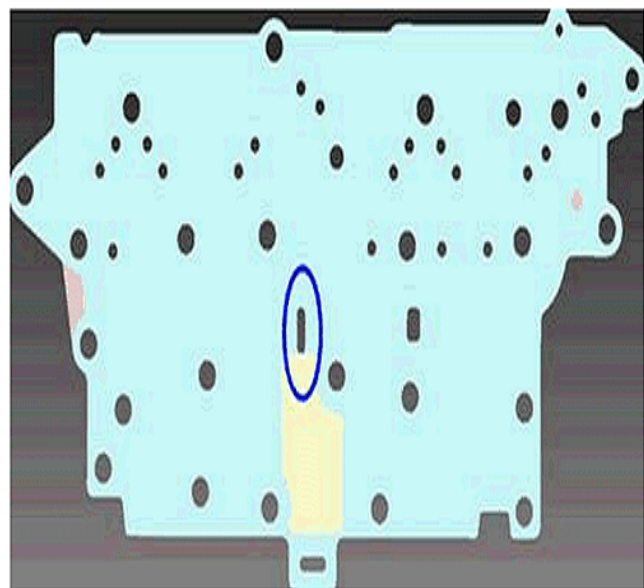
2584820

Note: 2007-2008 applications – when assembling these transmissions, inspect the control valve channel upper plate (301) to make sure that it contains the slot as indicated above. Plates installed that do not include this slot may result in DTCs.
