Program Bulletin

SB-10057698-4581

SUBJECT: Crank / No Start – DTC U0100, U1000, B2193 Stored

MODELS: 2015 Chevrolet City Express

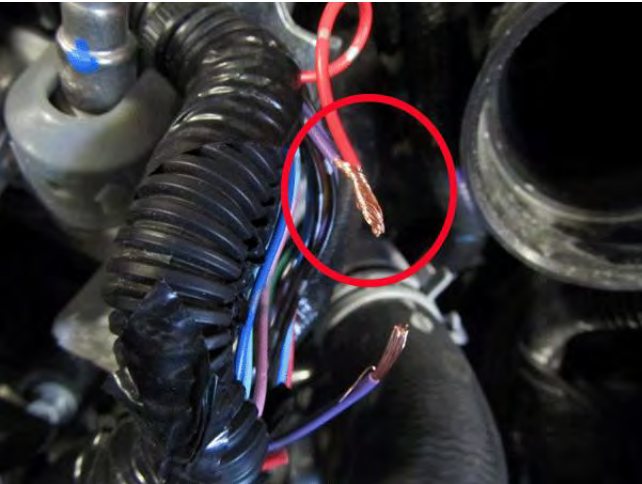
4100174

Note: There are four red wires in this wiring harness. Identifying the **largest red and largest purple** wires are critical to the procedure. Compare the wires to identify which wires are the largest.

8. Locate the largest gauge **red** (1) and **purple** (2) wires in the harness.
9. Once the wires are identified, cut the **purple** wire (1) approximately in the middle from the removed wires and cut the **red** wire (2) approximately 13 mm (0.50 inch) below the **purple** wire.
10. Strip approximately 5.0 mm (0.20 inch) of insulation from each wire except the lower **red** wire. The lower red wire will have heat shrink tubing installed in a later step.
