**NUMBER:** 18-015-15

Malfunction Indicator Lamp (MIL) Illumination And/Or Intermittent No Crank No Start

2014-2015 (DS) Ram 1500

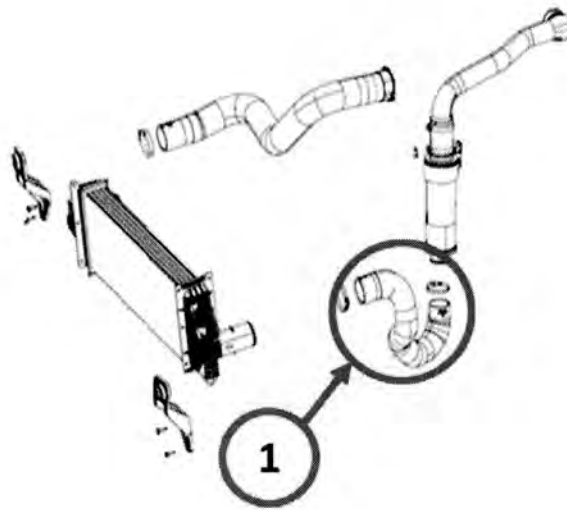
**Fig. 2 CAC System**

1 - Lower CAC hose.

13. Inspect for and drain any accumulated water from the CAC hose. Dry using shop air.
14. Was excessive moisture found in the lower CAC tube?
  - a. Yes>>> Proceed to Step #15.

12. Loosen the clamps and remove the lower CAC hose from between the CAC and resonator. See (Fig. 2).

19. Tip the CAC up on end and allow all accumulated moisture to thoroughly drain. Dry using shop air if necessary.
20. Reinstall the CAC assembly. Refer detailed service procedures in DealerCONNECT/TechCONNECT Service Information Section 09 - Engine, 3.0L Turbo Diesel> Turbocharger system> Cooler and Hoses, Charge Air> Installation.
