Service Bulletin

Bulletin No.: PIT5374

Subject: Headlight Performance (BCM Calibration and Bulbs)

Models: 2015 GMC Sierra
2014 GMC Sierra 1500

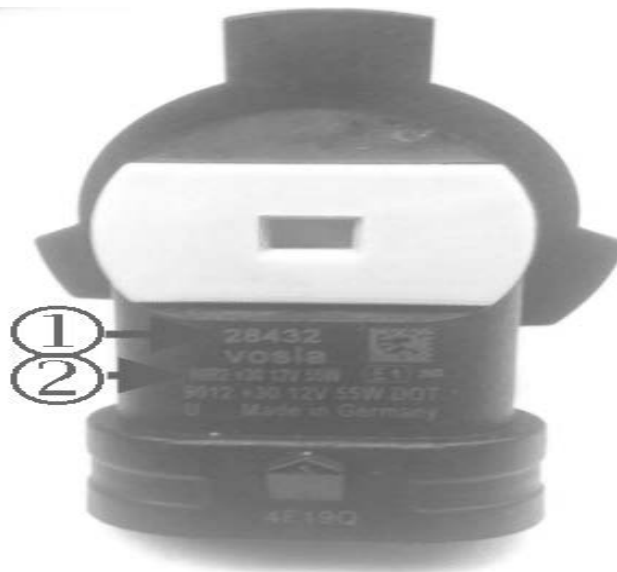
1. 28432
2. HIR2+30

2. Replace both headlight bulbs with updated bulb part number 23342527. **IMPORTANT:** Verify the correct bulb is being installed by confirming the following markings on the bulb:

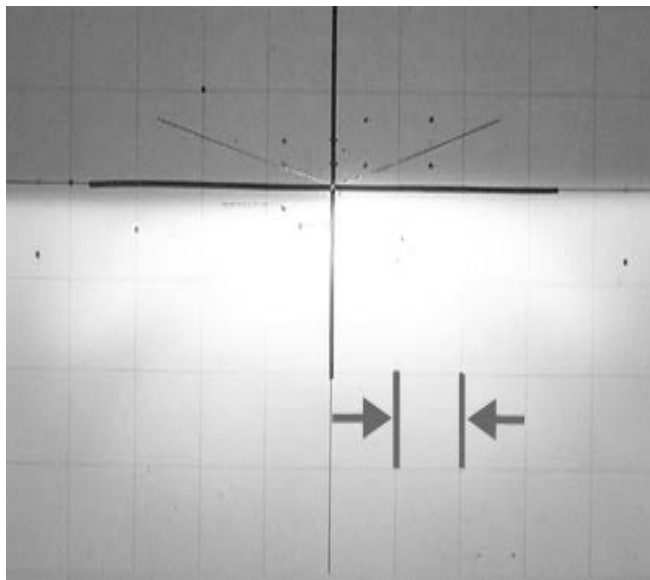
4092519

Important: When installing the new headlight bulbs, do not touch the glass and pay close attention that the bulbs are fully seated into the headlight housing. If the bulb is not properly installed it can lead to an incorrect light pattern. A beam pattern photo with a properly installed bulb is shown below. This photo is of a GMC Sierra Low beam pattern (1 Lamp with opposite lamp blocked) on wall/aiming screen at 25 ft (7.62 m). Each block division is approximately 10.5" (26.67cm)

3. After bulb replacement, perform Headlamp Aiming procedure (see below)

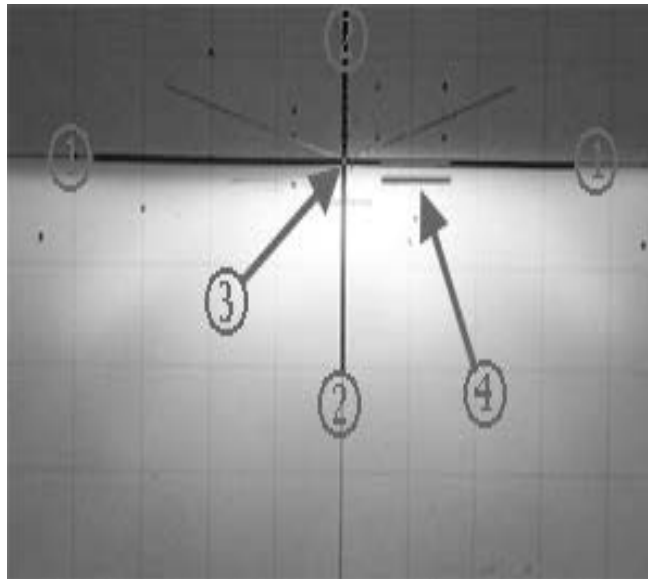
4092365

Note: GMC Sierra Low beam pattern (1 Lamp) on wall/aiming screen at 25 ft (7.62 m)

1. Horizontal Aiming Line
2. Reference line only, Not needed for proper aiming
3. Step in beam pattern
4. Top of beam pattern (cutoff line) positioned at the horizontal aiming line +0 / -0.75" (-19mm)

13. Adjust the vertical headlamp aim adjustment screw until the cutoff (top of the beam pattern) on the right side of the beam pattern step is set between the Horizontal Aim Line and 0.75 (19mm) inches below
14. Repeat the aiming procedure for the passenger's side headlamp while blocking the light from projecting onto the screen from the driver's side headlamp.
