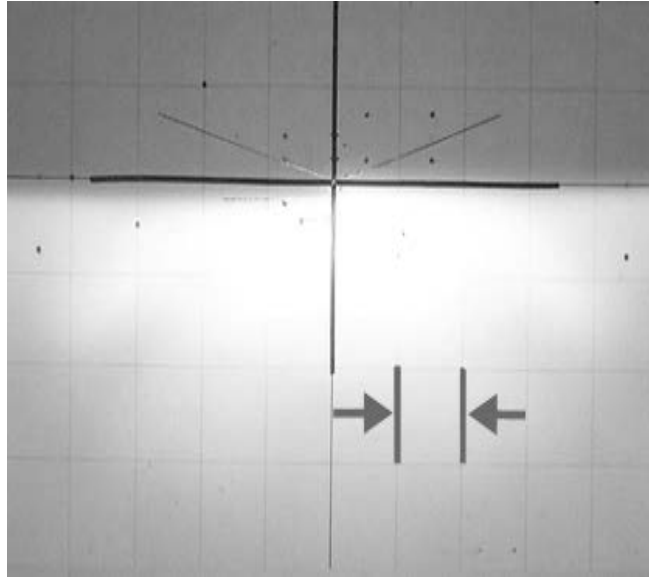
4092519

Important: When installing the new headlight bulbs, do not touch the glass and pay close attention that the bulbs are fully seated into the headlight housing. If the bulb is not properly installed it can lead to an incorrect light pattern. A beam pattern photo with a properly installed bulb is shown below. This photo is of a GMC Sierra Low beam pattern (1 Lamp with opposite lamp blocked) on wall/aiming screen at 25 ft (7.62 m). Each block division is approximately 10.5" (26.67cm)

3. After bulb replacement, perform Headlamp Aiming procedure (see below)

Important: The replacement of the bulb along with the calibration change should ONLY be performed at the same time. Doing them as separate service visits may not show the overall desired effect to the customer. Performing these repairs at the same time will show a dramatic improvement.

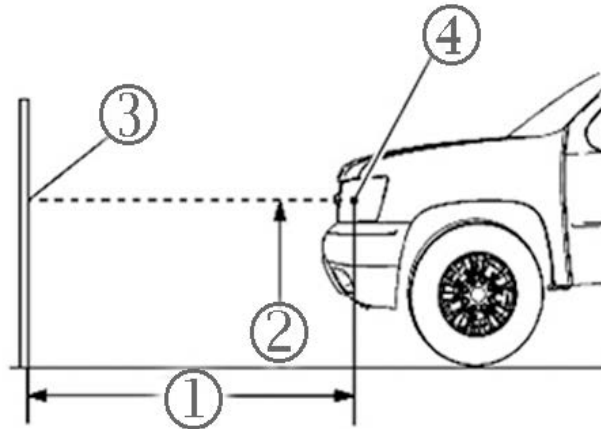
4092121

1. 25 ft (7.62 m)
2. Height of Horizontal Aiming Line on screen
3. Aiming Screen or Wall
4. Reference mark (small circle) on headlamp lens
9. Turn the headlamps ON.
10. Block the light from projecting onto the screen from the passenger side headlamp. This will allow the cutoff ("top" of the beam pattern) in the beam pattern from the driver's side to be more pronounced for easier aim verification.

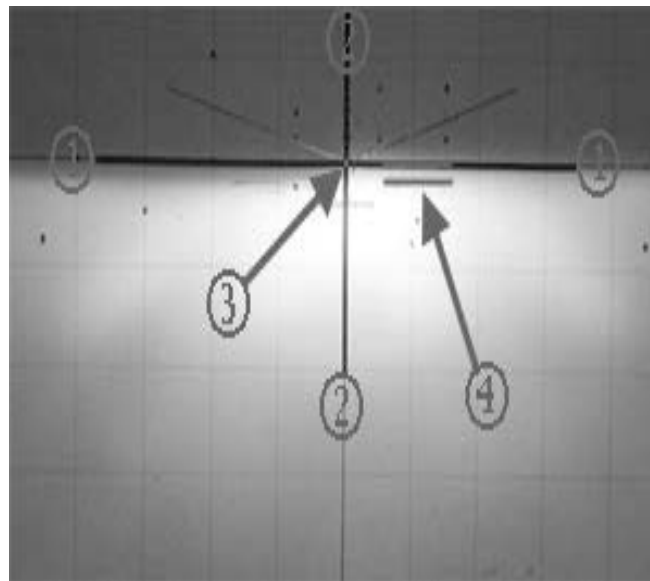
4092365

11. On this vehicle you will be verifying the vertical aim of the cutoff (top of the beam pattern) on the right side of the "step" in the beam pattern.
12. If the vertical location of the cutoff projected onto the screen or wall differs from the figure below, then an adjustment to the beam pattern location is necessary.

Note: GMC Sierra Low beam pattern (1 Lamp) on wall/aiming screen at 25 ft (7.62 m)

1. Horizontal Aiming Line
2. Reference line only, Not needed for proper aiming
3. Step in beam pattern
4. Top of beam pattern (cutoff line) positioned at the horizontal aiming line +0 / -0.75" (-19mm)

13. Adjust the vertical headlamp aim adjustment screw until the cutoff (top of the beam pattern) on the right side of the beam pattern step is set between the Horizontal Aim Line and 0.75 (19mm) inches below.
14. Repeat the aiming procedure for the passenger's side headlamp while blocking the light from projecting onto the screen from the driver's side headlamp.
