**WIND OR WHISTLE NOISE FROM EXTERIOR MIRROR(S) AT HIGHWAY SPEED - BUILT ON OR BEFORE 5/18/2015****TSB 15-0135**

**LINCOLN:**  
**2015 MKC**

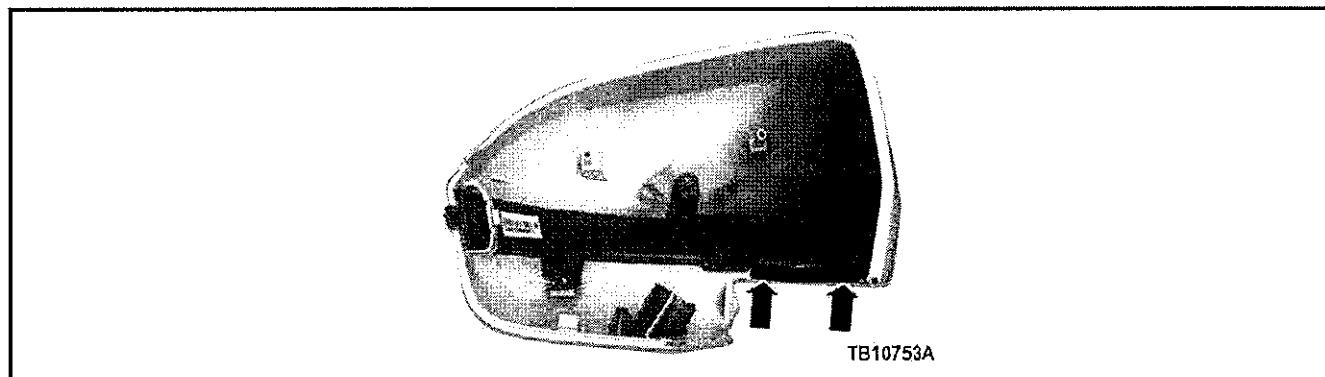
Figure 6 - Article 15-0135

Some 2015 MKC vehicles built on or before 5/18/2015 may exhibit a wind or whistle noise from the exterior mirror(s) at highway speed.

7. Dry the surface using a lint free cloth.
8. Install foam seal tape. (Figure 6)
