Service Bulletin

Bulletin No.: PIT5171C

Subject: Service Stability, Traction, ABS Rear Wheel Speed DTC Or Chassis Expansion And High Speed Bus Communication Fault

Models: 2010 - 2013 Chevrolet Equinox
2010 - 2013 GMC Terrain
With Any Combination of DTCs U0073 U0074 U1826 U1827 U18A2 U0125 C0196 C0287
C0186 C056D C0045 C0050 Symptom 00 06 3B 4A 4B 5A 39 42 54 71

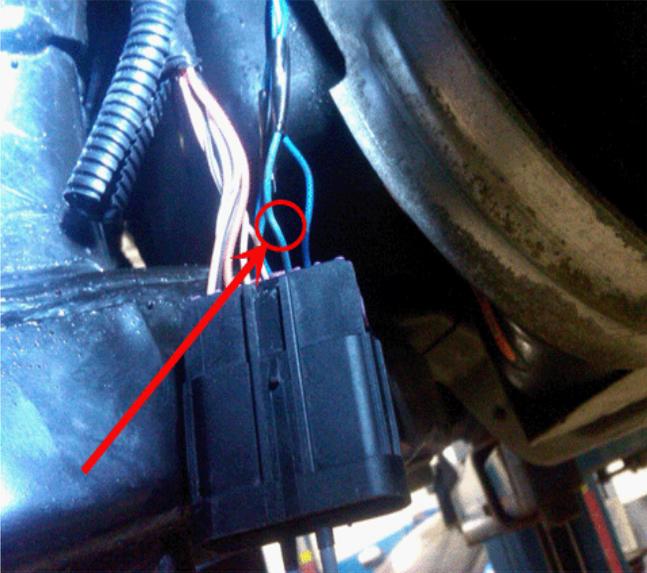
2893988

Note: Wire broken within the insulation has also been found high up in the harness X411 it will be necessary to lower the harness to gain access. Reference the following photos:

Several conditions and symptoms have been found to be related to a wire harness at the left rear under vehicle. Inspect the wire harness insulation within 1 inch of the X411 before and after connector. It may be necessary to remove the tape and conduit from the wire harness for inspection upstream from the X411 connector. Some Issues have been found with circuits 6105 and 6106 for chassis bus wires and serial enable circuit 5986 and 120 ohm opens in 2500 and 2501 or 6106 and 6106. Other circuits 884, 885, 882, and 883 when related to rear wheel speed sensor codes C0045 or C0050. During inspection you may notice chewed up conduit or a discoloration in insulation in one spot of the wire. If you pull the wire near that area the insulation it will break exposing the broken wire and possible corrosion or rodent damage. Repair the circuit to complete the procedure.

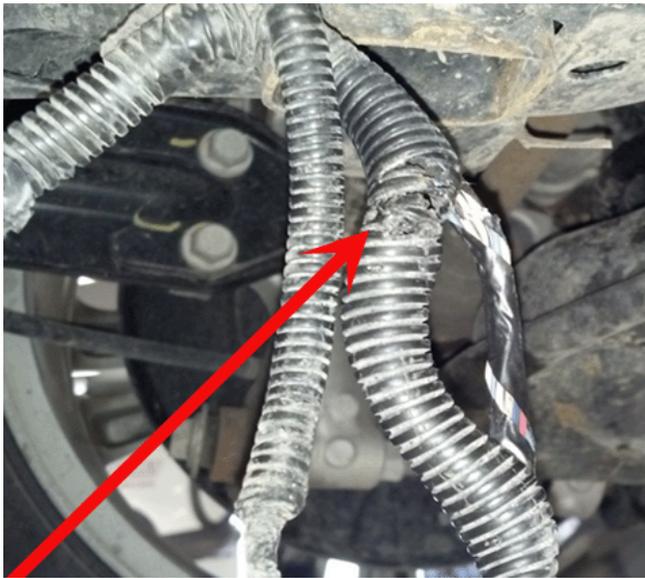
3420854

Damaged conduit

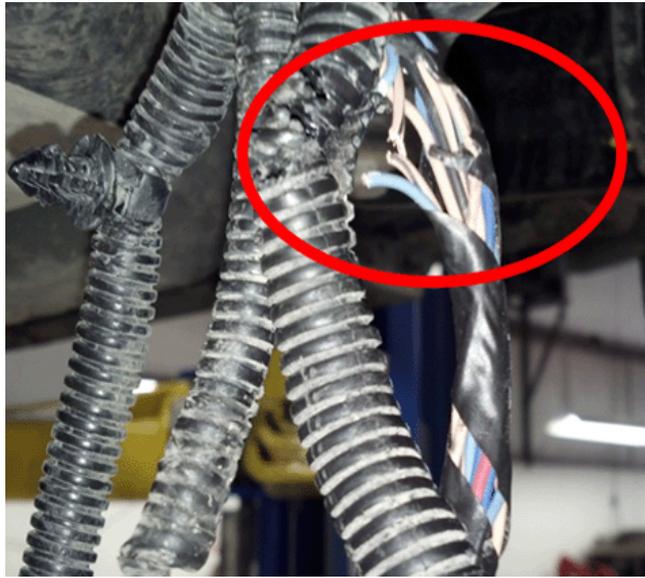
3420856

Wires chewed through
