SERVICE BULLETIN

APPLICABILITY: 2014MY Forester Turbo Models

NUMBER: 02-139-13

SUBJECT: Change to Oil Level Switch

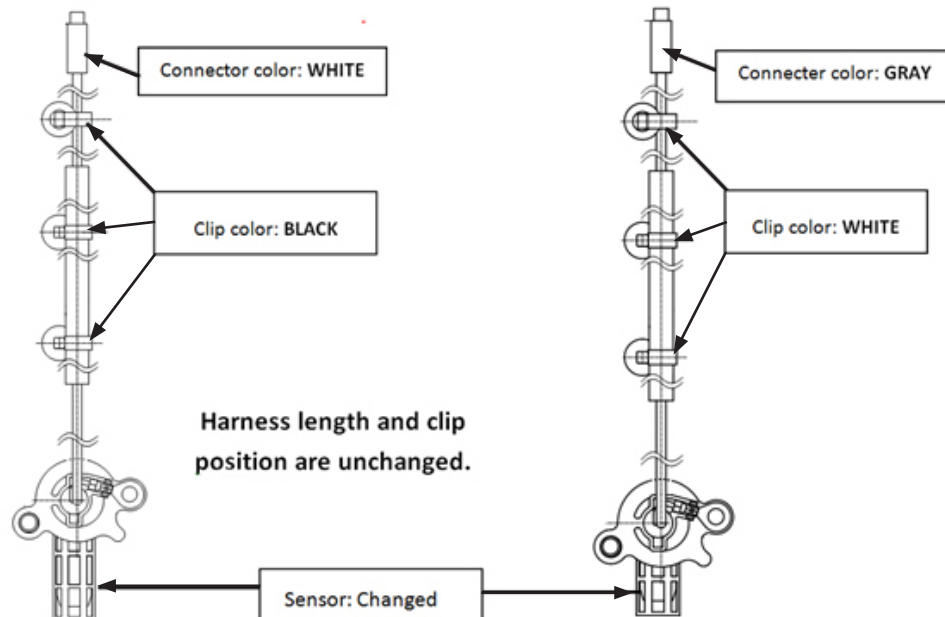
This Bulletin provides information regarding changes made to the oil level switch assembly designed to improve its accuracy. In addition, the wiring harness connector and harness retaining clip colors have been changed for identification purposes to help distinguish between the original and the new part.

New Part: 11136AA120

Original Part: 11136AA100

2. If the VIN of the vehicle is **BEFORE E*417779**, replace the oil level switch assembly with the new part (white connector with black harness retaining clips) following the procedure in the applicable Service Manual.

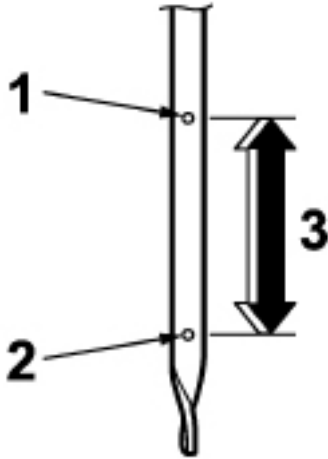
1. When receiving a customer concern of the engine oil level warning lamp coming on, confirm the engine oil level is within the operating range (#3) on the dipstick as shown below. Park the vehicle on a level surface and stop the engine. If you check the oil level just after stopping the engine, wait a few minutes for the oil to drain back into the oil pan before checking the level.

- 1) Full Level
- 2) Low Level
- 3) Approximately 1.1 US qt (1.0 liter, 0.9 imp qt) from low level to full level
