**SERVICE BULLETIN**

**APPLICABILITY:** 2010MY and later Legacy and Outback Models      **NUMBER:** 12-164-14  
**SUBJECT:** Film Residue Removal from Underside of Front Seat Cushion Covers      **DATE:** 02/24/14

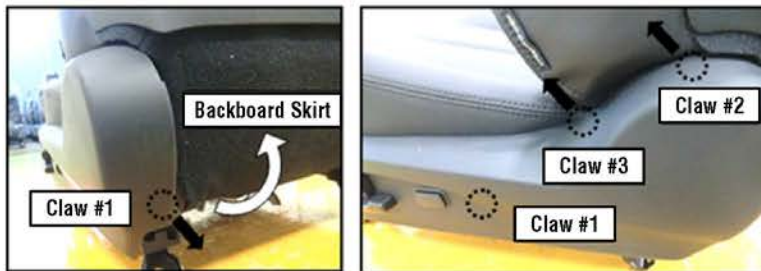
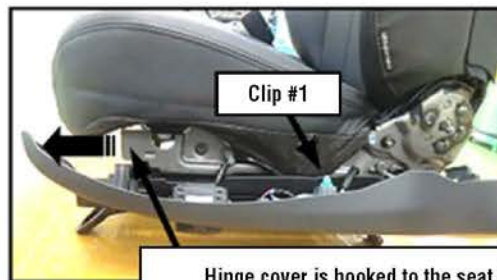
Hinge cover is hooked to the seat frame at this point. Unhook it by sliding the hinge cover toward the front after releasing Clip #1

- Remove the front seat assembly following the procedure in the applicable Service Manual.
- Remove the side hinge cover by first releasing and turning up the backboard skirt as shown in the photo sequence below then **CAREFULLY** releasing all 3 of the hinge cover claws and Clip #1 from the back of the cover as shown below.

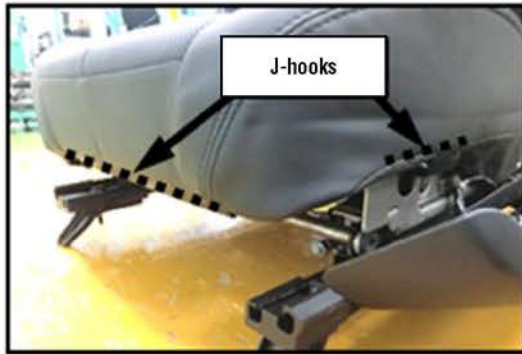
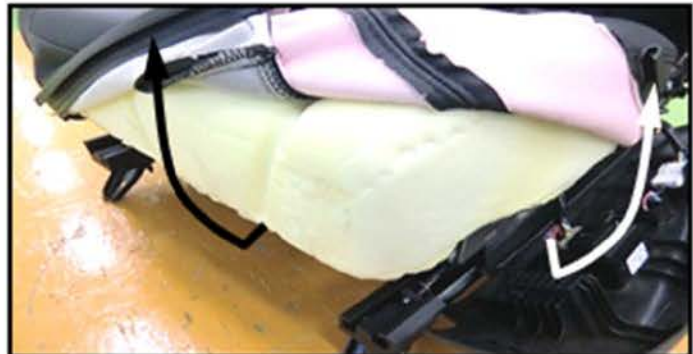
- After the hinge cover is removed, remove the two J-hooks and release the seat cushion trim cover from the corners of the seat cushion and frame. There should be no need to remove any hog rings. The pinkish-colored material shown below, right is the DOW film which may separate and gather or “ball-up” causing bumps or similar surface appearance imperfections as described previously.
