## SERVICE BULLETIN

**APPLICABILITY:** 2014-15 Forester Models

**NUMBER:** 15-173-14

**SUBJECT:** Exterior Auto Dim Mirrors with Approach Lighting

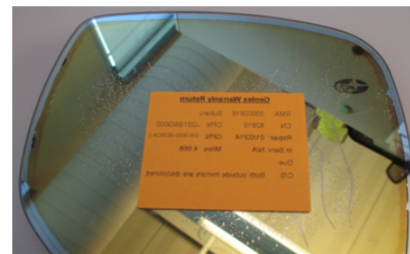
There have been a limited number of cases where the appearance of the exterior Auto Dim mirror glass has changed to having a permanent dark blue or yellowish tint (sometimes also with a pattern) as shown in the example photos below.

The source of this condition has been traced to a short to ground in the interior Auto Dim mirror harness as a result of improper routing during installation. The interior Auto Dim mirror controls the dimming function of the 2 exterior mirrors. This short to ground may result in excessive voltage (more than 1.6v) being applied to the Auto Dim mirror circuit. The result is damage to both exterior mirrors as described above.

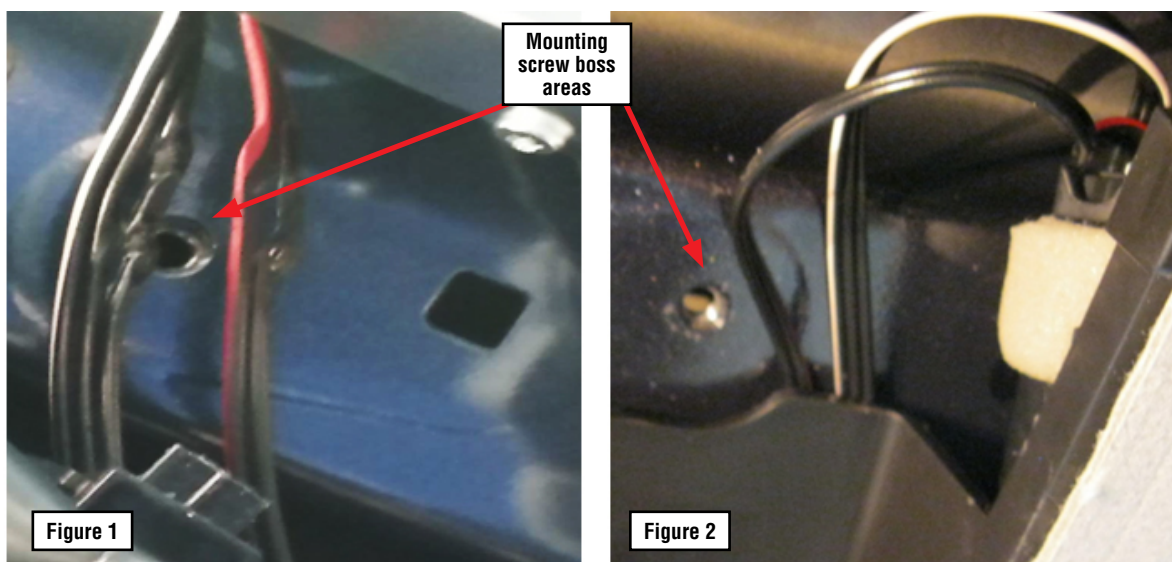
**Figure 1** below shows a damaged (pinched) wiring harness. **Figure 2** shows how the Auto Dim mirror harness should **NOT** be routed.

If after removing the upper console / map light assembly, harness damage is confirmed, replace the interior Auto Dim Mirror w/Compass wiring harness. Repairing this harness is **not** recommended. **REMINDER:** Always confirm any part numbers being ordered are the most up-to-date. Install the new replacement wiring harness. It must be routed as to not interfere with either of the 2 map light assembly mounting screw boss areas or any other potential harness pinch area (e.g. clips, metal brackets, etc...) then tucked above the headliner as shown in **Figures 3A and 3B** on the next page.
