## SERVICE BULLETIN

APPLICABILITY: 2015 WRX STI NUMBER: 03-74-14

SUBJECT: Gear Oil Leaking from Rear Differential Cover DATE: 08/18/14

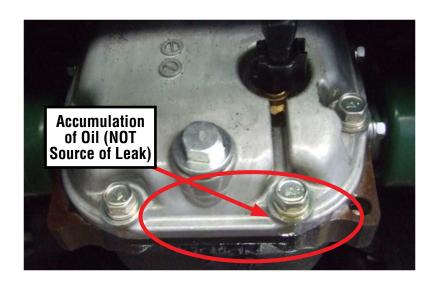
This bulletin provides a repair procedure to address a customer concern of a gear oil leak from the rear differential cover area. As with any diagnosis, begin by confirming the source of the leak. This will involve thoroughly cleaning the contaminated surfaces of all residual gear oil and the application of a suitable leak tracing developer such as Castle® Leak Tracer Powder™ or similar. If the source of the leak is confirmed as the breather vent assembly which is pressed into the aluminum rear differential cover, both the cover and the breather vent will require replacement. In some cases, you may find the breather vent is visibly not fully or evenly seated while in others, it may appear flush. Proper seating of the breather vent is not the criteria for replacement of the vent and cover. Rely on the results of your leak tracing to determine what repair is required. While this bulletin addresses a specific possible leak source, if your diagnosis leads to a different source, repair that condition by following the applicable Service Manual information.
