Service Bulletin

Bulletin No.: PIP4554J

Subject: Clunk Noise After Shifting From Reverse To Drive Or Drive To Reverse And Then Accelerating

Models: 2007-2009 Cadillac SRX
2007-2011 Cadillac STS
2008-2013 Cadillac CTS
2010-2013 Chevrolet Camaro
RWD only, equipped with 6L45 or 6L50 (RPO MYA, MYB) Automatic Transmission

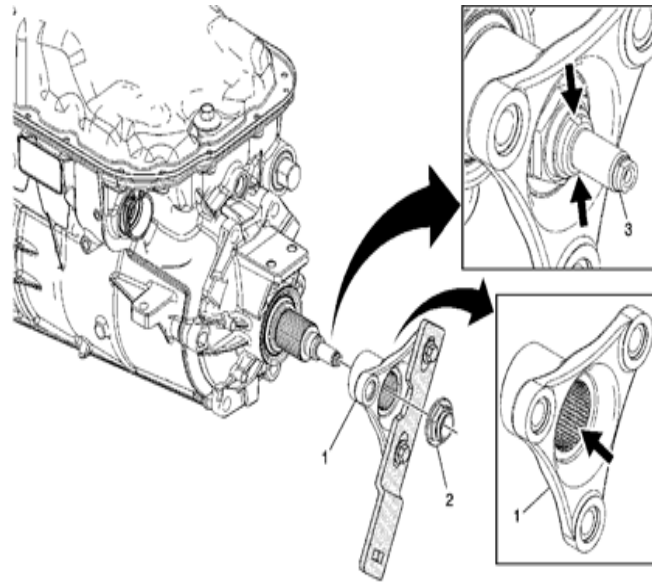
2610907

Some customers may comment on a clunk noise after shifting from reverse to drive or drive to reverse and then accelerating. This noise typically does not occur during the reverse to drive or drive to reverse shift, but is heard after the shift when the vehicle is accelerated. The noise may sound like it is coming from the rear of the vehicle from the rear drive axle.

This condition may be caused by the torque on the propeller shaft flange nut or movement between the flange and the transmission output shaft.

Apply thread locker to the transmission output shaft flange splines and a new front propeller shaft flange nut following the procedure below.

The existing output shaft and output shaft flange can be re-used and does not require replacement. A new front propeller shaft flange nut should be used.

1. The output shaft flange splines must be thoroughly clean and dry before installing the flange.

2. Apply GM P/N 89021297 (Canadian P/N 10953488) evenly across the width and length of the flange splines and install the flange onto the transmission output shaft.
3. Sufficient application of adhesive to every tooth on the flange will leave excess adhesive on the output shaft after installation. If no excess is observed, reapply adhesive. Remove excess adhesive.

1. The output shaft nut threads must be thoroughly clean and dry before installing the nut.
2. Apply GM P/N 89021297 (Canadian P/N 10953488) across the width of the nut threads, prior to tightening and staking.

Tighten 55 N·m (41 lb ft).

Caution: Stake the flange nut onto the output shaft. Use the two staking grooves on the shaft to locate the staking points. Failure to stake the flange nut may result in damage to the transmission.
