# Service Bulletin

Bulletin No.: PIP5096C

**Subject:** DTC P0011 P0014 P0021 Or P0024 Light With No Drivability Concerns

**Models:** 2012-2015 Buick Lacrosse  
2013-2015 Cadillac ATS  
2012-2015 Cadillac CTS SRX  
2012-2015 Chevrolet Captiva Sport Equinox  
2012-2015 Chevrolet Impala Classic  
2014-2015 Chevrolet Impala (W1)  
2012-2015 GMC Terrain  
with 3.0L LFW and 3.6L LFX engines

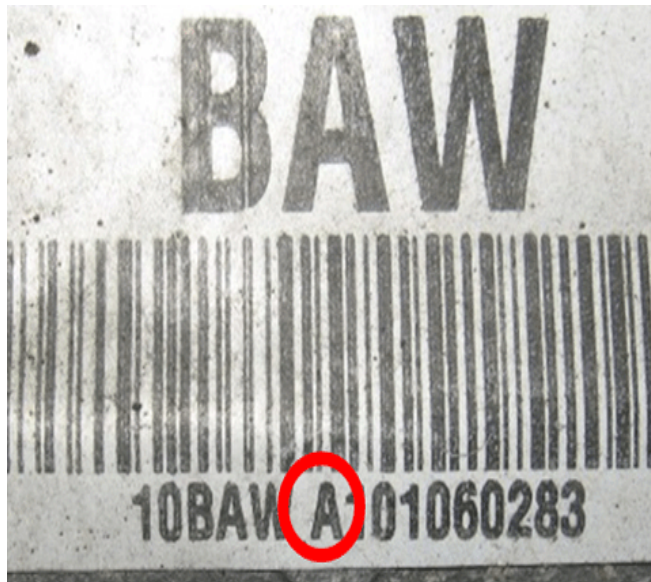
3291987

If you get a vehicle with one of these codes, and no other drivability concerns, inspect the engine EUN sticker for an A before the sequence number; before replacing the actuator.

The engine EUN sticker should be located on the engine left side below the left head or on the back of the right head.

(See the example below)

If there is an "A" before the sequence number then replace the OCV/Cam Actuator Solenoid Valve with a replacement "service" valve.

The service OCV is from a different supplier and can make up the difference in the clearance that causes this concern.
