Service Bulletin

Bulletin No.: PI0928C

Subject: Bump, Surge or Vibration at Idle in Drive at a Stop

Models: 2013-2014 Buick Encore
2012-2014 Chevrolet Cruze, Sonic
2013 Chevrolet Tracker, Trax
Equipped with 1.4L and 1.8L Engines (RPOs LUJ, LUV, 2H0) and 6T40 Automatic Transmission (RPOs MHB, MH8)
Vehicles Built Prior to August 1, 2013

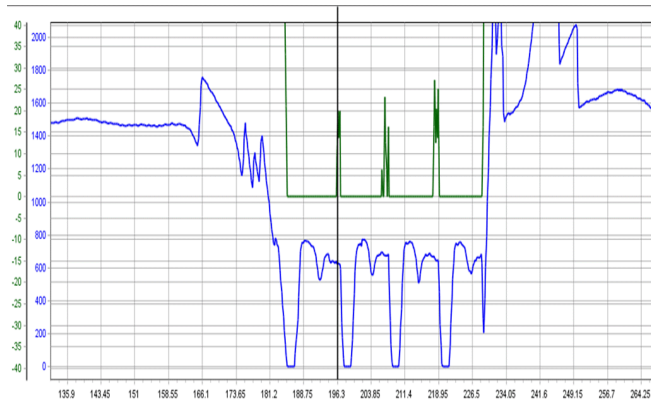
3610529

If the concern is eliminated by moving the transmission shift lever to the manual position, it is caused by the Neutral Idle feature and variation in the 1-2-3-4 clutch fiber plates. The 1-2-3-4 clutch fiber plates should be replaced with the part number listed below. This is a kit that contains two clutch fiber plates.

For diagnosis purposes, a typical Neutral Idle bump is illustrated in the GDS2 snapshot below. When Neutral Idle is activated Transmission ISS will nearly match Engine Speed. When Neutral Idle is deactivated, 1st gear will be engaged and Transmission ISS will drop to zero as long as the vehicle is stopped. The variation in the 1-2-3-4 clutch fiber plates create the variation in Transmission ISS and the small spikes in the Transmission OSS. These Transmission OSS spikes cause Neutral Idle to be commanded on/off/on/off as seen below creating the bump or surge sensation.
