Service Bulletin

Bulletin No.: PI1183

Subject: Front Seat Lateral Movement and/or Click Type Noise While Driving

Models: 2014 Chevrolet Silverado 1500
2014 GMC Sierra 1500

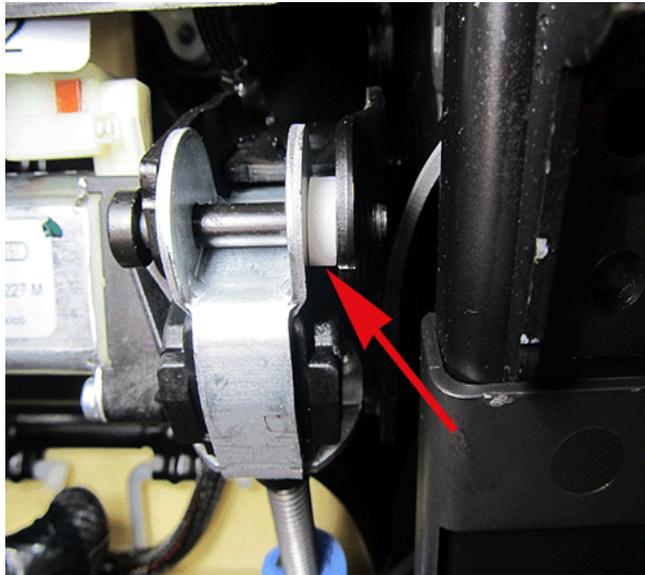
3619968

This condition may be caused by movement in the seat cushion and/or movement between the seat pan front pivot points and the seat frame. The plastic attachment points may "stick" then "slip" creating the condition. There may also be excessive clearance between the power seat vertical adjuster actuator and the attachment point on the seat frame.

22. Locate the power seat vertical adjuster actuator attachment to the seat frame.

23. Install the shim clip as shown.

It may be necessary to slightly spread the bracket on the seat frame with a large screwdriver to allow clearance for the clip.
