Service Bulletin

Bulletin No.: PIT5272

Subject: Diagnostic Tip: Whistle Noise From Inside Vehicle

Models: 2014 Chevrolet Silverado 1500
2015 Chevrolet Silverado HD , Suburban and Tahoe
2014 GMC Sierra 1500
2015 GMC Sierra HD and Yukon models

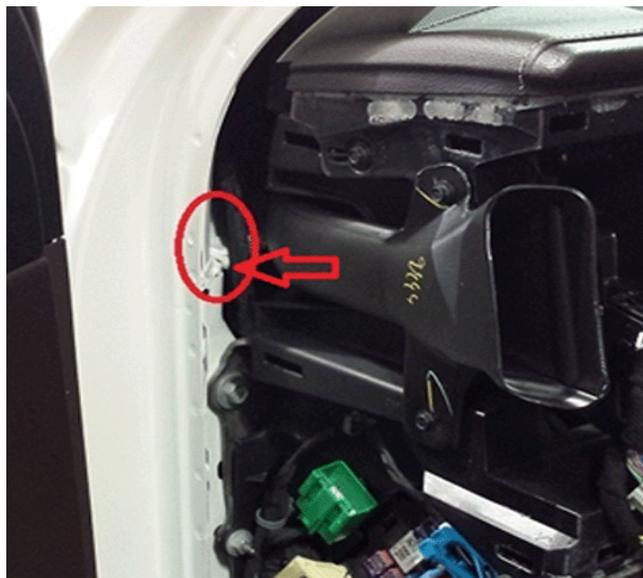
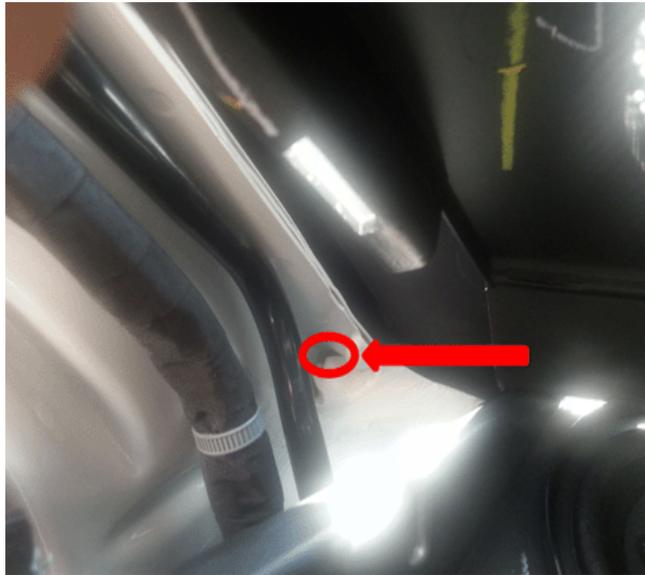
3802323

Some customers may comment there is a whistle noise in the vehicle from the driver or passenger side. Some may also state this is present while driving or with the HVAC on and in recirculation mode or the noise will change if a window is cracked open. This could be caused by voids in the body sealer in one or more places.

1. Inspect for voids in the body sealer on the left or right side A-pillar as shown in pictures below
