Service Bulletin

PRELIMINARY INFORMATION

Subject: Wind Whistle Noise At Highway Speeds From Left Or Right Rear Quarter Glass Area

Models: 2015 Chevrolet Suburban, Tahoe 2015 GMC Yukon Models

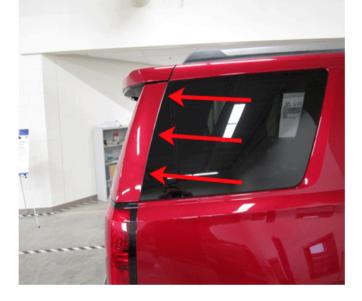
3827986

1. The fit between the exterior "D" pillar trim and the rear quarter glass in the area shown below.

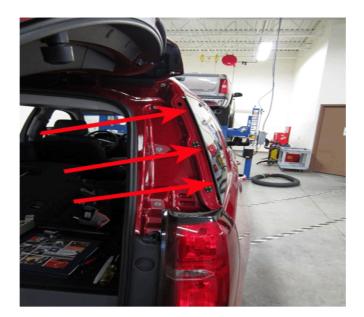
Excessive urethane from the quarter glass installation may not allow the exterior "D" pillar trim to fit properly against the rear quarter glass, as shown below.

1. Use a sharp knife and cut off the excessive urethane, as shown below. In most cases the urethane will need to be cut sub-flush to the sheet metal. This will allow the exterior "D" pillar trim to fit correctly against the rear quarter glass.

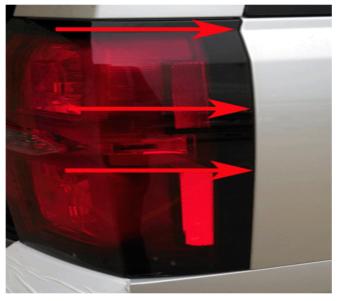
3901934

2. Between the rear tail light assembly and the quarter panel, as shown below.

2. Install a 5mm X 5mm (3/16 X 3/16) piece of closed cell foam tape along the entire length of the tail light assembly, as shown below.
