# Service Bulletin

Bulletin No.: PI0928A

**Subject:** Bump, Surge or Vibration at Idle in Drive at a Stop

**Models:** 2013-2014 Buick Encore  
2012-2014 Chevrolet Cruze, Sonic  
2013-2014 Chevrolet Trax  
Equipped with 1.4L Engine (RPOs LUJ, LUV) and 6T40 Automatic Transmission (RPOs MHB, MH8)  
Vehicles Built Prior to August 1, 2013

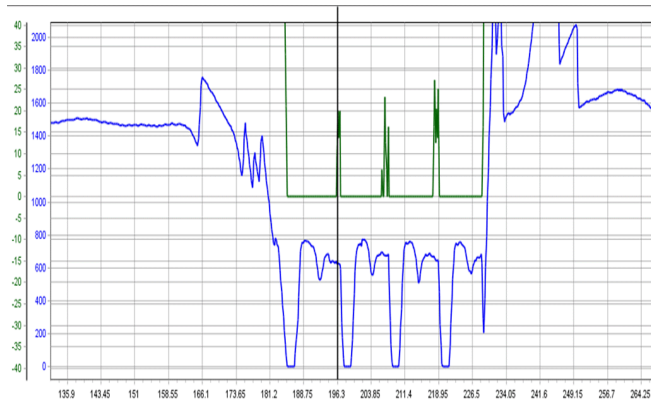
3610529

If the concern is eliminated by moving the transmission shift lever to the manual position, it is caused by the Neutral Idle feature and variation in the 1-2-3-4 clutch fiber plates. The 1-2-3-4 clutch fiber plates should be replaced with the part number listed below. This is a kit that contains two clutch fiber plates.

For diagnosis purposes, a typical Neutral Idle bump is illustrated in the GDS2 snapshot below. When Neutral Idle is activated Transmission ISS will nearly match Engine Speed. When Neutral Idle is deactivated, 1st gear will be engaged and Transmission ISS will drop to zero as long as the vehicle is stopped. The variation in the 1-2-3-4 clutch fiber plates create the variation in Transmission ISS and the small spikes in the Transmission OSS. These Transmission OSS spikes cause Neutral Idle to be commanded on/off/on/off as seen below creating the bump or surge sensation.
