Service Bulletin

Bulletin No.: PI0997

Subject: Convertible Top Difficult to Latch Closed

Models: 2013-2014 Chevrolet Camaro Convertible
Condition/Concern

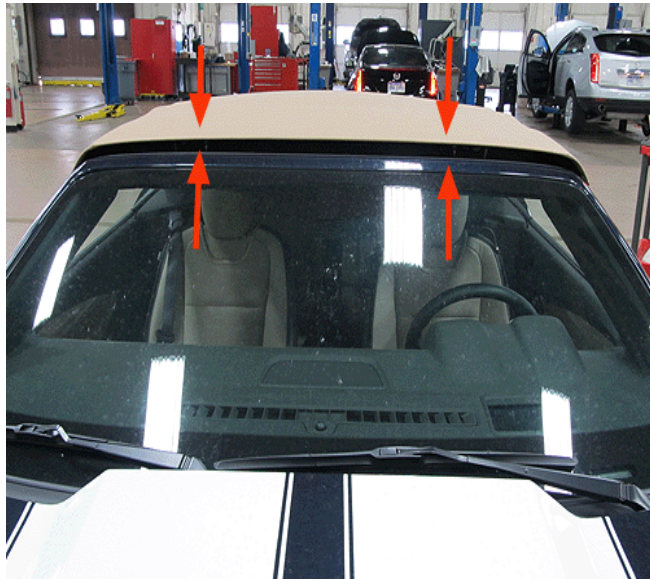
3470275

Commonly, when not latched at the header, the top will still show a uniform gap across the top of the windshield.

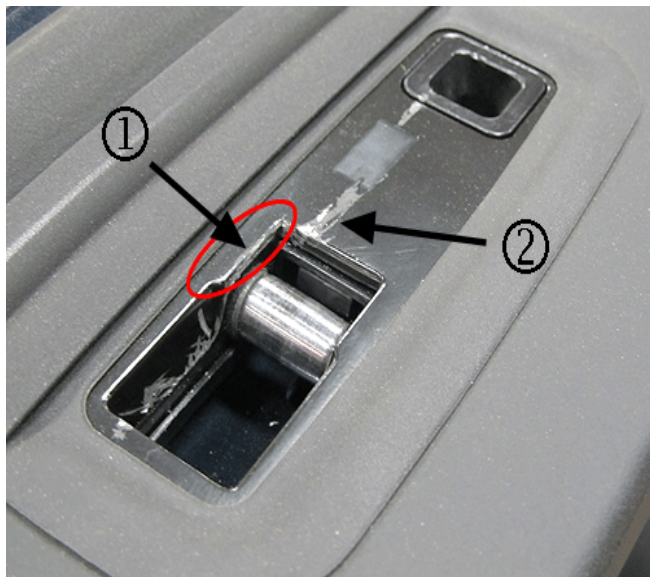
3470283

This driver side front striker shows latch impact marks at the forward edge (1) and the latch hook wear marks (2) too far forward.

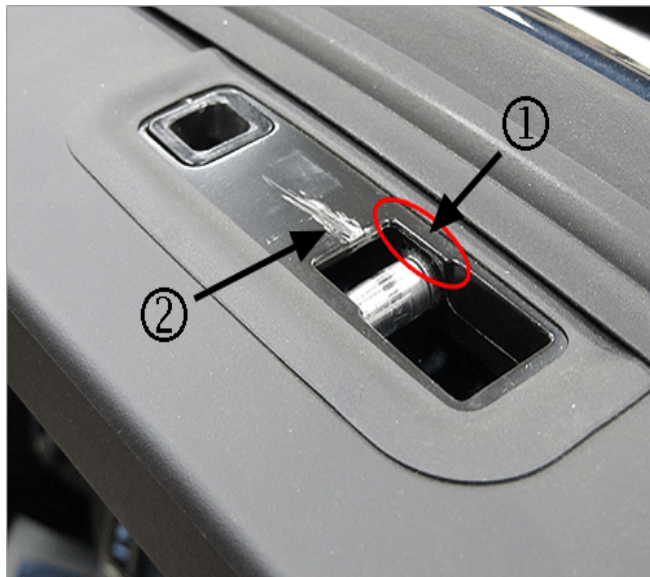
3470288

This passenger side front striker shows no indication of latch impact marks (1) and the latch hook wear marks (2) are more centered to the opening.
