Service Bulletin

Bulletin No.: PIT5318

Subject: Wind Buffeting Droan Type Noise And/Or Body Pressure Booming

Models: 2015 Cadillac Escalade Models
2015 Chevrolet Suburban, Tahoe
2015 GMC Yukon Models

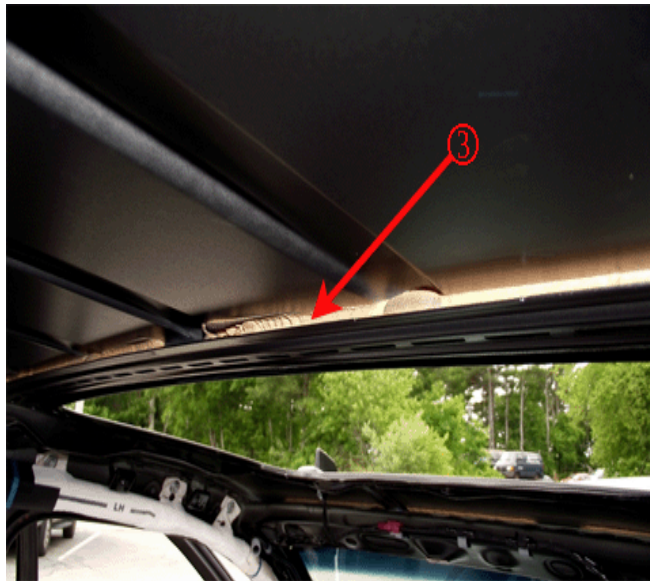
3973294

Some owners may comment of a wind buffeting/droan noise or body/pressure booming (the feeling of pressure in the ears) while driving. The body booming issue may be more noticeable when the engine is in V4 mode. In some cases, they may also notice a water leak from the headliner area, if equipped with a sunroof. These concerns could be caused by the roof sheet metal no longer being attached to the roof bows (1). On trucks with a sunroof, it may be noticed that the rear edge of the sunroof glass is considerably lower than the roof (2). This is due to the roof sheet metal being detached from the roof bow directly behind the sunroof opening (3).

To correct this concern, apply panel vibration control material between the roof bow and roof sheet metal, along with foam shim material when necessary.

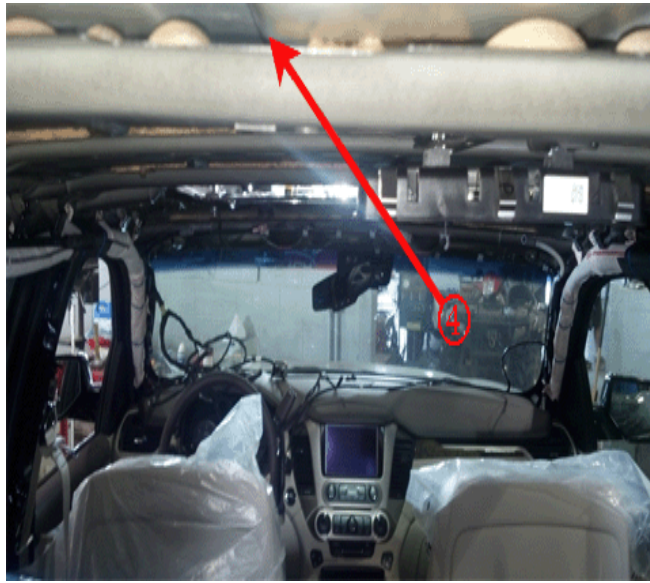
3973295

Remove the headliner to access the underside of the roof. Inspect all 4 roof bows for insufficient bonding to the roof sheet metal (4). Any roof bow that is not bonded to the sheet metal will need to be repaired.

Use the following repair for all 4 bows on trucks without a sunroof, and for the 3 rear bows on trucks with a sunroof: Use a plastic scraper or similar tool to remove the old foam. Measure the gap between the top of the roof bow and bottom of the roof sheet metal. If the gap is 5/16" (8mm) or greater, use a combination of 3/4" wide by 5/16" or 7/16" thick foam shim material (as listed below) to fill the gap between the roof bow and the sheet metal. Care should be taken to add only the correct thickness of foam to fill the gap so it does not push up on the roof. Cut the foam into 5 inch lengths and place in three spots along the roof bow, one piece in the middle and one at each outer edge. With the foam shim material in place, or if the gap is less than 5/16" (8mm), use the panel control vibration material (as listed below) to fill the voids between the roof bow and sheet metal. In some cases, it may take a couple layers of material to fill the void.
