Service Bulletin

Bulletin No.: PIC5412B

Subject: High-Pitched / Whine Noise Heard Intermittently From Behind Rear Seats

Models: 2011-2013 Chevrolet Volt

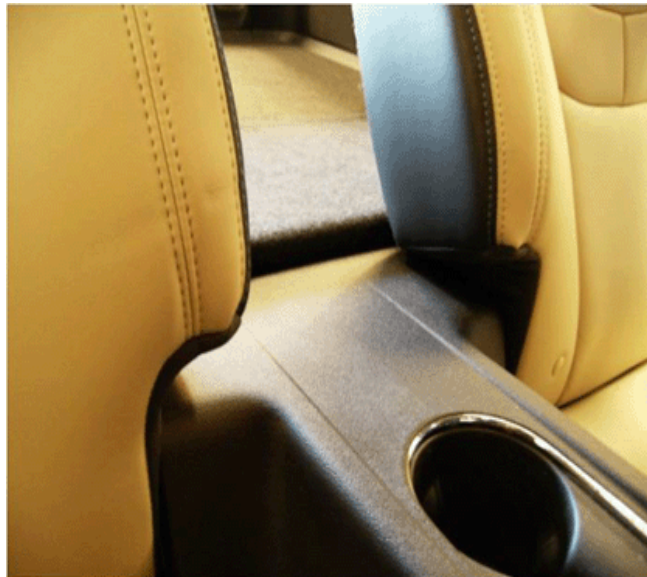
Some customers may comment on hearing a high-pitched whine noise during braking or accelerating, mostly in Extended Range Mode with the engine running. The noise is coming from the 14-Volt Power Module under the rear load floor.

The picture below shows a load floor that is NOT properly snapped into place:

If a customer is experiencing a high-pitched whine noise from the rear of the vehicle, check the load floor, in the rear of the vehicle, for being properly secured. Check for any noticeable gaps between the load floor and the vehicle. See Photos below.

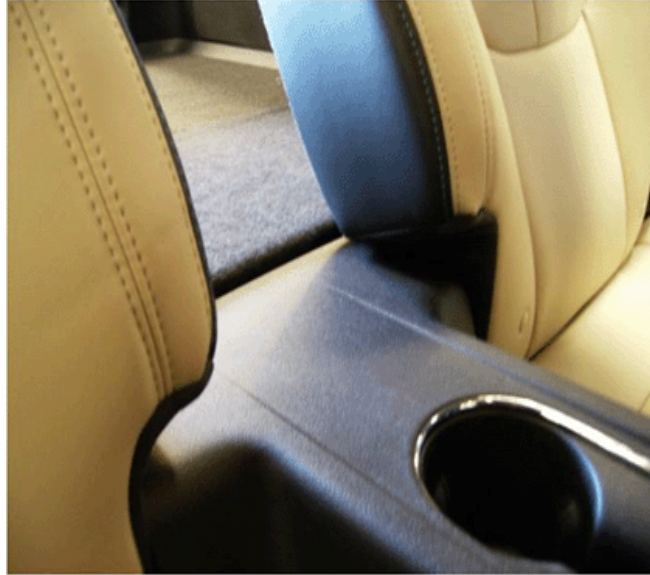
2551929

The picture below shows the load floor installed correctly:

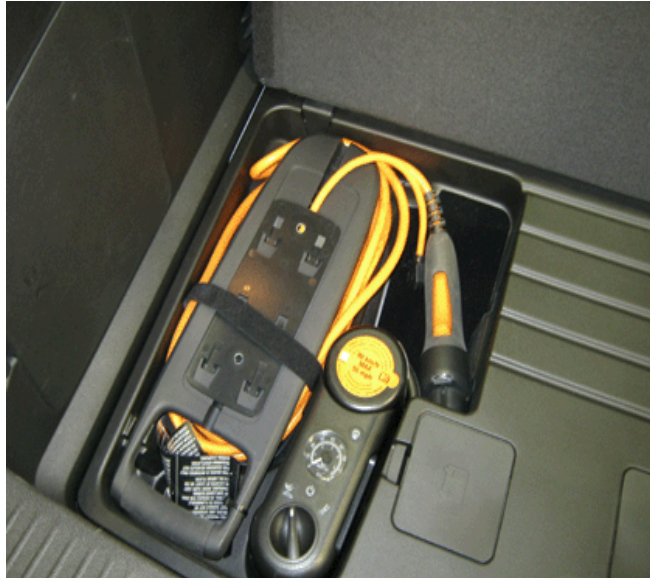
2551928

The picture below shows the 120v charge cord set stored properly in its place:

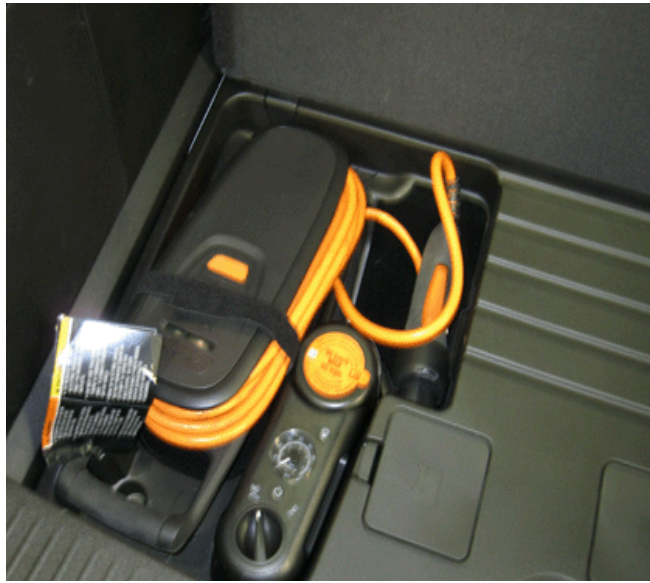
2551926

1. An improperly stowed 120v charge cord set.
2. Cargo in the lower tray that can pop the load floor up.
3. Damage to the load floor that causes the floor not to clip into place.

The picture below shows the 120v charge cord set NOT stored properly, which would cause the load floor not to secure properly in the front and causes a gap and an entry point for noise into the front of the vehicle.
