# Service Bulletin

Bulletin No.: PIC5449C

**Subject:** Convertible Roof Cloth Sags At Rear / Large Gap Between Number 5 Bow And Rear Panel

**Models:** 2011 - 2013 Chevrolet Camaro Convertible

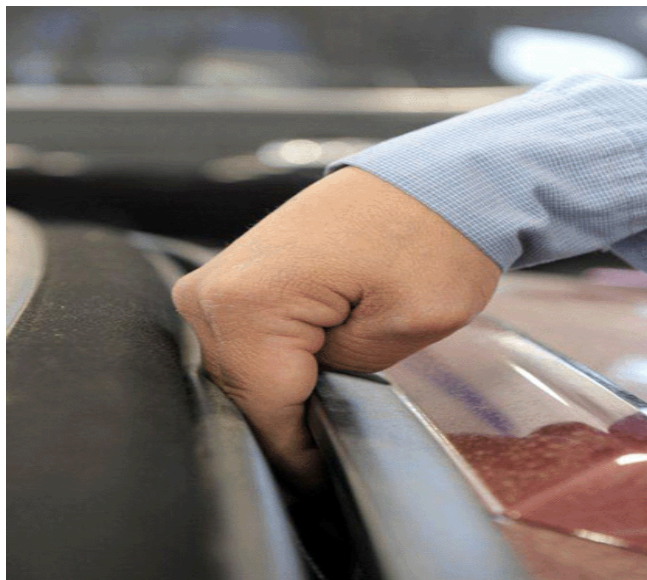
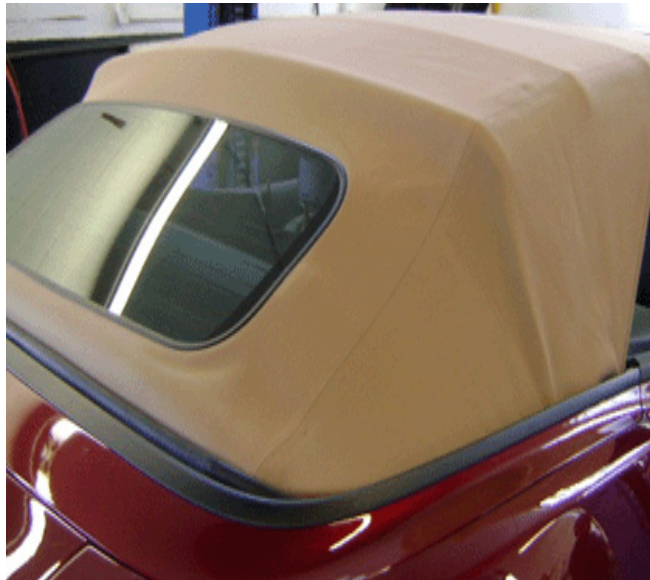
2637852

A dealer may report that there is a large gap between the #5 bow and the rear "tulip" panel when the top is closed and latched. This may cause a sag in the cloth top material, causing the appearance of a loose fit.

This condition may have been caused by the topics discussed in PI0378 and/or PI0406. Review the latest revision of PI0378 and PI0406 prior to beginning repairs.

Replace the #5 bow following repair procedures in SI.

Immediately following replacement of the #5 bow assembly or any time the top assembly has been removed from the vehicle and prior to cycling the top for the first time, it is necessary to follow the latest version of PI0406 to ensure that the Folding Top Quarter Outer Drain Panel (water management bag) is not interfering with the top assembly.
