NUMBER: 23-001-16 REV. A

Center Console Lid Binding

This bulletin involves adding a rubber bumper to the console lid to prevent the lid from binding.

2015-2016	(DS)	Ram 1500 Pickup
2015-2016	(DJ)	Ram 2500 Pickup

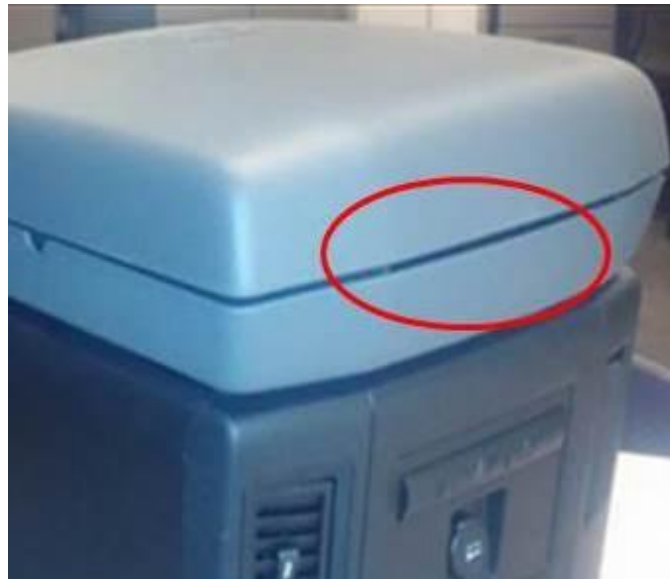
Fig. 1 Check Lid For Rubbing

1. Locate the center console inside the vehicle.
2. Slowly open the upper lid of the center console while checking the gap between the bottom of the upper lid and the top of the lower lid for rubbing together as shown in (Fig. 1).

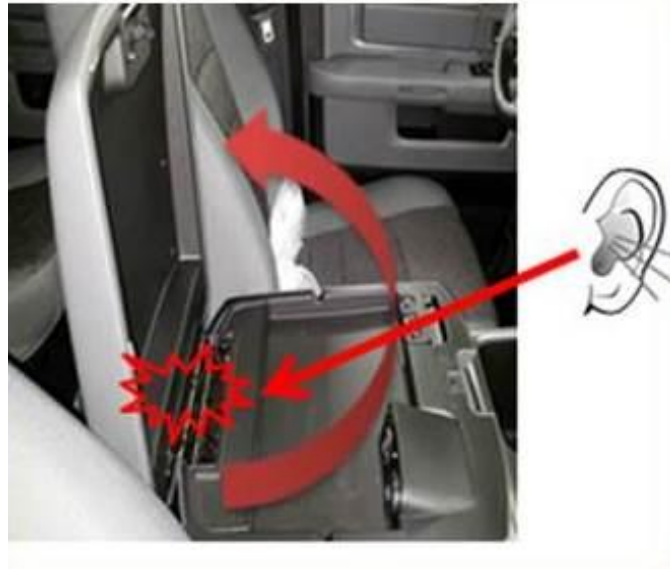
Fig. 2 Checking Lid Noise

3. Check the rear of the upper lid hinge for binding or an audible clicking as shown in (Fig. 2).

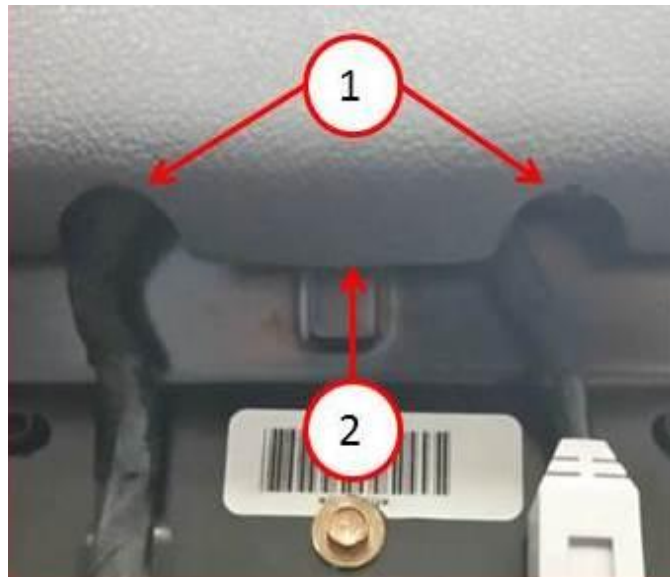
Fig. 5 Bumper Location

1 - Notches

2 - Location Of Bumper Installation

- At the rear of the center console wall on the lower lid, identify the two notches as shown in (Fig. 5).

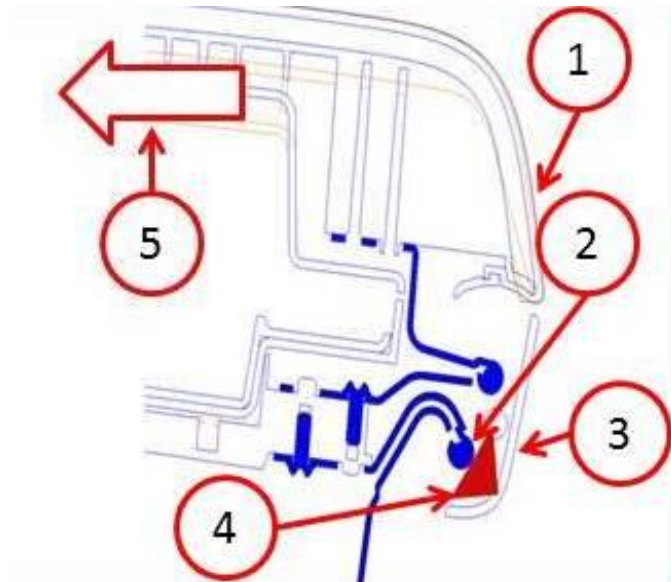
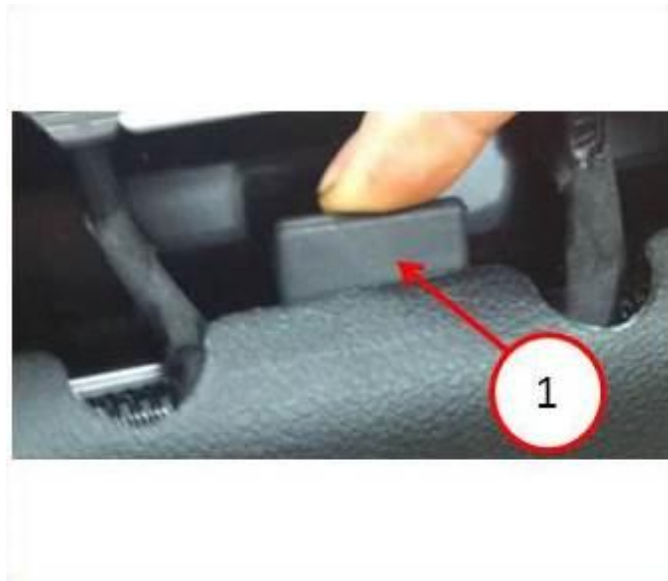
- 1 - Rear Of The Center Console
 - 2 - Hinge
 - 3 - Lower Lid
 - 4 - Bumper
 - 5 - Front Of The Console
-

1 - Bumper

11. At the center of the console wall on the lower lid (as noted in the previous step), insert the bumper where the red triangle is shown. It will take some effort to push the bumper in flush with the edge of the lower lid as shown in (Fig. 6) and (Fig. 7).

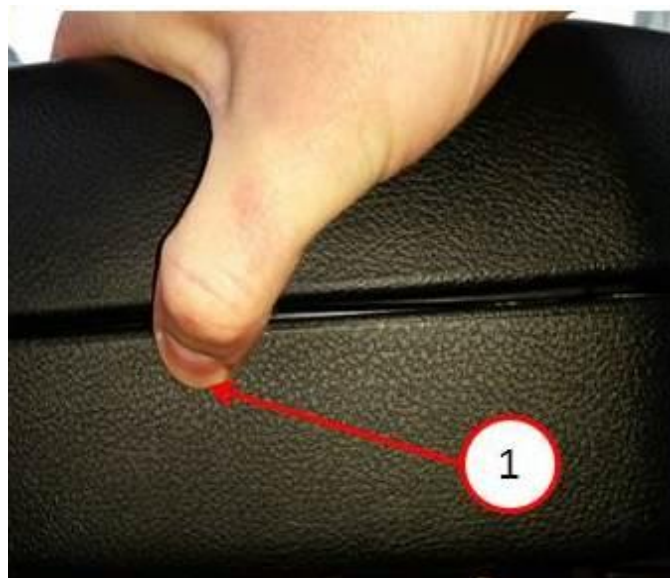
Fig. 8 Bumper Installation Continued

1 - Press The Back Wall

12. To assist the installation of the bumper, press the back wall of the lower lid to relieve some tension while inserting the bumper as shown in (Fig. 8).

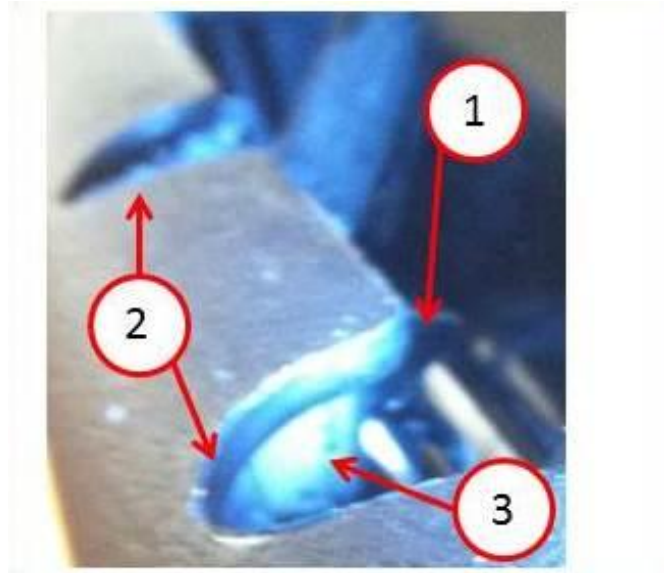
Fig. 9 Bumper Installed

- 1 - Metal Tab On The Lower Lid Hinge
- 2 - Notches
- 3 - Bumper Installed

13. Visually inspect the area of repair that the bumper is installed as shown in (Fig. 9).
