Service Bulletin

Subject: Water Leak into Driver/Passenger Footwell or Within IP and/or Lower Dash Panel Insulators (Hush Panels)

Models: 2010-2012 Chevrolet Malibu

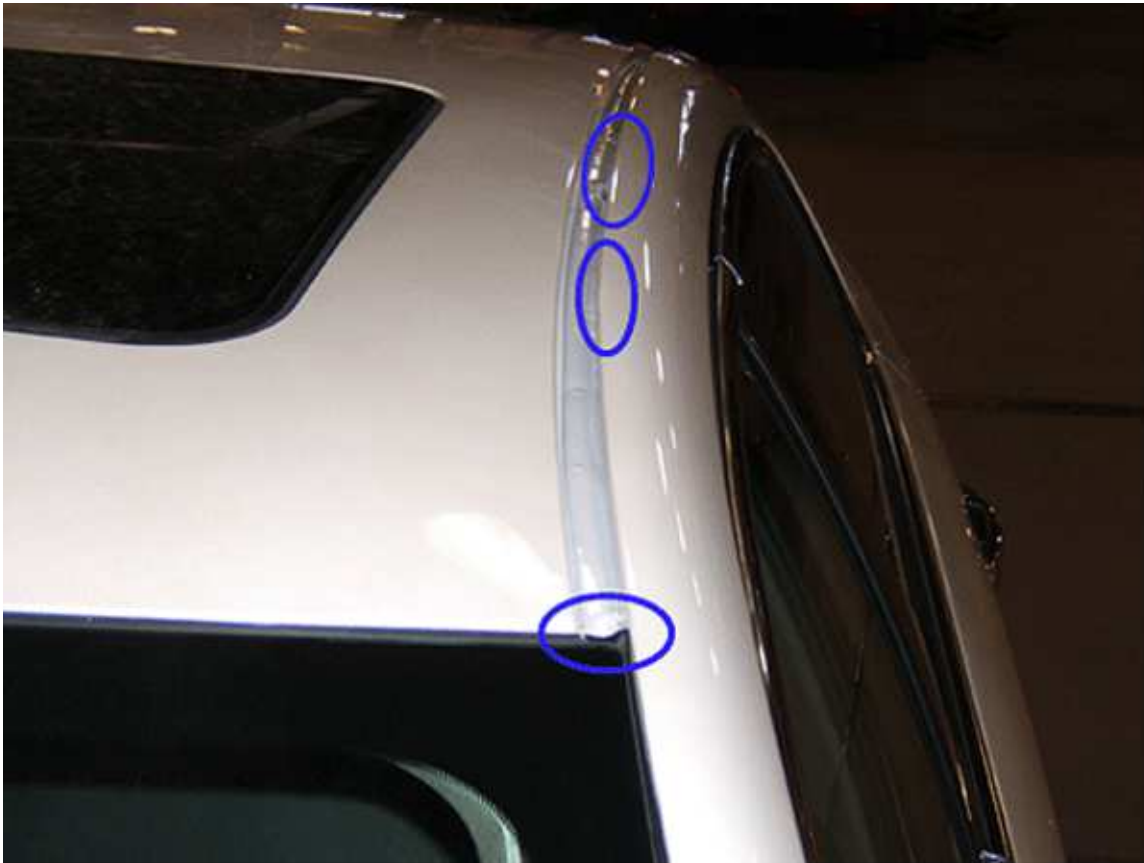
Some customers may comment on finding wet carpet in the driver or passenger footwell area. Upon further inspection, a technician may note water spotting or water accumulation within the IP structure and/or hush panel.

This condition may occur due to incomplete sealing within the roof to windshield header, A-pillar and/or B-pillar seams.

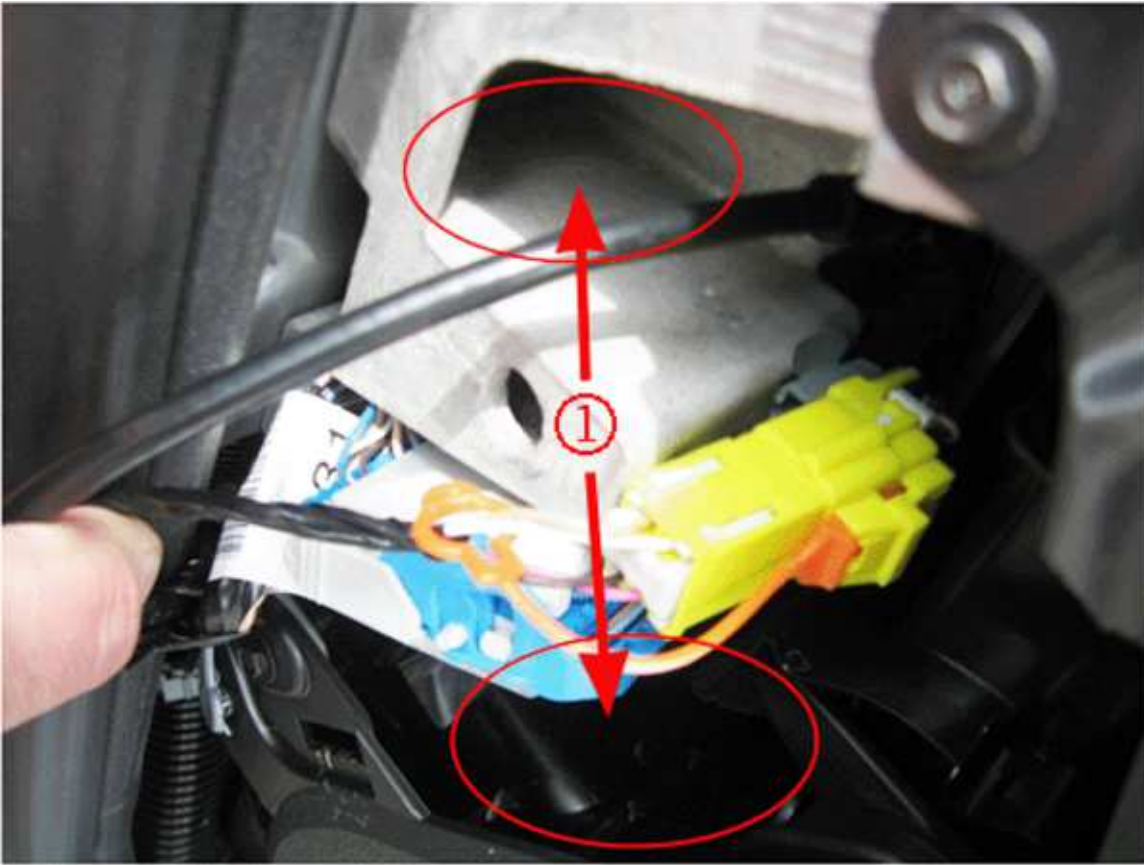
- Remove the IP outer trim cover and inspect for water/spotting within the end opening on the IP (1).

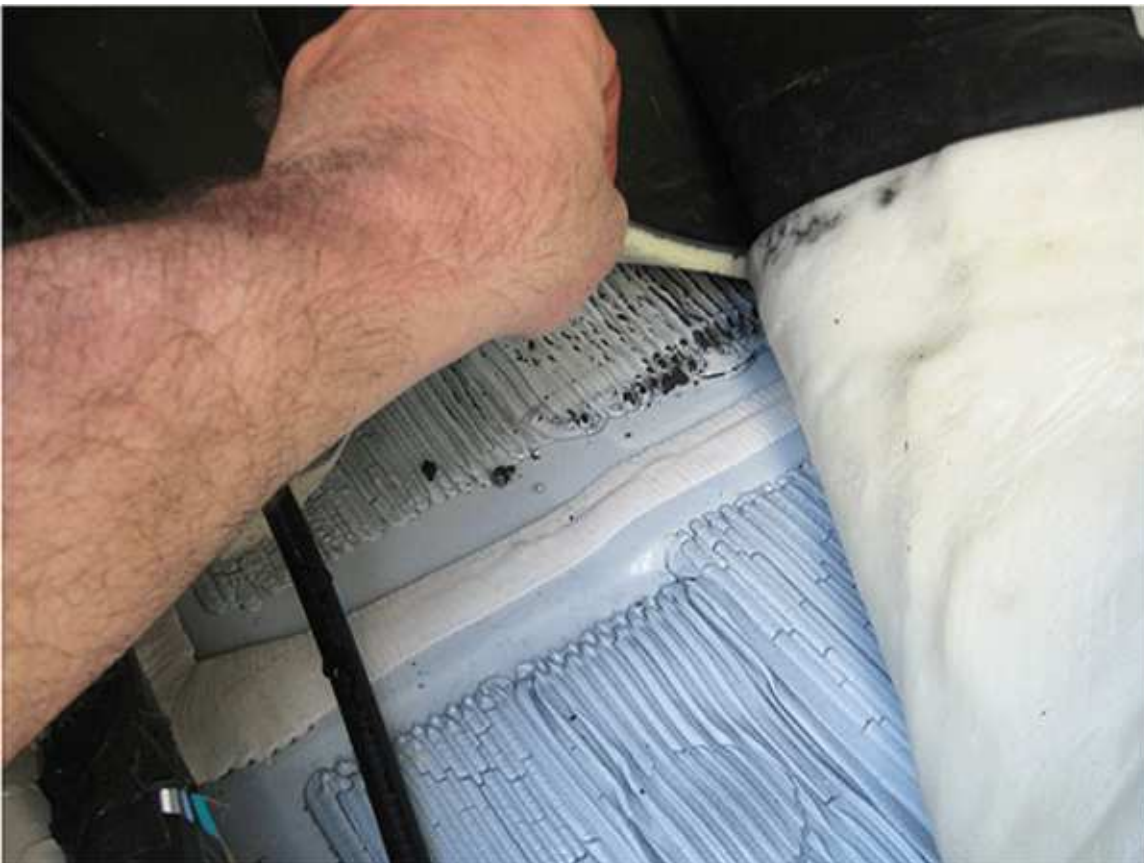
- Repositioning the front carpet, inspect for water/spotting between the carpet and the floorboard.

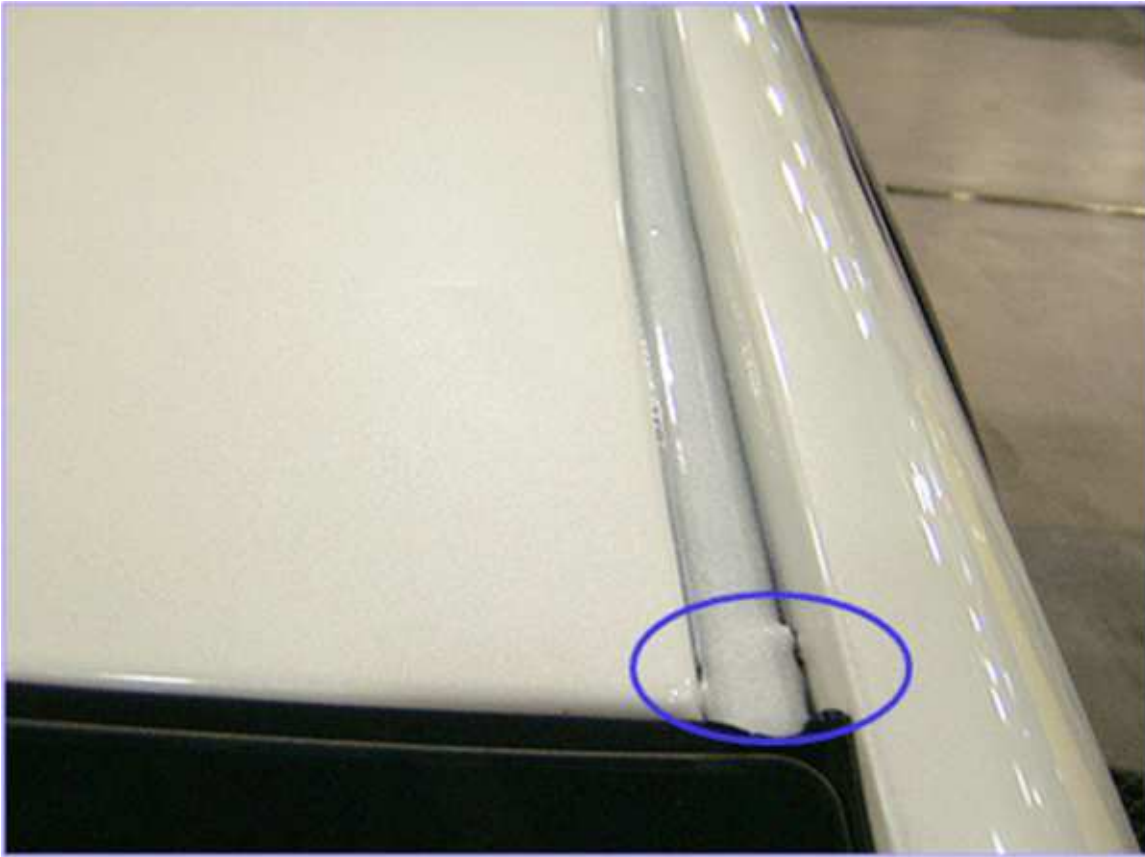
- At the windshield header and between the roof panel to A-pillar seam

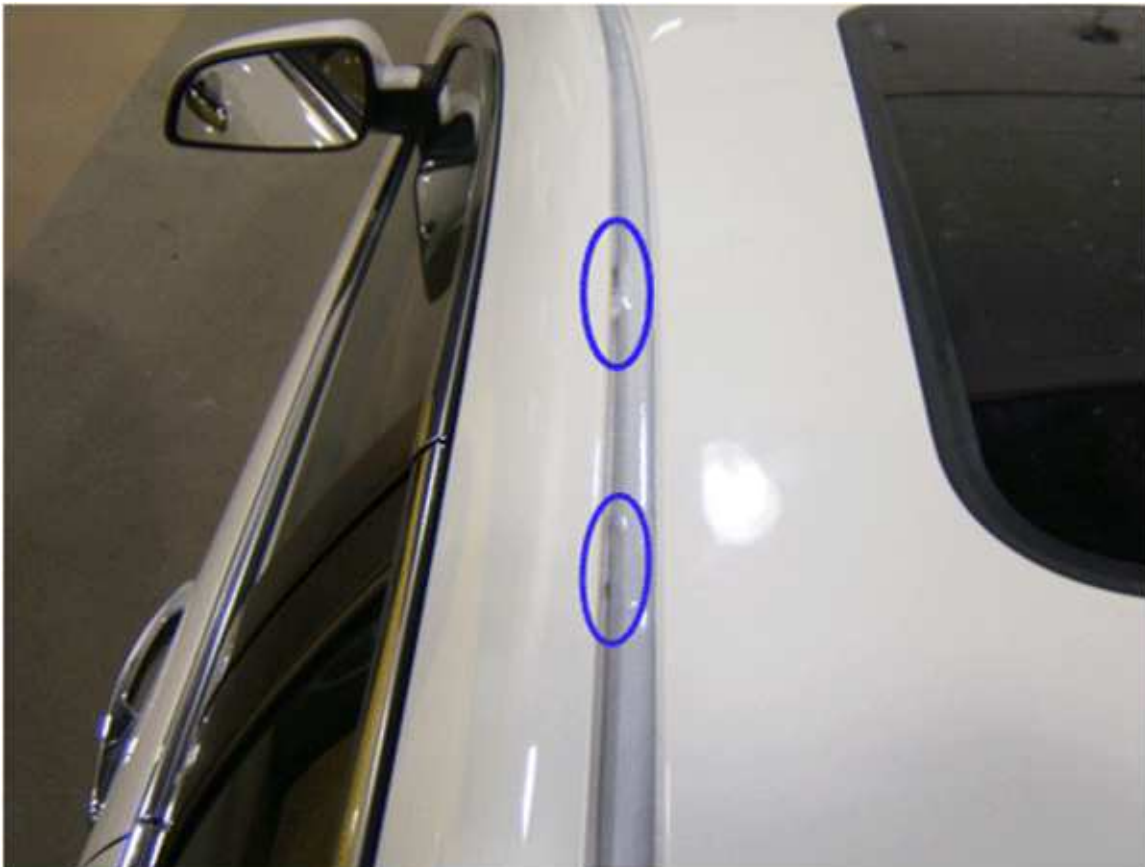
- Between the roof panel to B-pillar seam

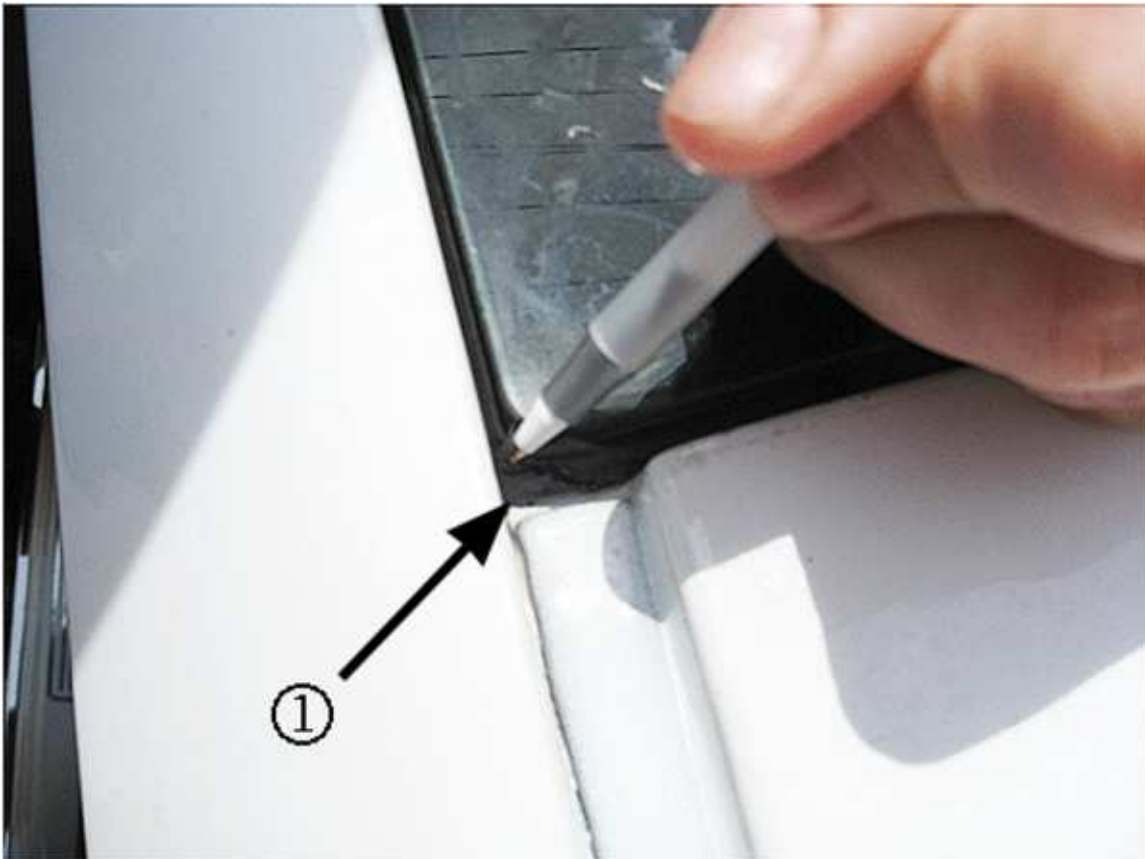
2. inspect for voids/gaps (1) in the seam sealer along the outboard edge of the roof ditch.
3. Seal all gaps with *Kent Automotive High-Tech™ Clear Seam Sealer, P/N 10200 (5 oz tube), or equivalent. Avoid excess sealer build up within the ditch while assuring any voids in the factory seal are filled.

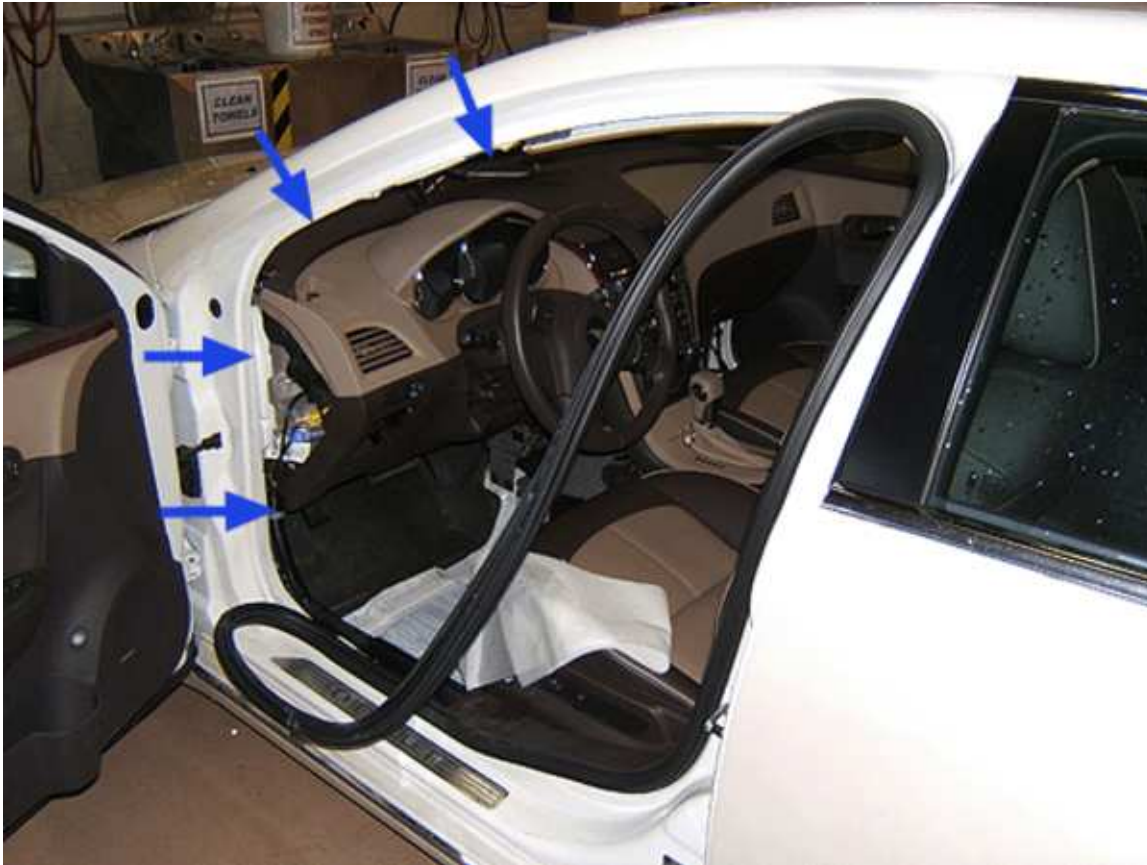
- Also inspect the forward-most edge of the ditch, assuring any gaps in the factory sealer are filled. Inspect and seal all the way to and below the rubber windshield lace (1).
