Service Bulletin

Subject: Diagnostic Tips for Reduced Acceleration at Low Speed and/or Transmission Slipping from a Launch, DTC P0751 Set

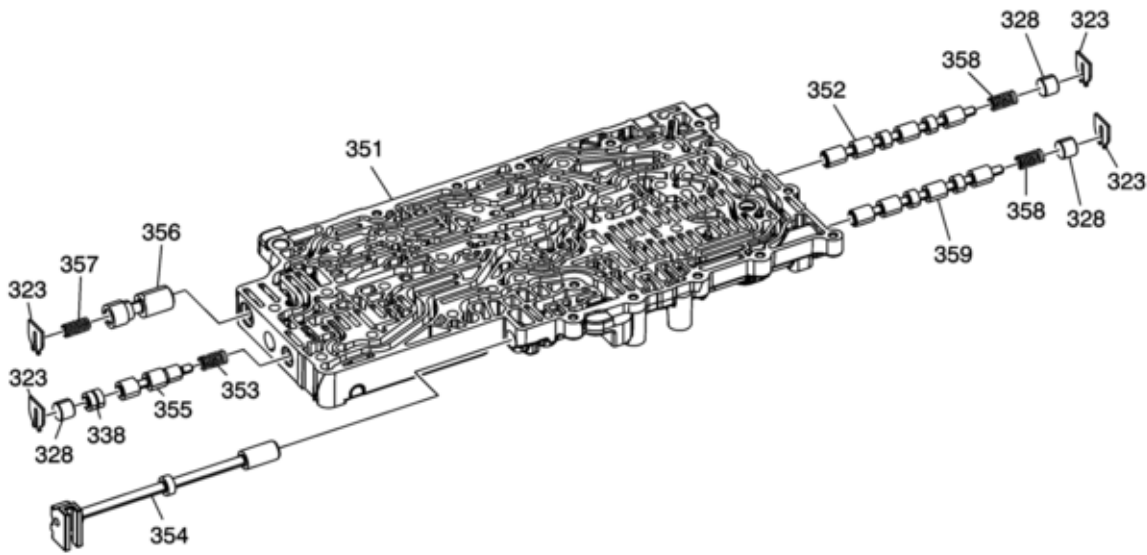
This condition may be caused by the Clutch Select Solenoid Valve 2 (359), located in the lower valve body, sticking in its bore resulting in a 4th gear start.

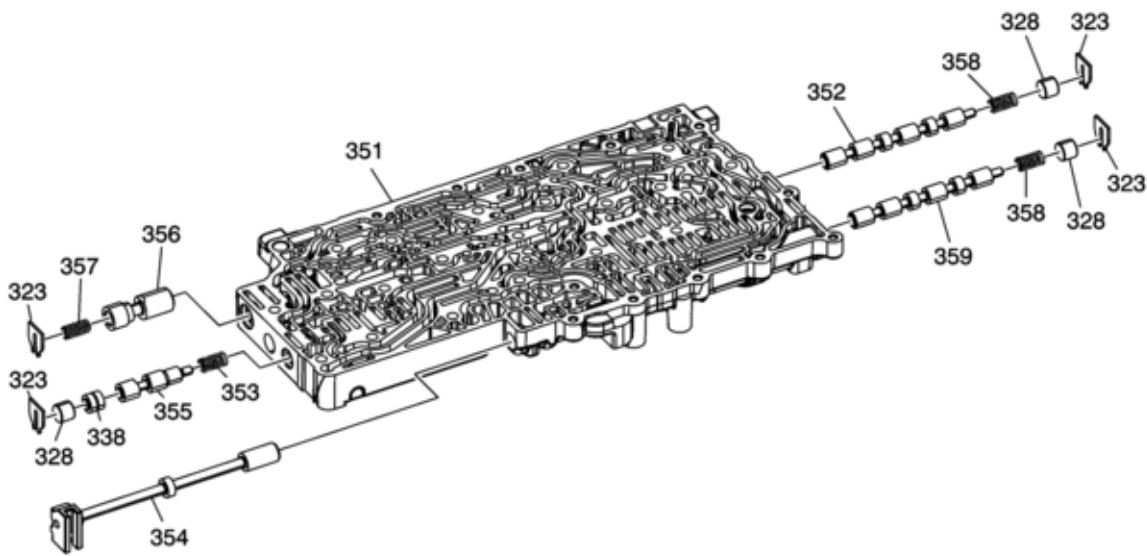
During inspection of the Clutch Select Solenoid Valve 2 (359), the valve may or may not be stuck in the bore due to the valve body bolts being loosened.

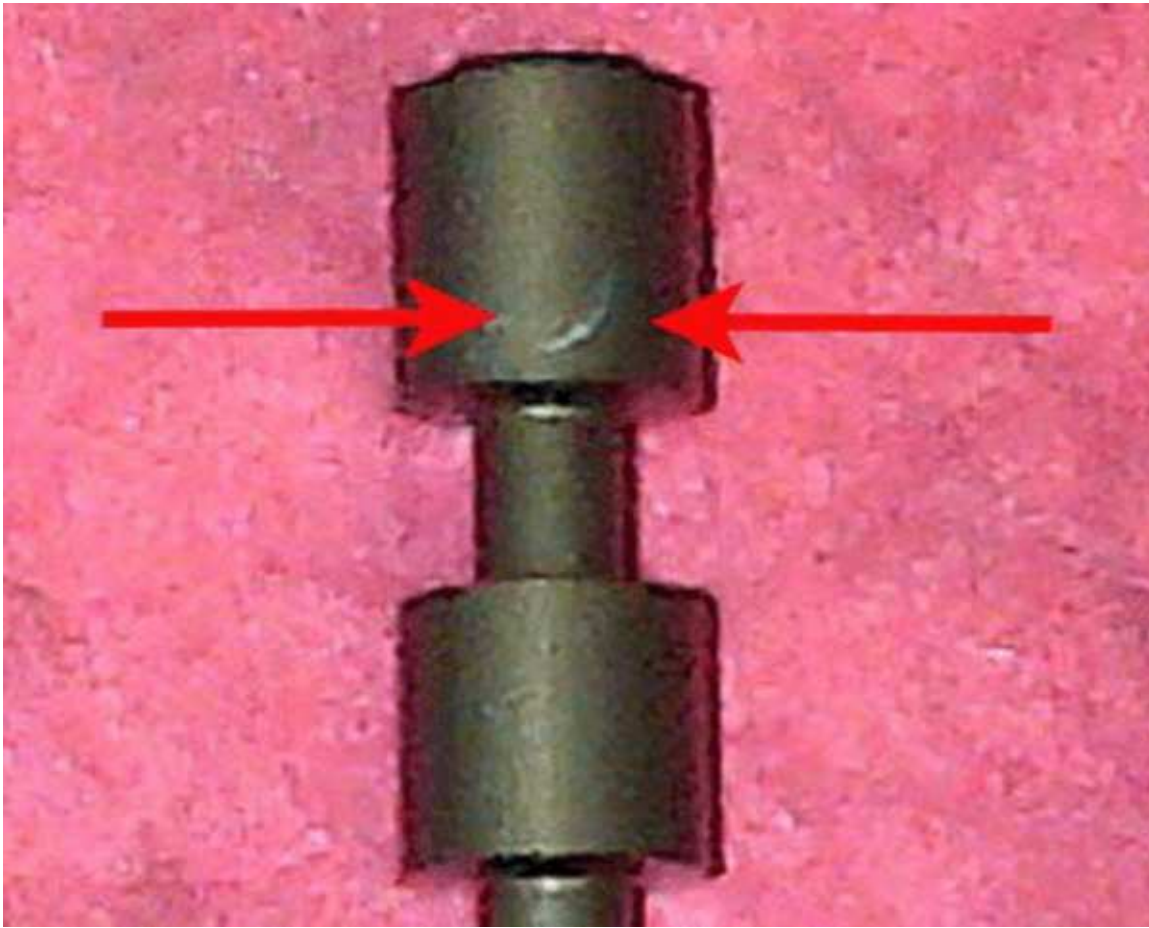
The recommended inspection procedure is to remove the valve and inspect it for any scratches on the valves. The illustration above shows an example of a valve with a scratch mark on it. If the valve is stuck in the bore or shows signs of scratching or damage, the lower valve body should be replaced.
