Subject: STAINS FOUND ON PAINT DURING PDI	Bulletin No: 09-010/16
	Last Issued: 02/17/2016

- 2014-2016 MX-5
- 2016 CX-3
- 2014-2016 CX-5
- 2014-2016 CX-9
- 2014-2016 Mazda2
- 2014-2016 Mazda3
- 2014-2015 Mazda5
- 2014-2016 Mazda6

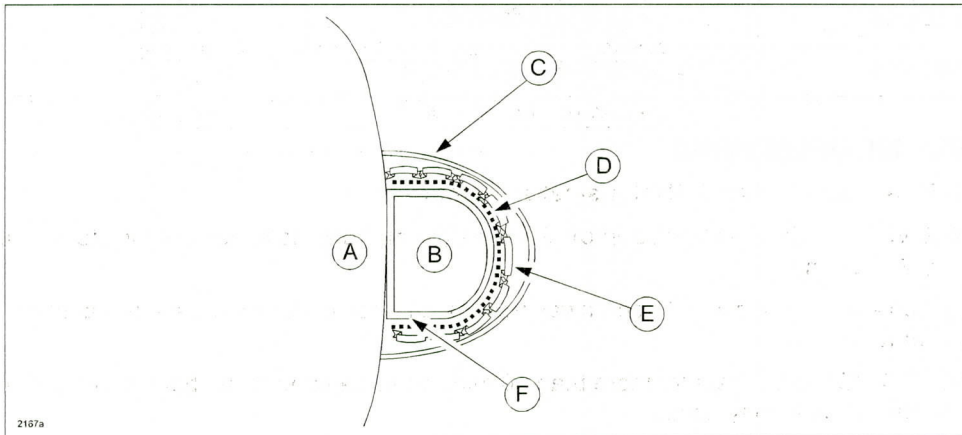
Some vehicles may experience stains appearing on the hood, roof and/or trunk of the vehicle. This concern is most likely to be found in a cold weather areas just after the RAPGARD is removed at PDI. This may be caused by moisture which has been trapped and condensed between the paint and the RAPGARD. These types of stains can be removed with a heat gun or an infrared drier.

1. Visually inspect the top coat surface for stains.
 - If stains are found, use a heat gun (for smaller stains) or an infrared drier (for larger stains) to heat the affected area and remove the stains.
2. Insulate all plastic and rubber parts (as shown below) using heat insulation materials (C ~ F) prior to beginning the application of heat.
 - A - Body Panel
 - B - Molding
 - C - Aluminum foil covering all area
 - D - Wet towel
 - E - Folded aluminum foil
 - F - Aluminum foil tape

- Since this repair procedure requires the use of heat from a heat gun or infrared drier, be sure to insulate all rubber or plastic parts which are easily affected by heat from near the affected stain area.
- Use extreme care to ensure the top coat surface temperature stays below 284°F (140°C).
- To protect materials inside the cabin area (i.e. carpet, seats, etc.), also place insulation over the glass as necessary.
