Bulletin No.: PI0754B Date: 12-Apr-2016

Service Bulletin

Subject: Rear and Side Tempered Glass Spots (Quench Marks)

Models: 2017 and Prior GM Passenger Cars and Trucks

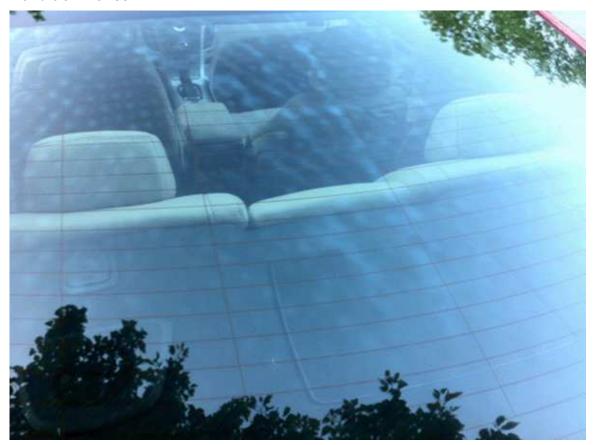
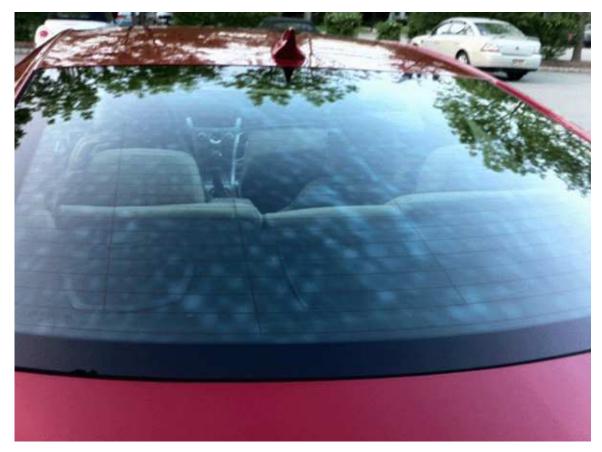
1

Some customers may comment on spots showing on the rear and side windows when the vehicle is in the sunlight. When wearing polarized glasses/sunglasses, these spots may be more magnified.

The spots are due to the manufacturing process and are "quench marks" in the glass. Quench marks are an unintentional side effect of the tempering process.

Technicians should explain to the customer that this is a normal condition and part of the manufacturing process for tempered glass. Do not replace the window(s) for this condition.
