Service Bulletin

Bulletin No.: 09-03-09-001D

Subject: Clunking Noise from Rear of Vehicle (Re-torque Leaf Spring Bolts)

Models: 2007-2017 Chevrolet Silverado
2014-2017 Chevrolet Silverado 1500
2014-2017 Chevrolet Silverado 2500/3500
2015-2017 Chevrolet Colorado
2007-2017 GMC Sierra
2014-2017 GMC Sierra 1500
2014-2017 GMC Sierra 2500/3500
2015-2017 GMC Canyon

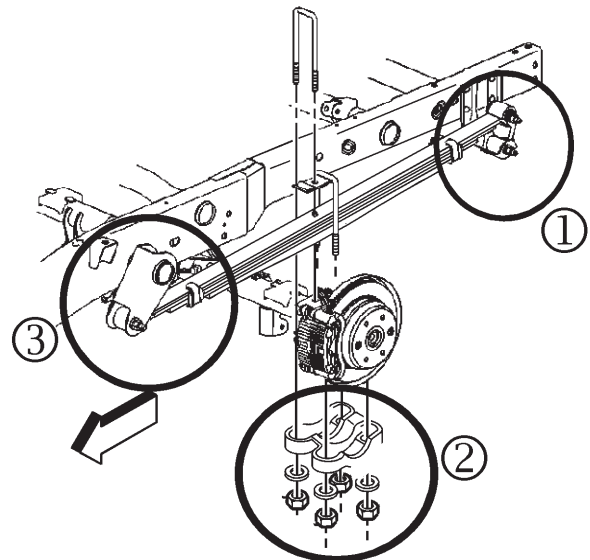
4080776

Some customers may comment about a clunking noise coming from the rear of the vehicle. Upon further investigation, the technician may diagnose the noise coming from the rear suspension leaf spring area.

2. Loosen the shackle joint to the frame, front eye joint to the frame, rear eye to shackle joint and the anchor plate U-bolts.
3. Re-torque the shackle joint to the frame and to the rear eye (1). Refer to SI for torque specifications.

4. Re-torque the anchor plate U-bolts (2). Refer to SI for torque specifications.
5. Re-torque the front rear spring mounting nut (3). Refer to SI for torque specifications.
