Service Bulletin

Subject: Groan, Squeak or Rubbing Type Noise When Turning Steering Wheel

Models: 2010-2016 Buick LaCrosse
2012-2016 Buick Regal, Verano
2012-2015 Chevrolet Cruze, Volt
2013-2016 Chevrolet Malibu Limited (VIN 1)
2014-2016 Chevrolet Impala

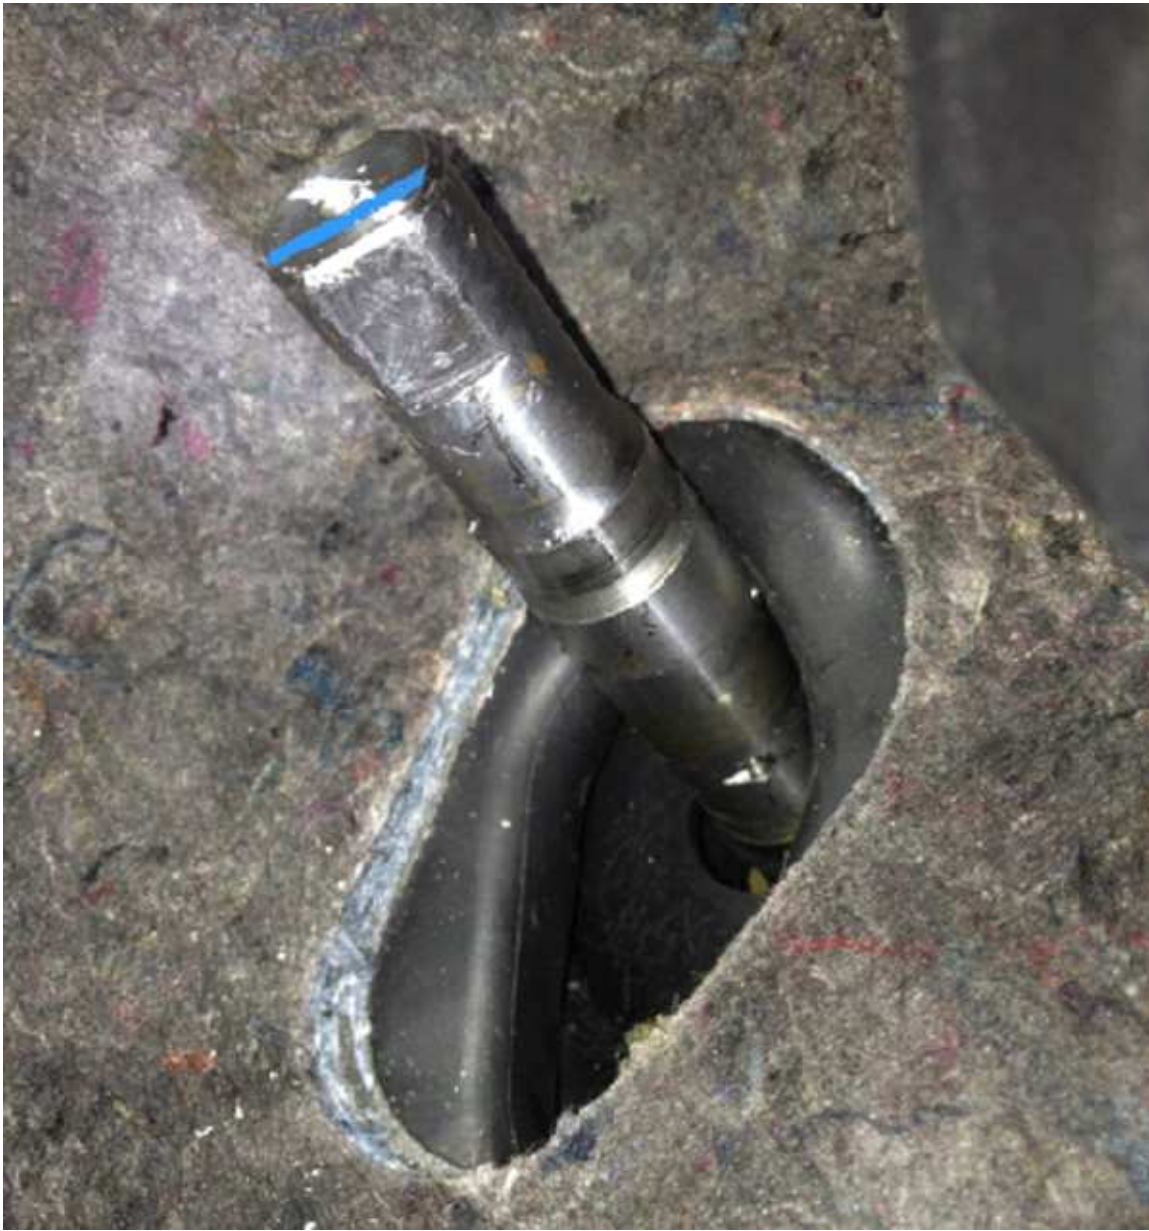
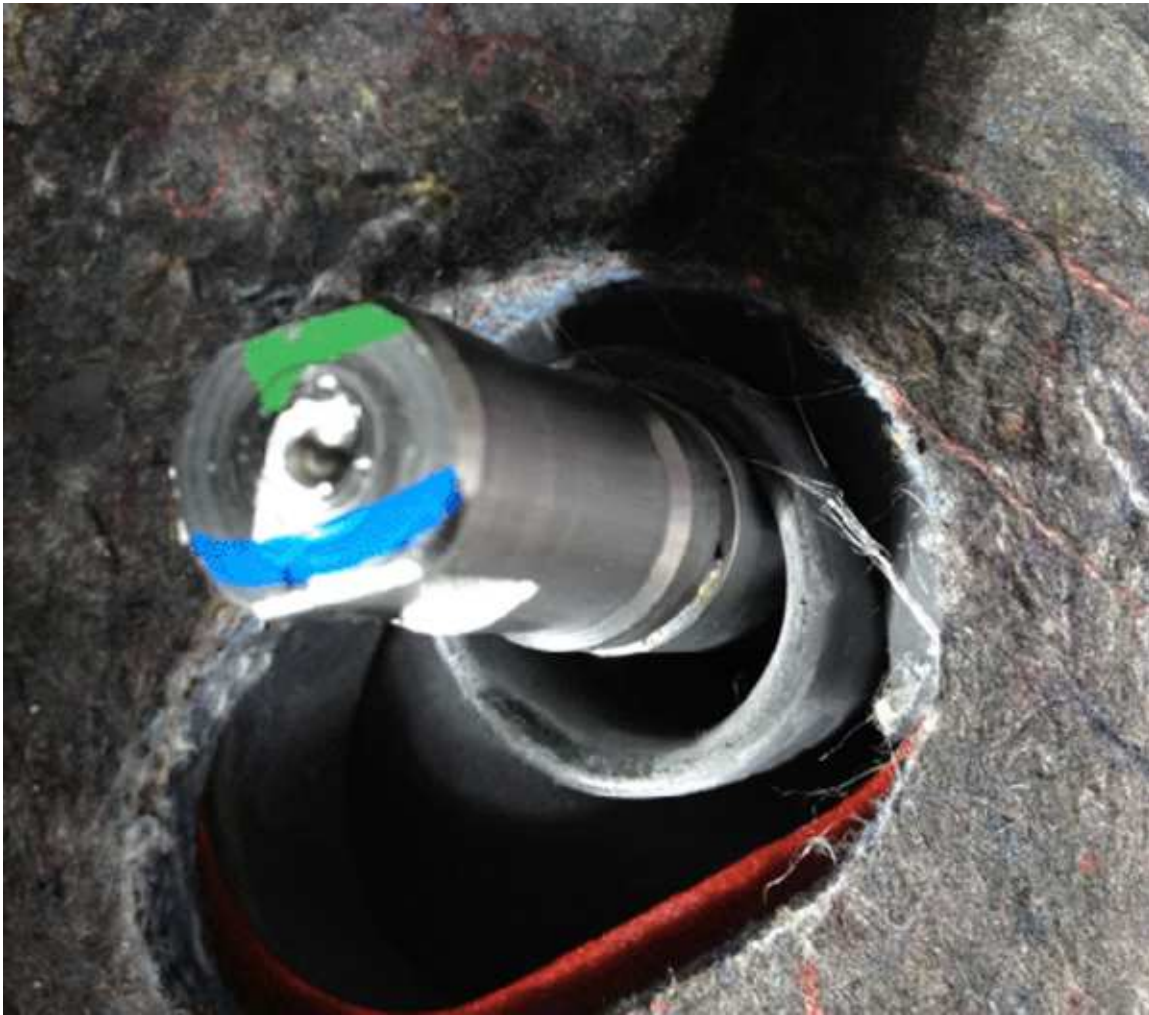
Condition/Concern (Impala)

Some customers may comment on a rubber squeak type noise when turning the steering wheel. This condition may be caused by the seal for the intermediate shaft, located at the front of dash, rubbing on the rotating intermediate steering shaft. Refer to the pictures above.

Technicians should inspect the steering column seal for proper installation by repositioning the inner intermediate steering shaft boot assembly to gain access. Inspect the seal at the front of the dash where the intermediate steering shaft passes through from the steering gear. Ensure that the seal is centered in the opening and around the intermediate steering shaft as shown above. If the seal is out of position, replace the steering column seal following the steps below.

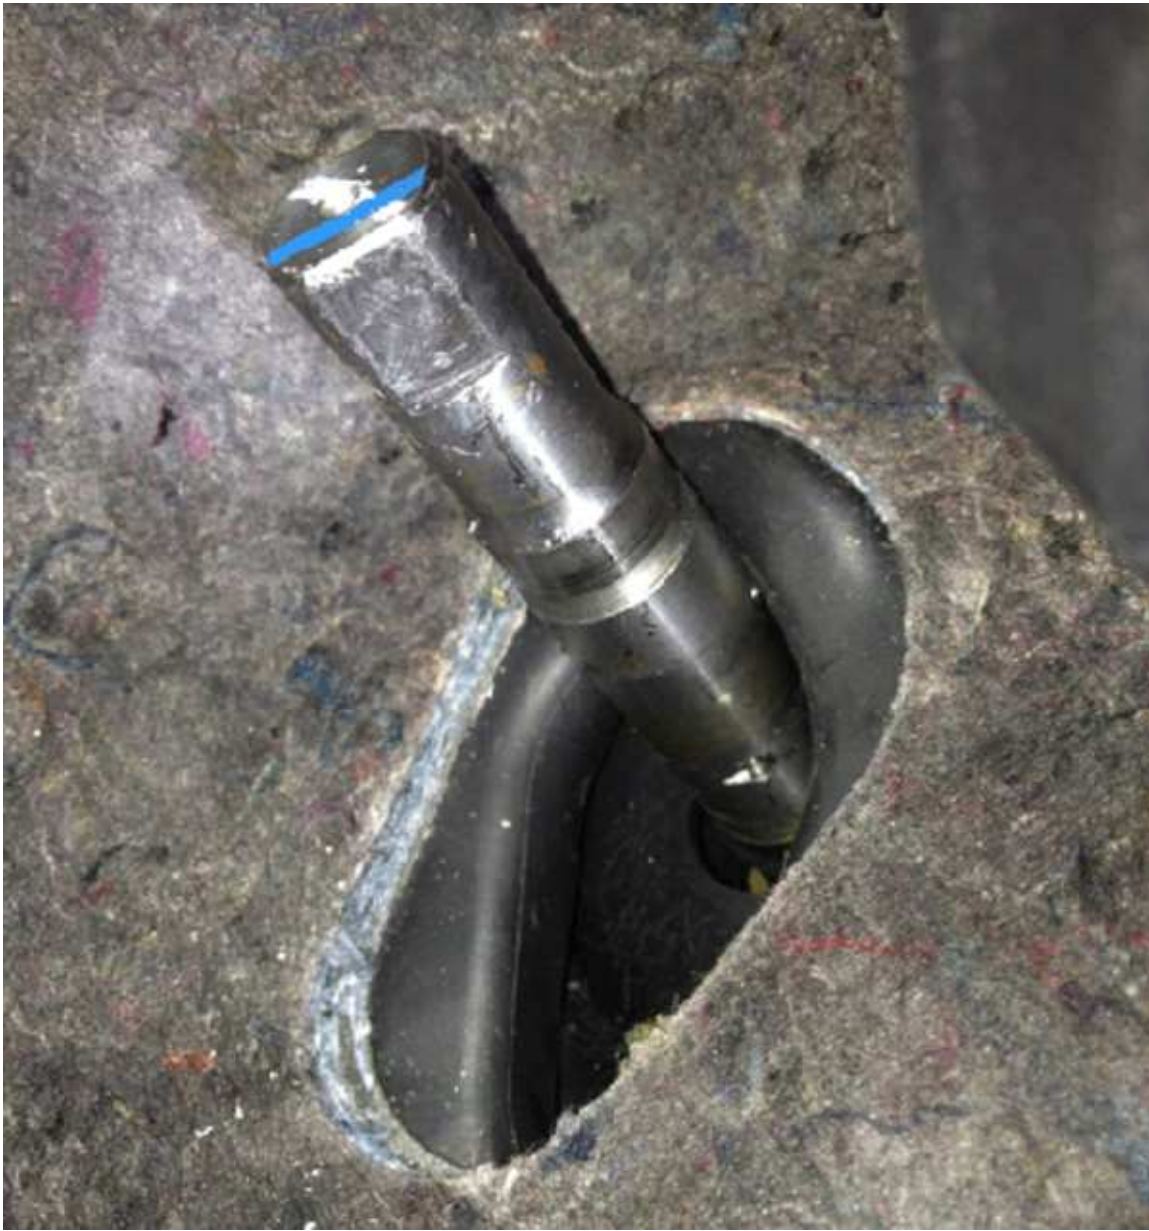
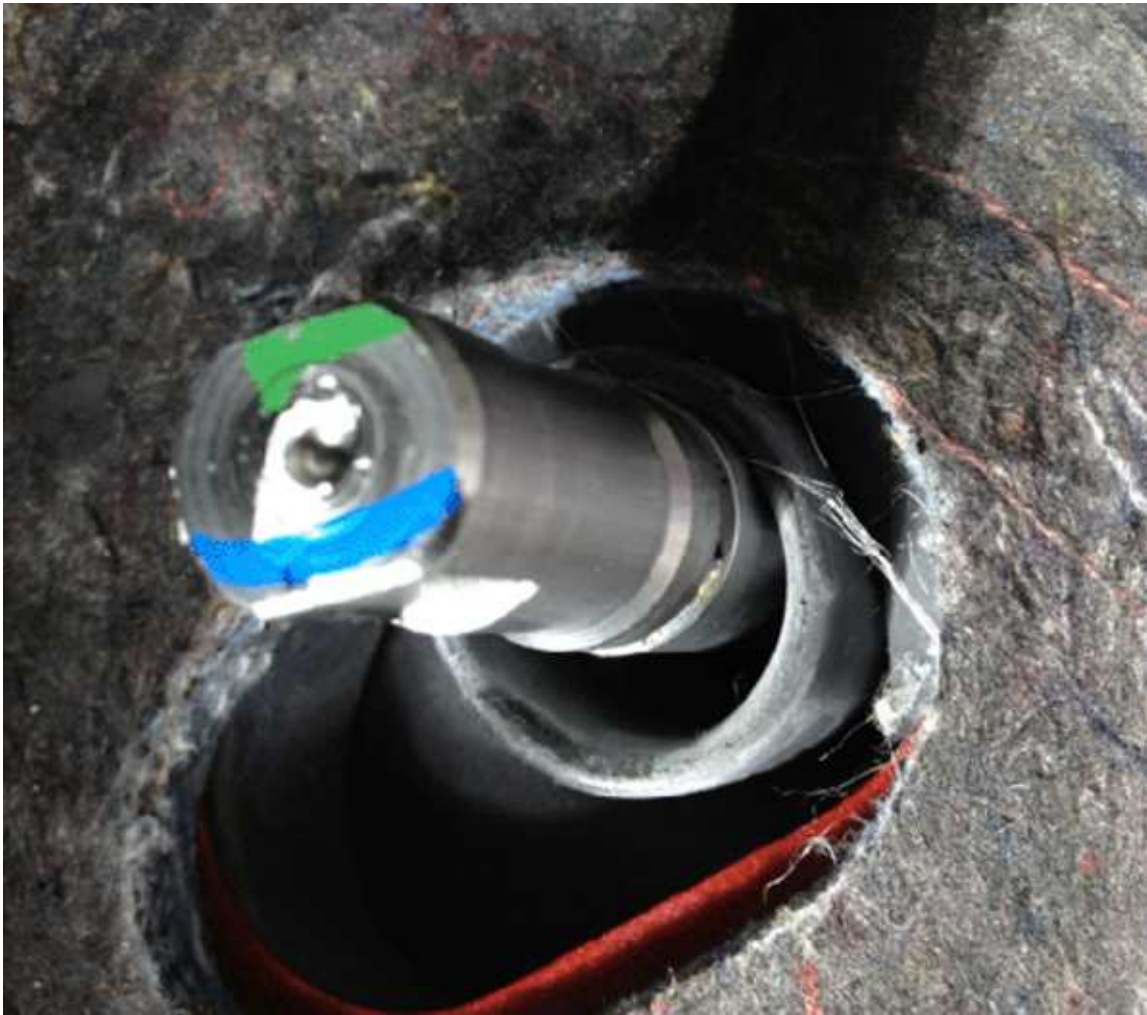
Condition/Concern (Malibu)

Some customers may comment on a rubber squeak type noise when turning the steering wheel. This condition may be caused by the seal for the intermediate shaft, located at the front of dash, rubbing on the rotating intermediate steering shaft. Refer to the pictures above.

The EPS wire harness bracket may also be contacting the steering column seal.

Technicians should inspect the steering column seal for proper installation by repositioning the inner intermediate steering shaft boot assembly to gain access. Inspect the seal at the front of the dash where the intermediate steering shaft passes through from the steering gear. Ensure that the seal is centered in the opening and around the intermediate steering shaft as shown above. If the seal is out of position, replace the steering column seal following the steps below.

Technicians should also inspect the EPS wire harness bracket if equipped and make sure that the bracket is not contacting the steering column seal. If contact is observed, manually adjust the EPS bracket to obtain an 8-12 mm (0.31-0.47 in) clearance from the steering column seal.

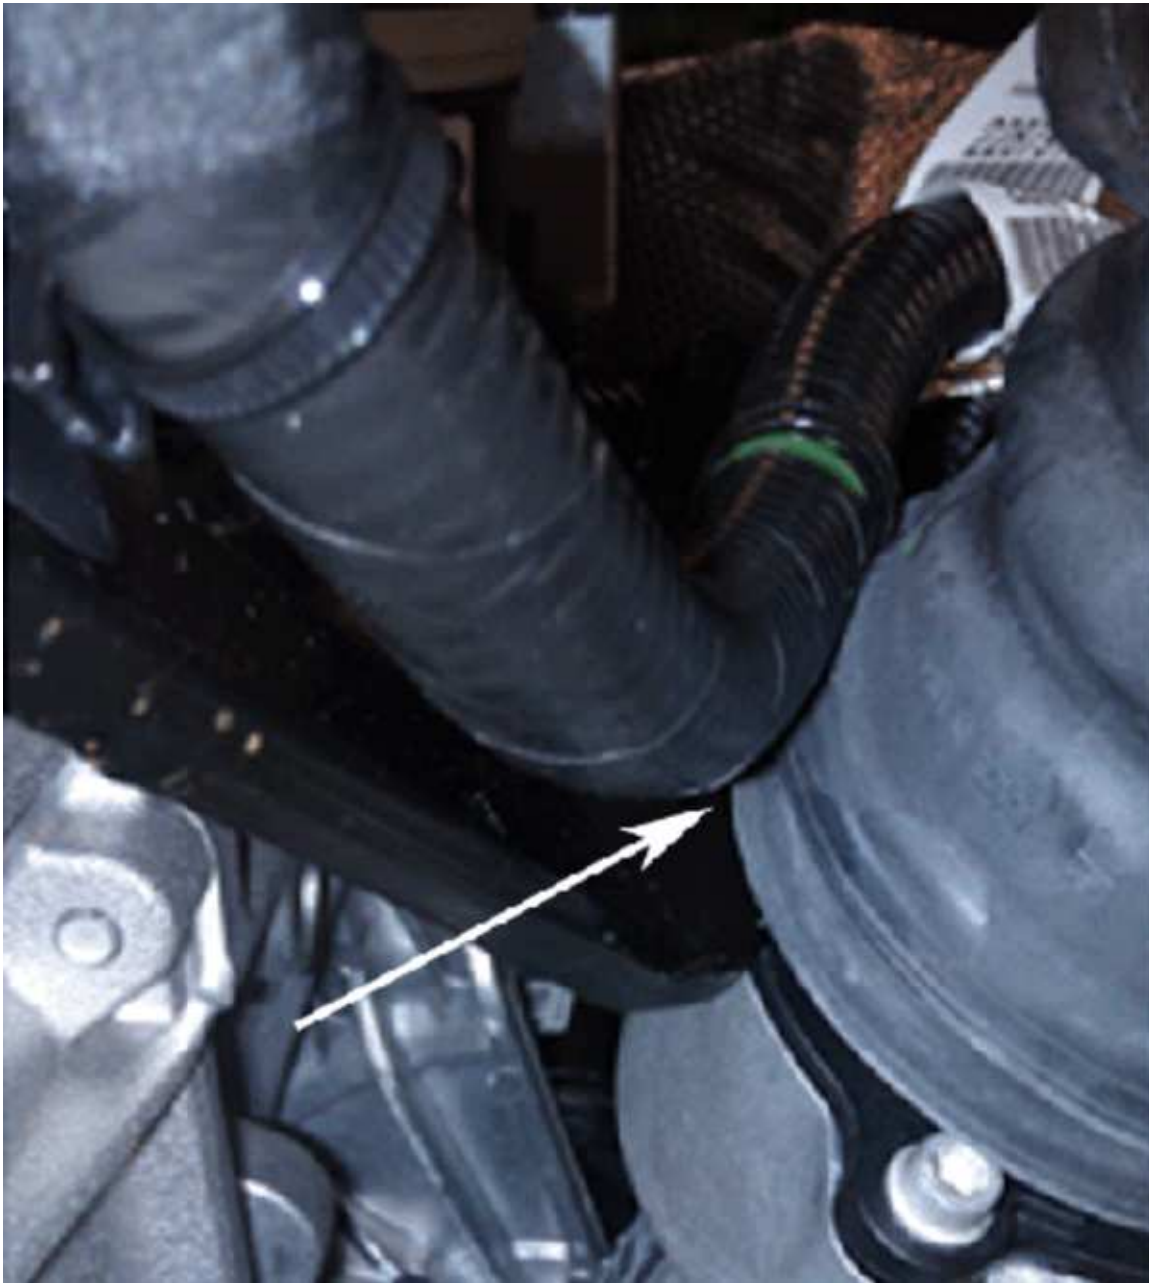
Recommendation/Instructions (LaCrosse, Malibu, Regal, Verano, Cruze, Volt)

This may be caused by the EPS wire harness bracket contacting the steering column seal.

Technicians should inspect the EPS wire harness bracket and make sure that the bracket is not contacting the steering column seal. If contact is observed, manually adjust the EPS bracket to obtain an 8-12 mm (0.31-0.47 in) clearance from the steering column seal.
