# Service Bulletin

## PRELIMINARY INFORMATION

**Subject:** Rough Idle In Drive

**Models:** 2015-2016 Cadillac Escalade Models  
2014 Chevrolet Silverado 1500  
2015-2016 Chevrolet Silverado 1500, Suburban, Tahoe  
2014 GMC Sierra 1500  
2015-2016 GMC Sierra 1500, Yukon Models  
With engines 4.3L, 5.3L, 6.2L RPO L83, L86, LV1, LV3

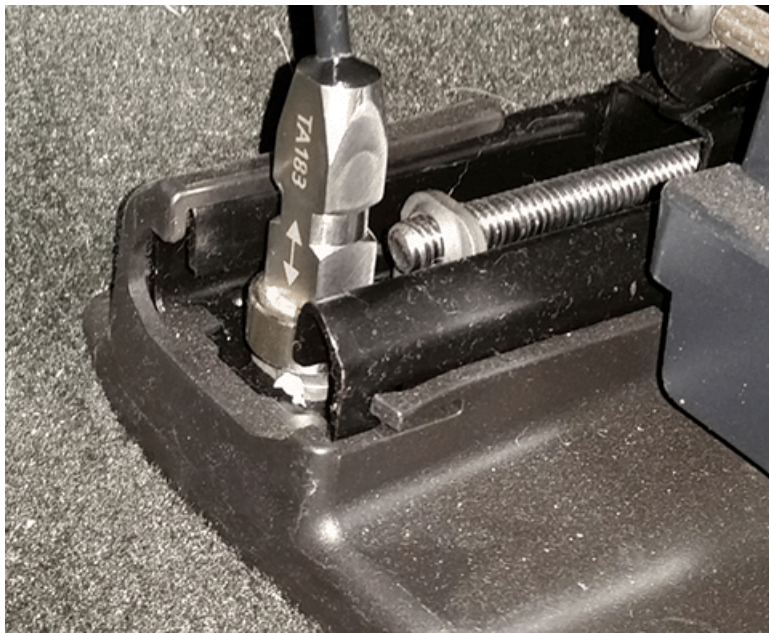
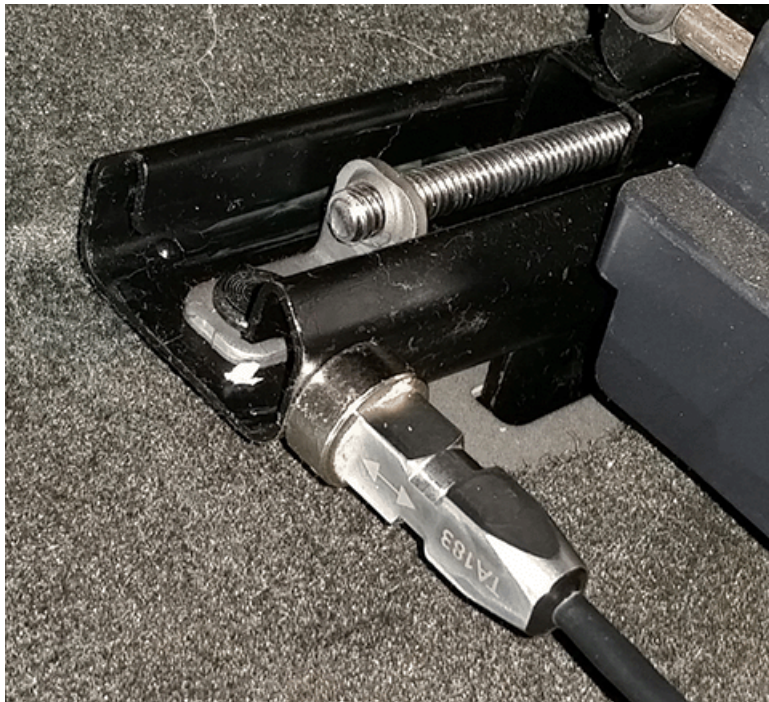
**Note:** If using a single-axis pico sensor, mount and test both vertically and horizontally – E1.5 rough idle vibration will usually be horizontal / lateral at the seat track.

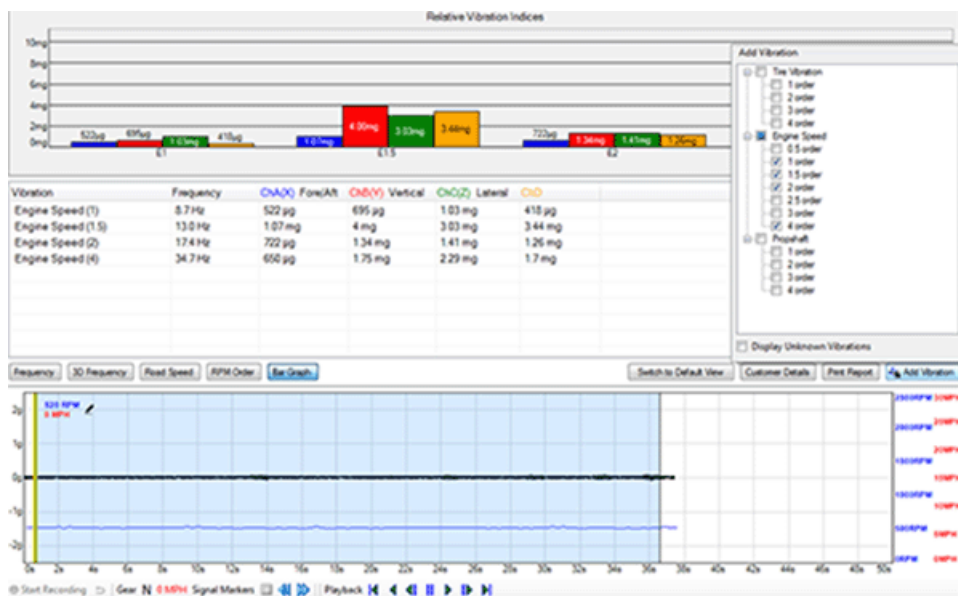
Add E1.5 to the displayed data and turn off T and P related data (under Add Vibration in Pico) since issue occurs with vehicle stationary.

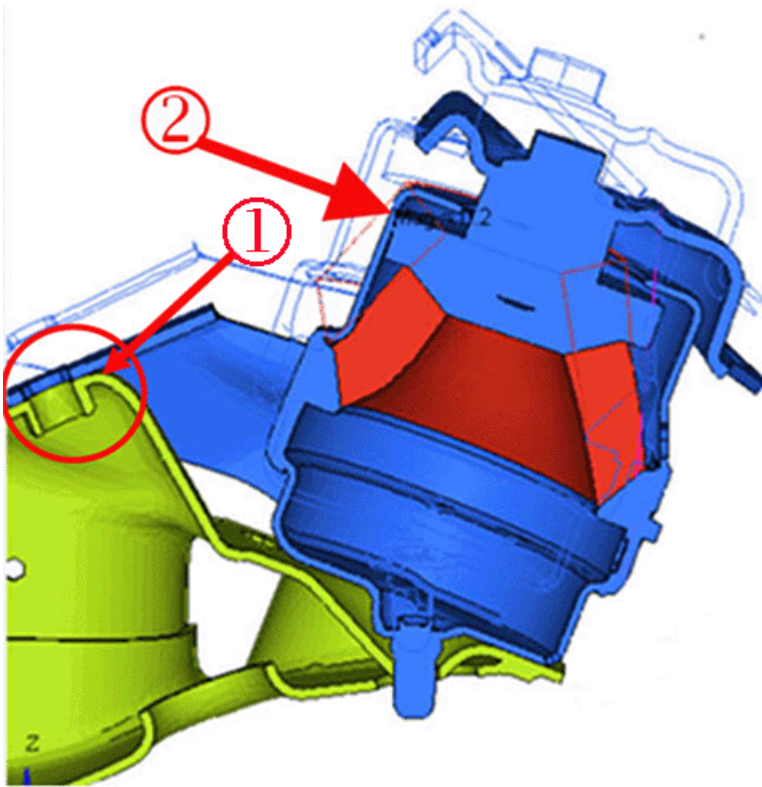
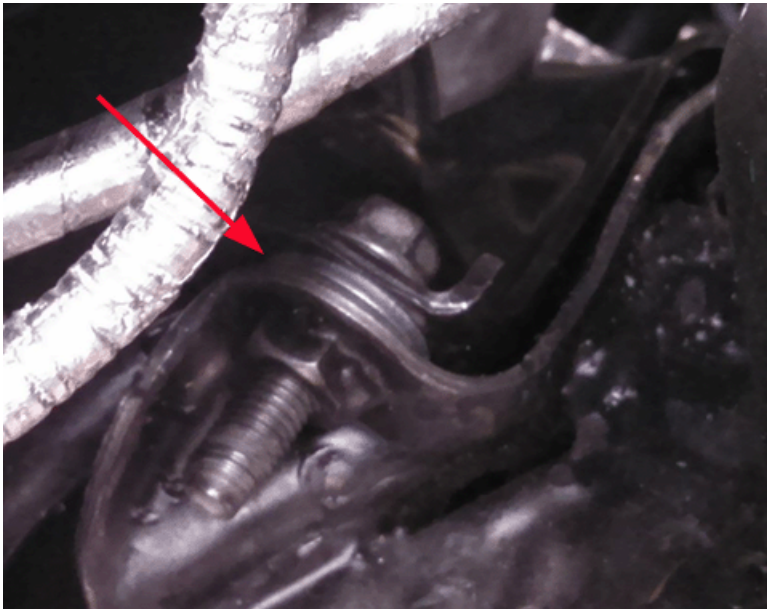
Spacer Washer at Frame Bolt Location Example

**Note:** Often the idle vibration caused by ground-out within an engine mount (2) may be able to be turned off/on with a single bolt location – shimming that bolt location may greatly reduce the vibration. In some cases, a combination of bolt location shimming may be needed.

**Note:** For spacer washers mild steel is recommended, no stainless; it may be necessary for some locations to use a small amount of adhesive such as 'dum-dum' to hold spacer in place.

- 1.5. If idle vibration could Not be turned off/on – repeat process with middle bolt.
  - 1.6. If the idle vibration Could be turned off/on with one bolt, add a spacer washer, approximately 2.5 mm thick (1) when the engine mount and frame attachment at that bolt location.

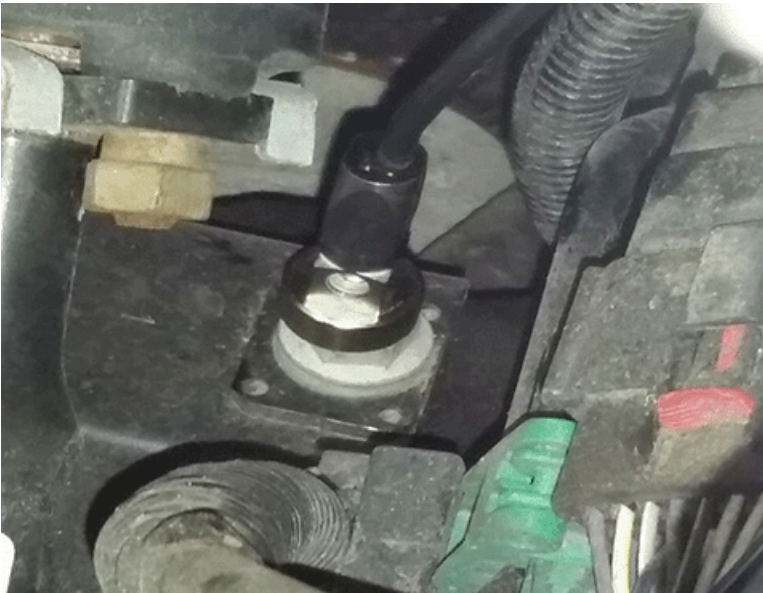
Fine Tuning - Pico Sensor on Mounts (if Needed):

**Note:** It is difficult to lower amplitude of E1.5 idle vibration at the seat track to about 2.5 mg or lower. Many customers are satisfied with approximately 3 mg or less. Some customers may not be satisfied until the idle vibration is brought below 3 mg, closer to 2.5 mg.

6. While the tri-axis sensor is mounted on the inboard seat track forward most location, Channels A-C – Add a second Pico sensor tri-axis or single plane using Channel D.
7. Place the added Pico sensor on the middle engine mount bolt head, beginning with RH side.
8. For Pico readings from the mount, focus on Vertical E1.5. (suggest removing lateral and fore/aft channels from display, and removing E1 and E4 from display).
9. While the idle vibration is active, record the E1.5 amplitude (mg).
10. Repeat steps 6-9 for LH side while the idle vibration is active, and compare readings.
11. Focusing on the side with highest E1.5 amplitude (mg), perform the following:
